Bendigo Creek

Citizen Science Project

River Health Snapshot Report 2021

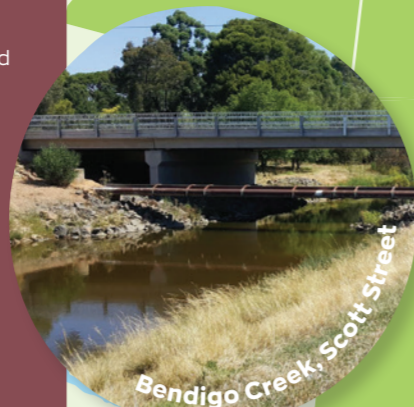
Bendigo Creek, Scott Street

COVID-19 restrictions during the reporting period led to insufficient water quality monitoring data being collected. Waterbug monitoring was undertaken with scores being very poor, likely due to lack of shade and variety of habitats at the site. Being downstream of the CBD, it can be assumed that the site may have recorded poor results for water quality indicators also. There was a slight increase in waterbug richness compared to 2019 results, however, a score of 9 is still well below 21 which is the expected score for a site of good ecological condition.

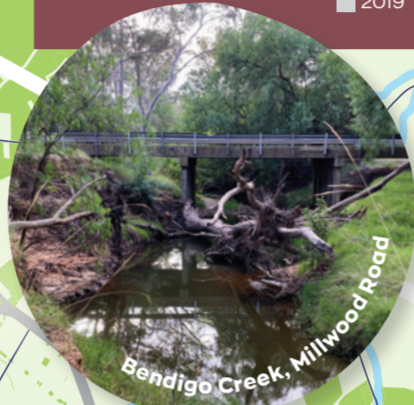
Bendigo Creek, Millwood Road

Water quality results in 2021 are much the same as 2019. As the creek exits the town center there is a gradual improvement in water quality. Aquatic plants and reed beds found through Epsom and Huntly help to filter nutrients and contaminants and no doubt contribute to the improved water quality at this site.

Phosphorous levels and electrical conductivity results have improved from poor to moderate since 2019. Turbidity has also improved due to suspended solids (sediments) being filtered out by the continuing instream vegetation.

Even though water quality scores for this site are good, the waterbug richness and EPT scores remain poor. The SIGNAL score, indicating the presence of more sensitive bugs at the site, has fallen since the 2019 survey.

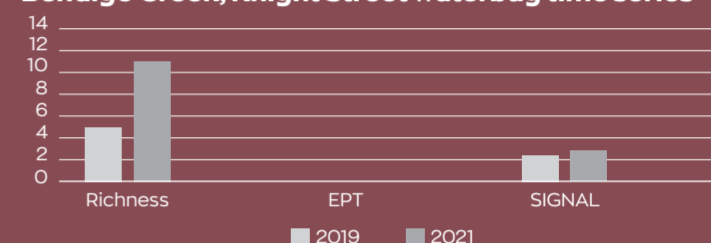
Bendigo Creek, Knight Street

This site is approximately 650 meters downstream from where the creek converts from concrete to an earthen bed, with instream and riverbank vegetation improving conditions. Vegetation plays a vital role in improving water quality and providing habitat which are compromised with a concrete base to the creek.

Unfortunately, this monitoring site was vacated during the reporting period and insufficient water quality data means results cannot be provided, however it can reasonably be assumed results in 2021 would be similar to those of 2019.

Waterbug taxa richness, EPT and SIGNAL scores all rated poor at the site in 2019. This is not surprising as the water in the creek has travelled through the city with various industrial and urban influences.

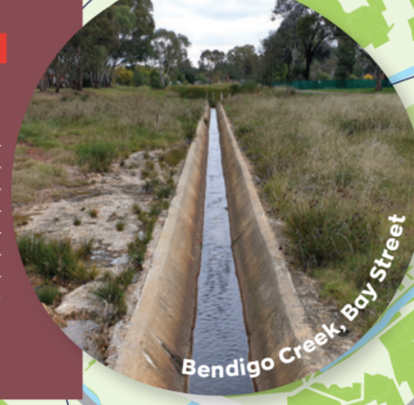
Bendigo Creek, Bay Street

Electrical conductivity at this site has increased since the 2019 report. This site has a high groundwater table, is a known salinity discharge point and has the potential for groundwater intrusion into the creek. Electrical conductivity results could be influenced by saline groundwater along this reach.

Reactive phosphorous has also declined from a good to a moderate rating, while turbidity remains fairly stable at moderate.

Waterbug taxa richness, EPT and SIGNAL scores are all rated poor at the site. Only 12 types of waterbugs were present and no stonefly, mayfly or caddisfly larvae being present. With their high sensitivity, this is likely attributed to the relatively poor water quality and the limited variety of habitats offered by this site.

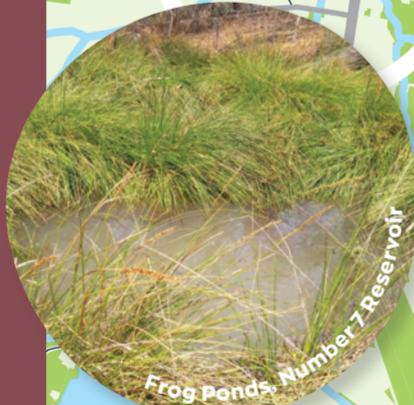
Frog Ponds, Number 7 Reservoir

The ponds are kept full by regular top-ups from the adjacent Number 7 Reservoir, so water quality is largely based on that of the Reservoir, combined with natural runoff following rain. Water quality results are similar to that in the 2019 report - generally good, with pH and electrical conductivity rating well, and reactive phosphorous at moderate levels. Turbidity at this site is often high, most likely due to inflows from the reservoir disturbing sediments in the ponds.

Despite the relatively good water quality, waterbug richness, EPT and SIGNAL scores rated low at the site, likely a result of poor turbidity.

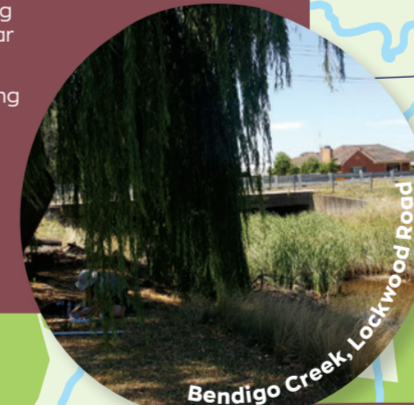
Bendigo Creek, Lockwood Road

Compared to 2019 water quality results, this site has seen an increase in electrical conductivity. This may be due to reduced inflows leading to a concentration of salts, an increase in industrial waste or saline water entering the creek, or creek bed disturbance leading to saline groundwater entering the waterway. Reactive phosphorous and pH have remained much the same. There has been an improvement in turbidity, perhaps due to a large urban housing development upstream now being largely complete resulting in less sediment being washed into the creek.

Results are as expected for an urban creek with a very narrow vegetated buffer. The adjacent walking track is popular for dog walking; faeces entering the waterway could be a contributor to the moderate nutrient (reactive phosphorous) level score, along with usual pollution pressures often seen in similar urban streams.

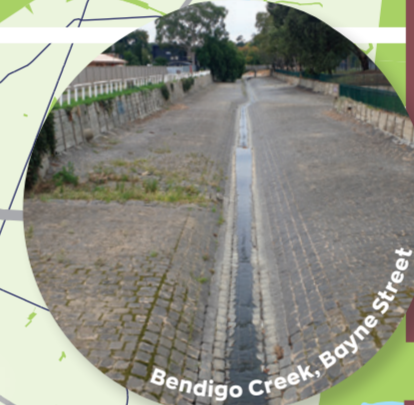
Bendigo Creek, Bayne Street

This site is immediately downstream of the Bendigo CBD and is the most impacted by stormwater inputs from the city and surrounding industries. Compared with 2019 results, electrical conductivity, reactive phosphorous and turbidity have slightly improved, but remain poor at this site.

As with the previous site, this reach of the creek is also characterised by a concrete bank and substrate with no instream or fringing vegetation.

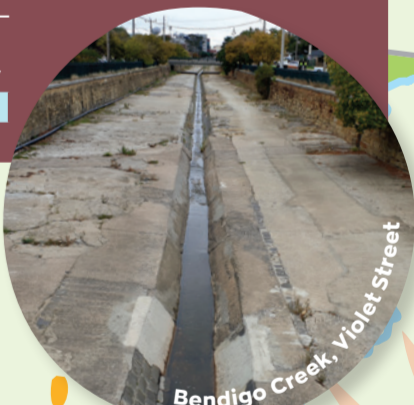
Bendigo Creek, Violet Street

This site is close to the central business district (CBD) of Bendigo and its health is likely being impacted by a variety of contaminants often seen in urban stormwater. Litter, organic pollutants (leaves, grass clippings, animal dropping etc.) and chemical agents, such as petrochemicals, oils, fertilizers and industrial waste, all have a significant impact on the health of our urban waterways. Contaminants are an issue along the length of Bendigo Creek but more compounded through the CBD where there is a concrete substrate and no instream vegetation to help filter out contaminants.

The Golden Gully tributary enters Bendigo Creek about 750 meters upstream of this site and may be a significant contributor to poor quality water as it travels through an industrial zone before entering Bendigo Creek.

As this reach of the creek is characterised by a concrete bank and substrate there is no instream or fringing vegetation to assist with water decontamination. Turbidity and electrical conductivity are poor, while reactive phosphorous is moderate.
