Bridgewater Flood Management Plan Study Report

March 2016

Project Name	Bridgewater Flood Study
Client	North Central CMA
Client Project Manager	Leila Macadam & Jolene Goulton
Water Technology Project Manager	Alison Miller
Report Authors	Alison Miller
Job Number	3524-01
Report Number	R06
Document Name	3524-01R06v01_StudyReport_DRAFT.docx

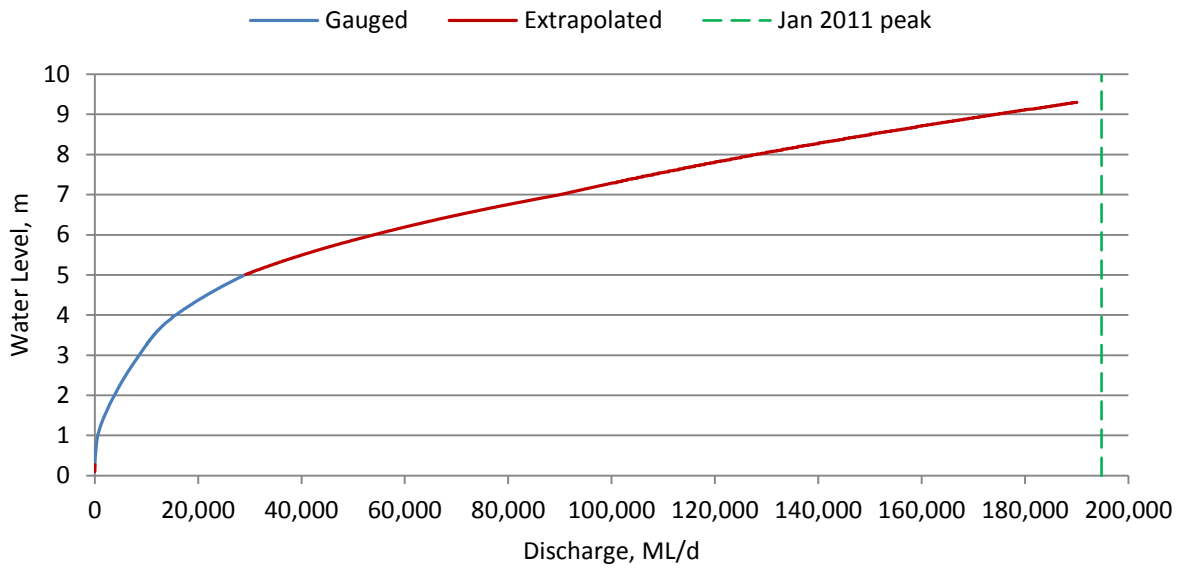
Figure 2-9 Laanecoorie gauge rating curve and reported peak Jan 2011 flow

It should be noted that the peak estimated flow during the January 2011 flood was approximately 195,000 ML/d, which is slightly beyond the extrapolated rating curve, as seen in Figure 2-9.

Further, the tail gauge was damaged to the point of being non-operational during the January 2011 flood event. The last streamflow recorded at the gauge was at 91,000 ML/d, taken at 12:30 pm on 12th January. A comparison of this data with the head gauge shows major discrepancies in the timing of the recorded flows, as seen in **Error! Reference source not found.**, with both gauges showing the same trend, but the Laanecoorie tail gauge reading approximately 24 hours earlier. This discrepancy in timing has only been observed in the January 2011 flood event. Timing of the peak flow recorded at the Laanecoorie head gauge is aligned with anecdotal evidence.

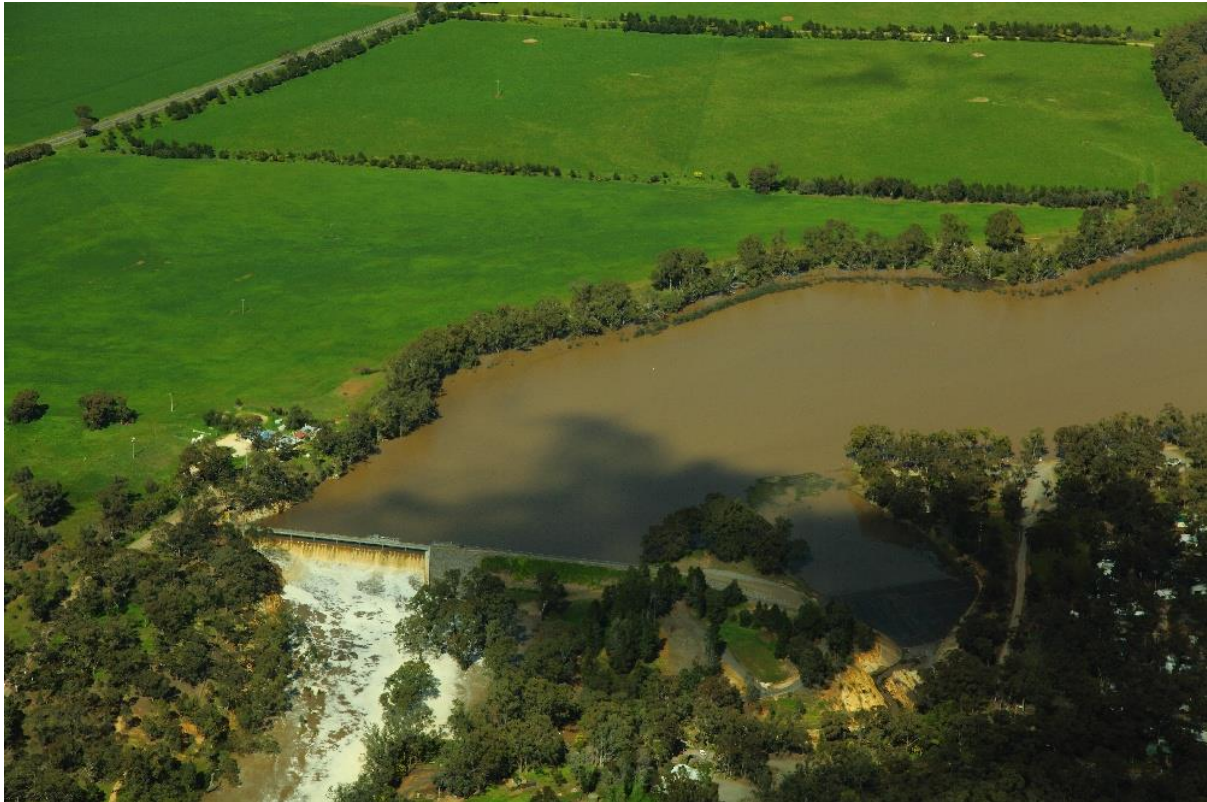
Figure 2-14 Laanecoorie Reservoir during January 2011 flood (NCCMA)

The Laanecoorie Reservoir has a full supply level of 160.2 m AHD⁴. The primary spillway is a series of automatic flood gates, which become fully open at a water level of 160.81 m AHD. A secondary bywash spillway exists on the north-west side of the reservoir, with a crest level of 160.53 m AHD. It joins the Loddon River downstream of the main embankment. These two spillways can be seen in Figure 2-13 and Figure 2-14. Four 915 mm diameter pipes allow the release of low operating flows down the Loddon River.

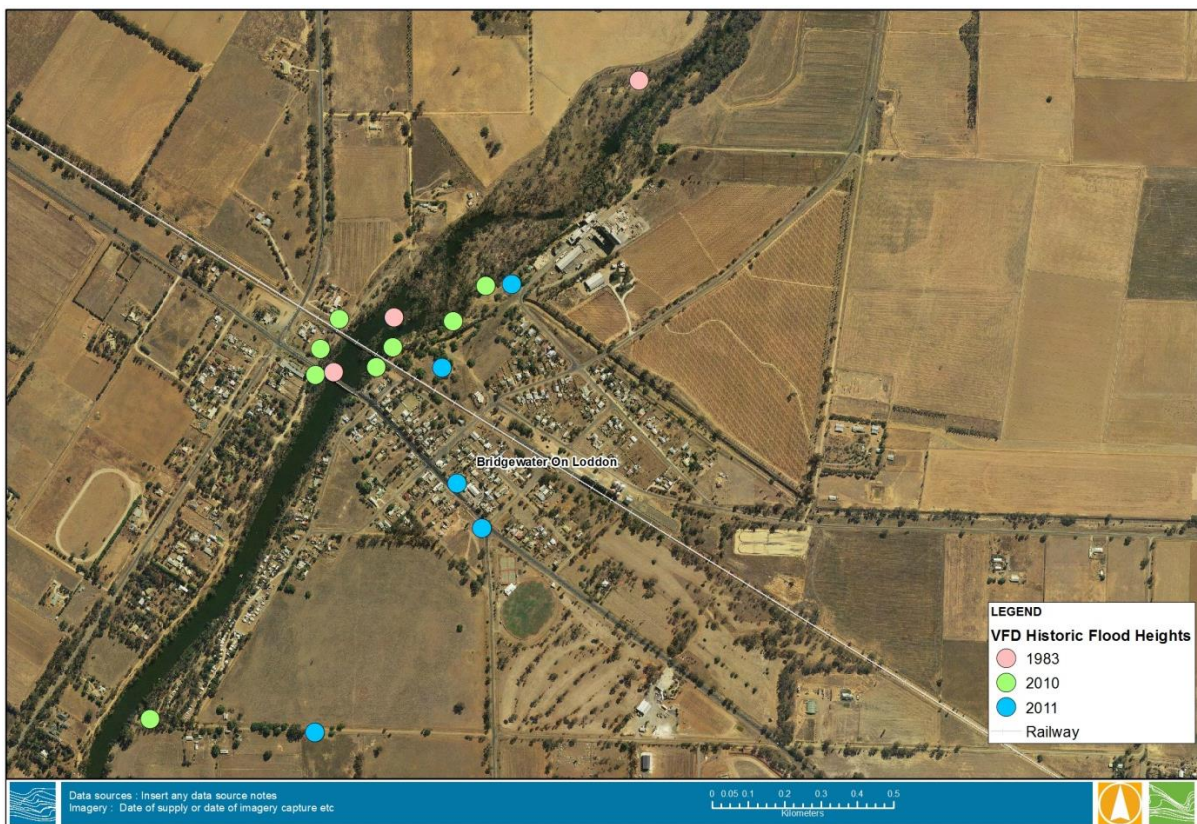
Figure 2-17 Historic Flood Heights from the Victorian Flood Database

The flood in September 1983 has also been ear-marked as a potential flood to use for calibration, due to the availability of data. The Victorian Flood Database maintains records of observed flood heights for the 1983, 2010 and 2011 flood events, as seen in Figure 2-17.

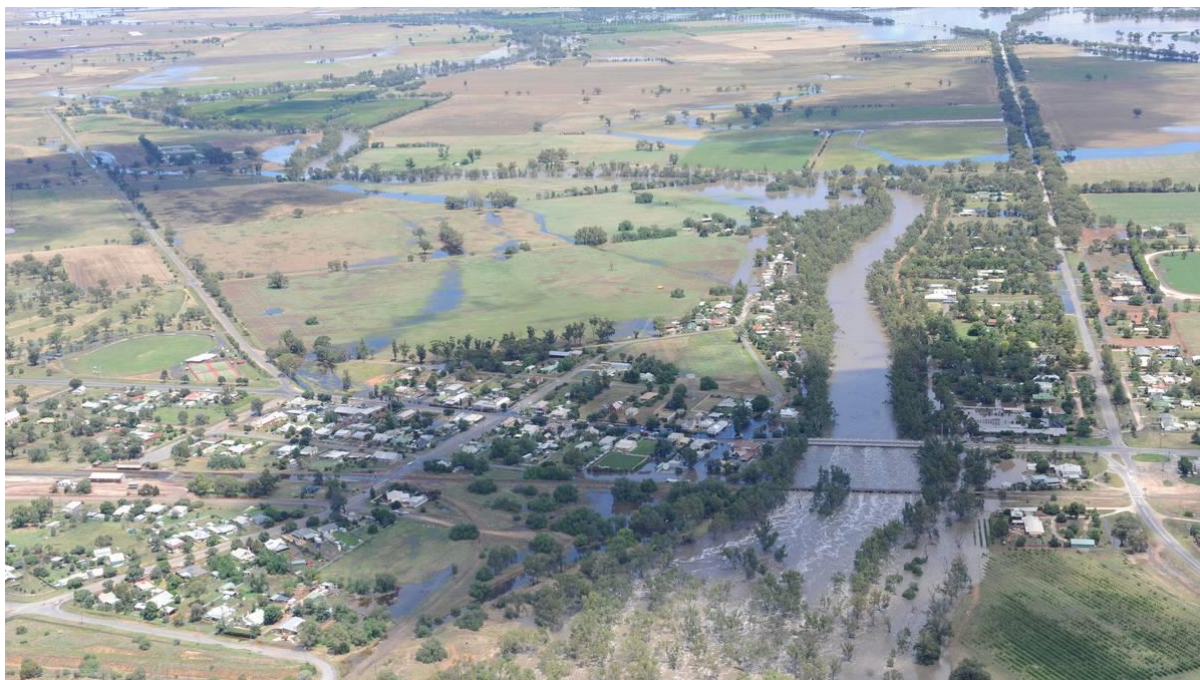
Figure 2-18 Bridgewater flooding 14 January 2011 (Bendigo Advertiser)

The heavy rainfall, coupled with storages that were already full from flooding in late 2010 led to large flood flows in the river. Floodwaters overtopped the banks of the Loddon River within Bridgewater itself, and broke away upstream, proceeding to flow down the main street of the town, as seen in Figure 2-18.

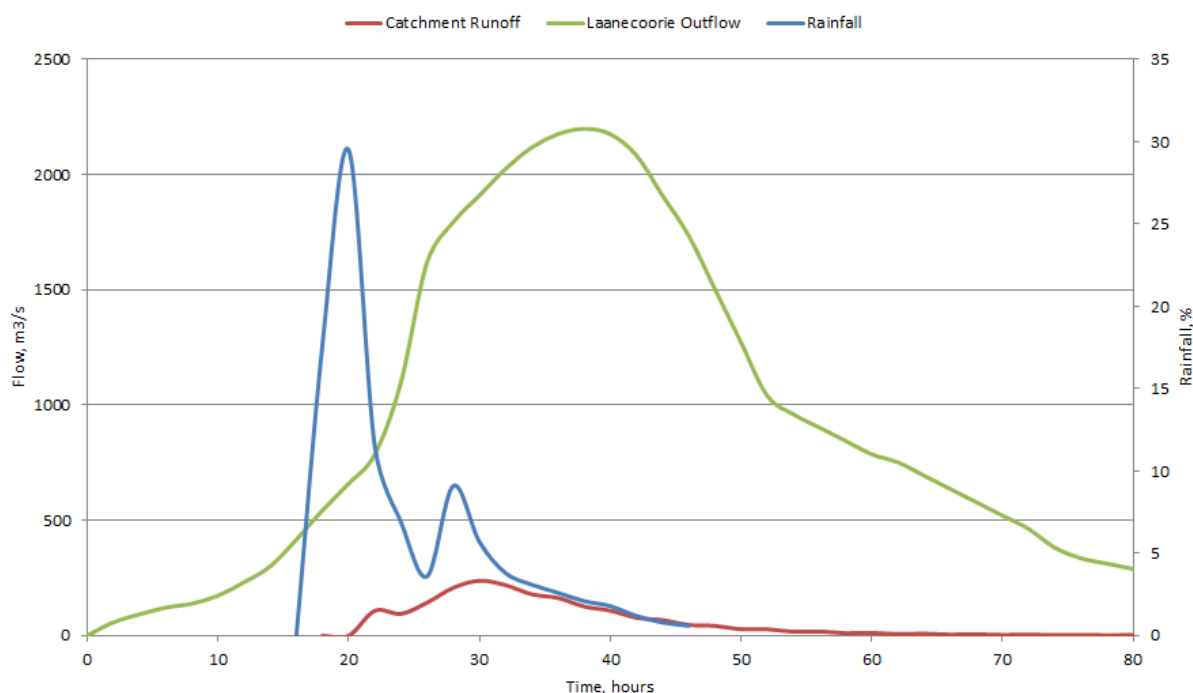
Figure 3-29 Relative timing of rainfall and runoff for the 1% AEP event

Historical floods were analysed to determine the relative timing of flows from the Loddon River and local catchment. It was found that on average, peak discharge at Laanecoorie occurred 18 hours after the peak rainfall. The design Loddon River hydrograph was therefore input to the RORB model to align with this timing, as indicated in Figure 3-29.

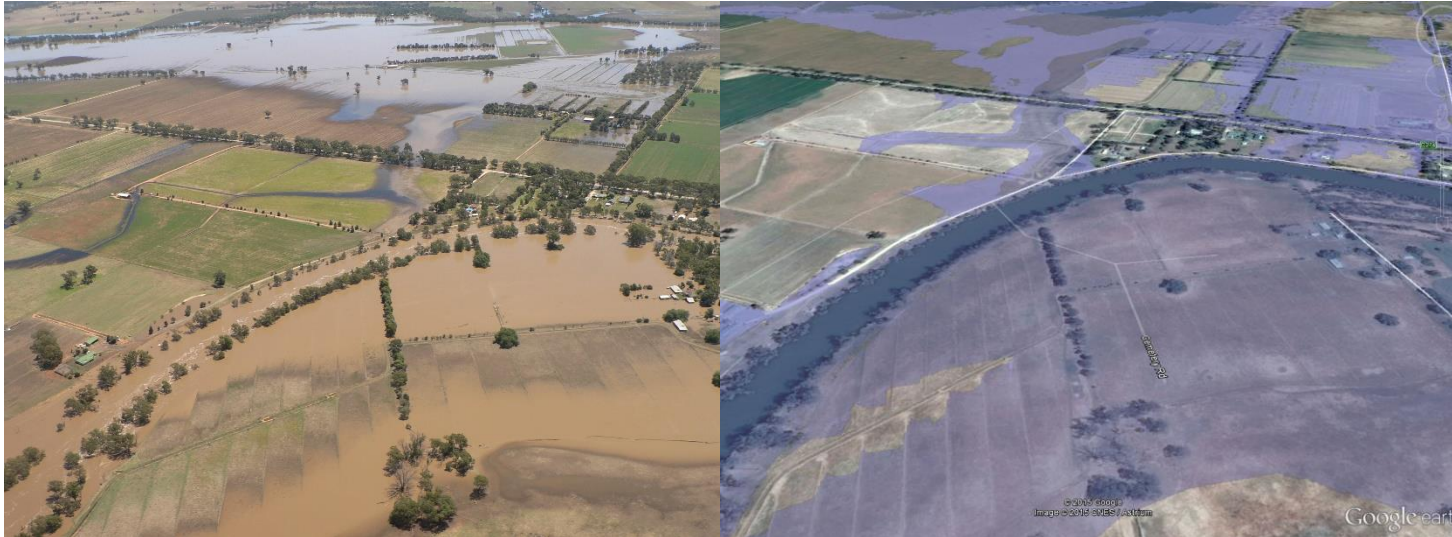
Figure 4-4 Bridgewater township on the 15th January 2011 looking north

Aerial photographs, such as those shown in Figure 4-4 and Figure 4-5 are invaluable to the calibration process. These photos are shown alongside the flood extent produced from modelling results and show a good calibration in regards to flood extent. It is rare to get such good coverage of observed flooding so close to the peak of the event, with these photos taken around 8-10 hours after the flood peak, however the flood extent is still visible in several locations. These photos (and many others) were used to validate the flood extent.

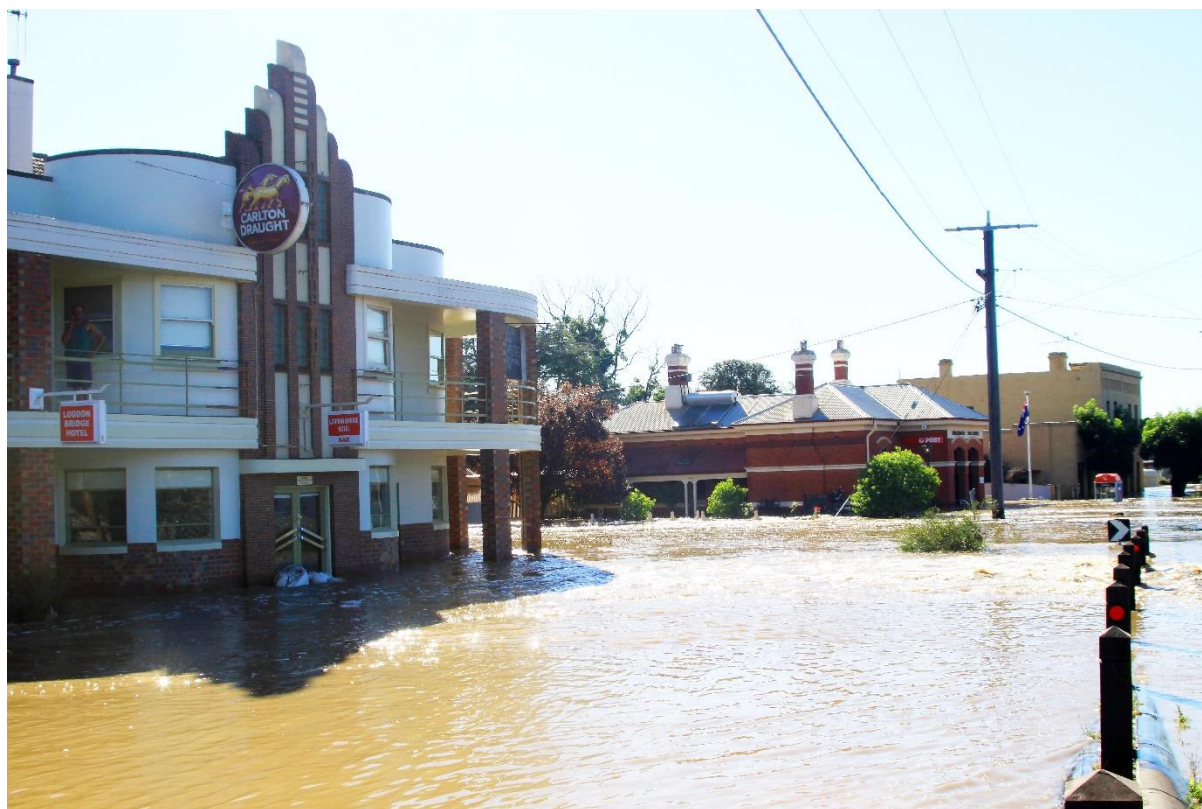
Figure 4-8 Bridgewater Hotel close to the peak of the January 2011 flood event

Several other locations throughout the town had recorded anecdotal water levels, which were captured from personal photographs and the flood impact register undertaken by the Loddon Shire Council. These observed levels were able to provide further validation that the flood model was matching the January 2011 flood event well. At the Bridgewater Hotel, photographs show that water level appears 1-2 bricks above the floor level which was estimated at approximately 400 mm depth above ground level or 200-300mm above the floor level which was surveyed at 137.18 m AHD, giving an estimated flood level of 137.40-137.50m AHD. Model results show that around the hotel, flood levels were in the range of 137.38-137.42m AHD which matches well within the estimated flood level.

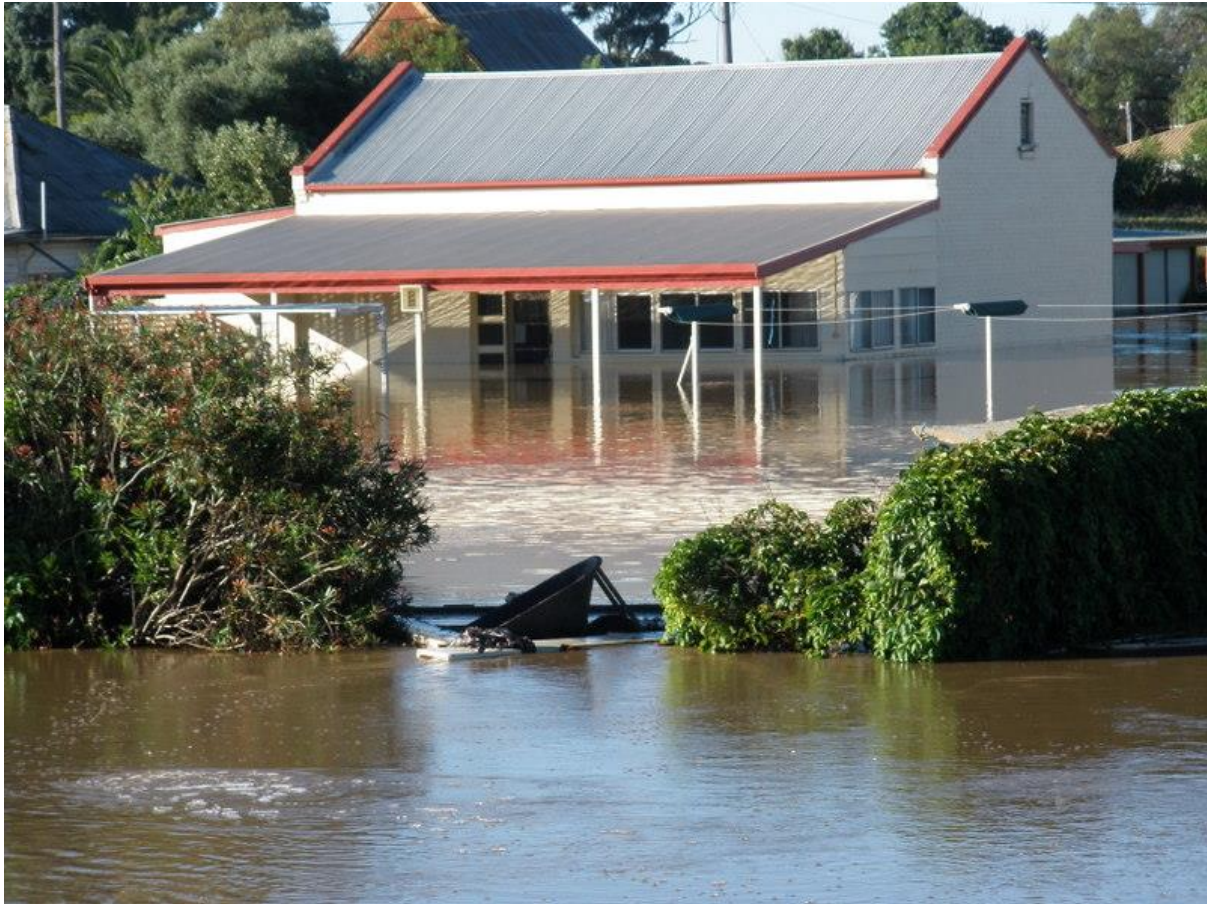
Figure 4-9 Bridgewater Bowling Club close to the peak of the January 2011 flood event

The Bridgewater bowls club also had observed flood levels from photographs just past the peak flood height. The photo shown in Figure 4-9 shows the peak flood level just under the level of the window sill. Using the surveyed floor level at the bowling club it was estimate that the flood level was approximately 750-900 mm above the ground level or 550-700 mm above floor level (136.94 m AHD) giving an approximate flood level of 137.50 – 137.65 m AHD. Modelling results showed that the peak water level at the bowling club was 137.47m AHD, close to the estimated flood level.

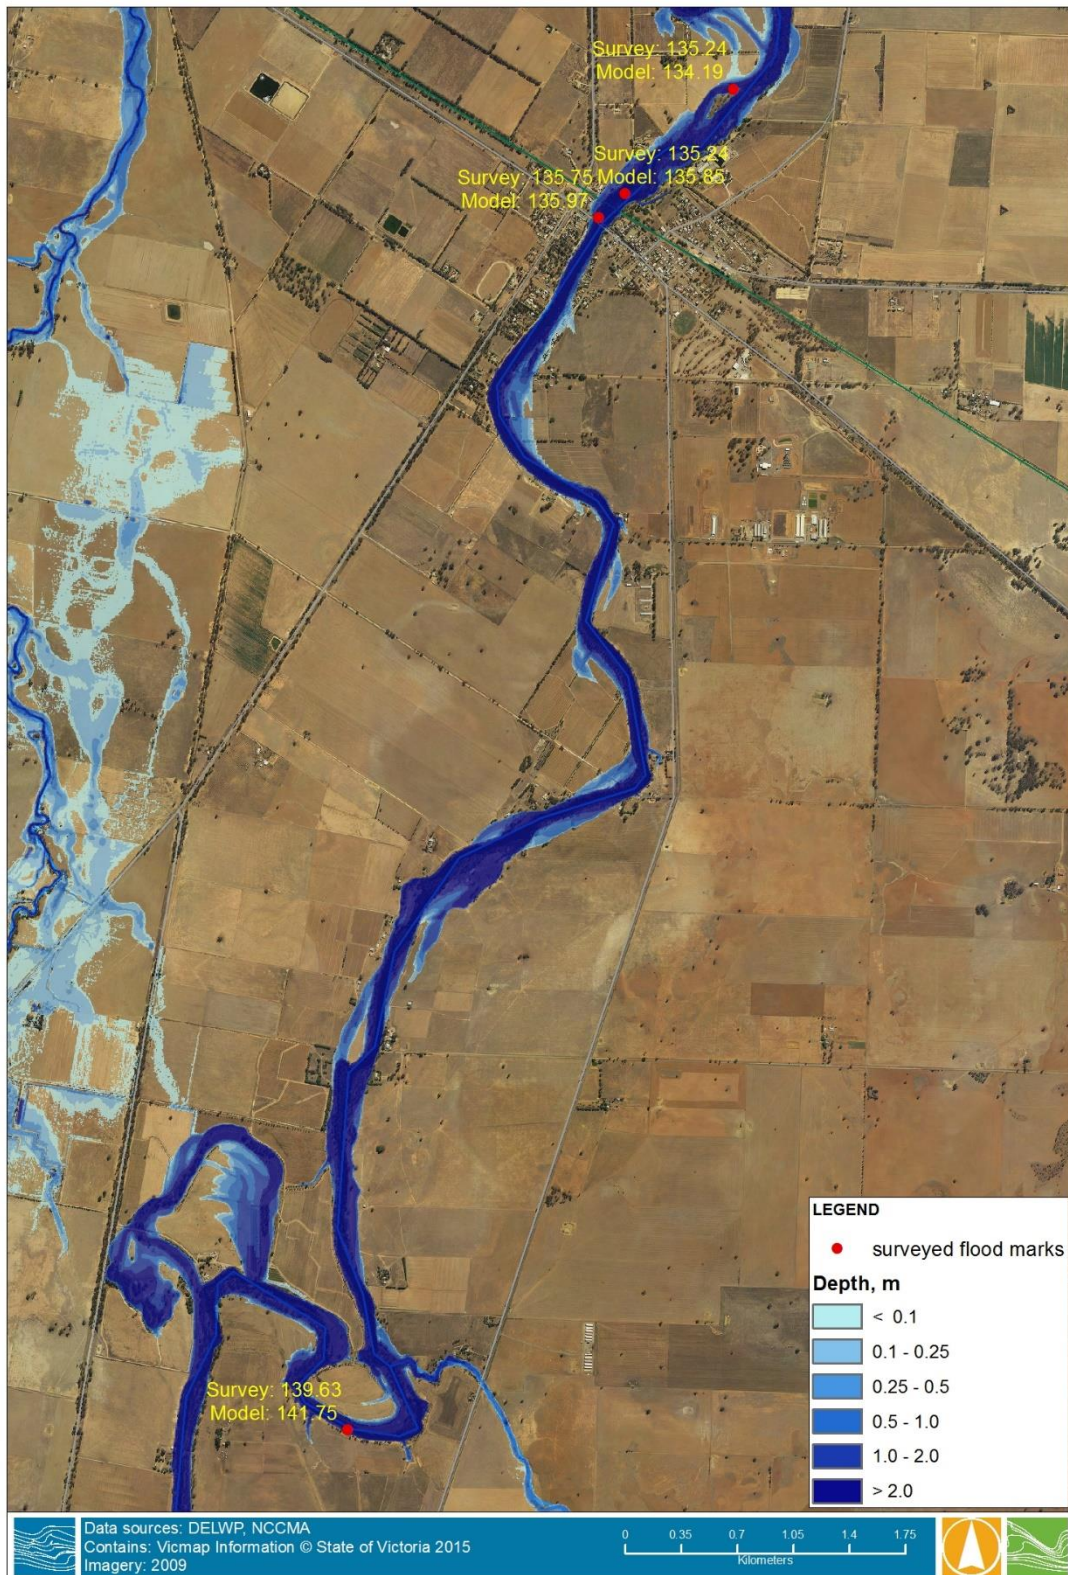
Figure 4-13 Surveyed and modelled flood levels for September 1983 flood event

The resulting flood extent for the September 1983 event is shown in Figure 4-12. Four surveyed flood marks were available, and have been compared to the modelled water surface elevations, as shown in Figure 4-13 and Table 4-5.

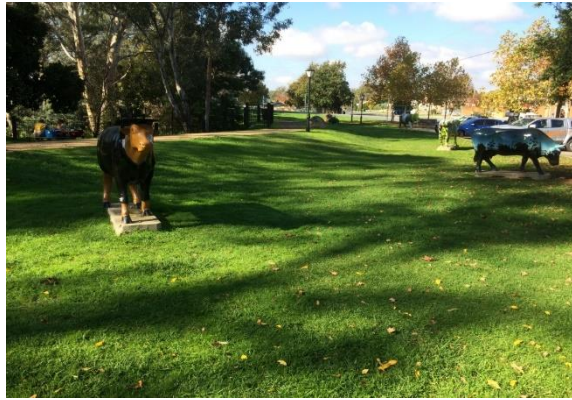
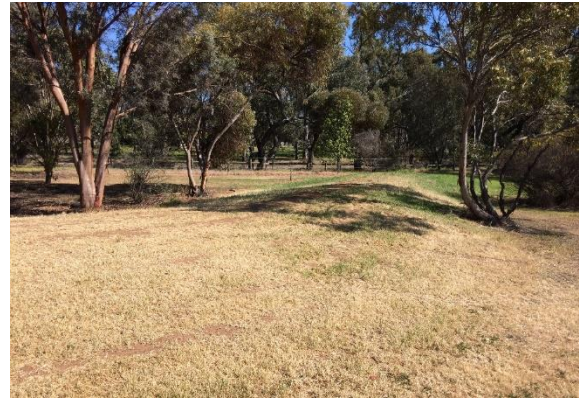
Figure 5-5 Examples of earthen levees

Examples of earthen levees and temporary levees are given in Figure 5-5 and Figure 5-6 consecutively. There is a common misconception that levees dominant the aesthetics of a landscape, however earthen levees can (and have been) pleasingly integrated into the existing environment.

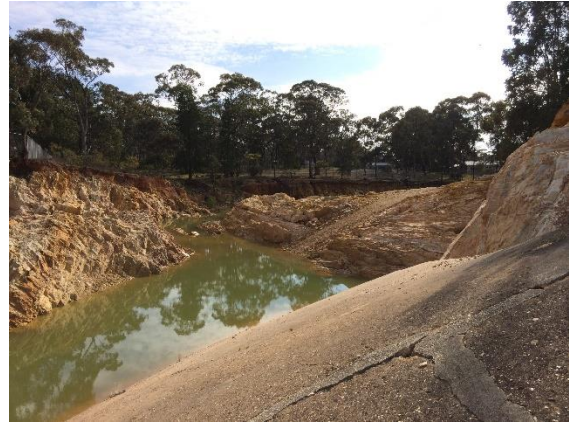
Laanecoorie Reservoir Spillway
