Clunes Flood Mitigation and Urban Drainage Plan Final Study Report

June 2013

Project Name	Clunes Flood Mitigation and Urban Drainage Plan
Client	North Central CMA
Client Project Manager	Camille White
Water Technology Project Manager	Aaron Vendargon
Report Authors	Aaron Vendargon
Job Number	2048-01
Report Number	R05
Document Name	2048-01R05v03_Clunes_Final_FS_Report.docx

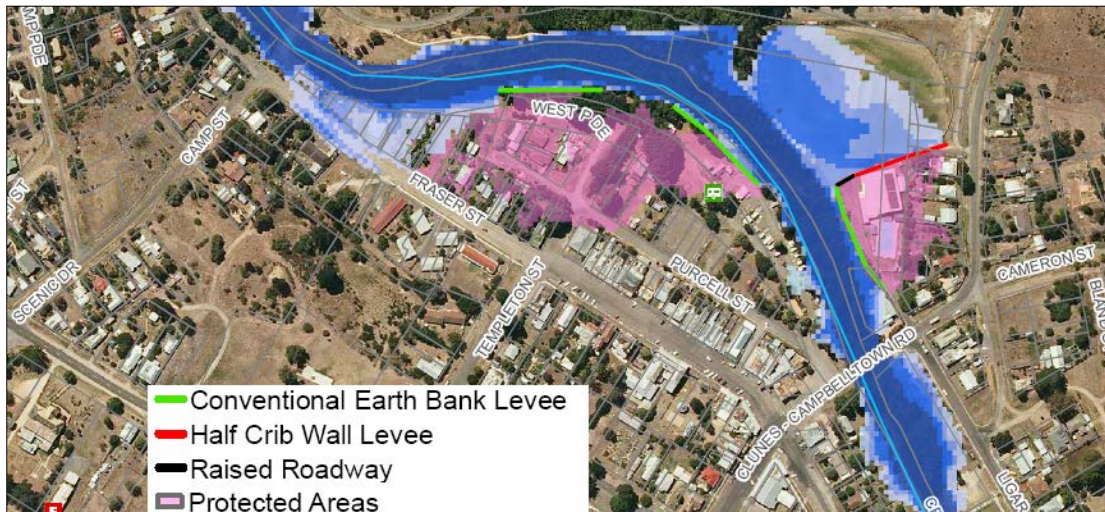
Mitigation Option 1 Works

This option would remove above floor flooding at one residential property in a 20 year ARI event. External flooding would be reduced at the swimming pool, basketball court building and a number of residential properties along Purcell Street, Fraser Street and next to the oval. The only property not protected in a 20 year event would be the 'old butter factory'. In larger events, the levee would not have any significant impact on the flood distribution and flood depths.

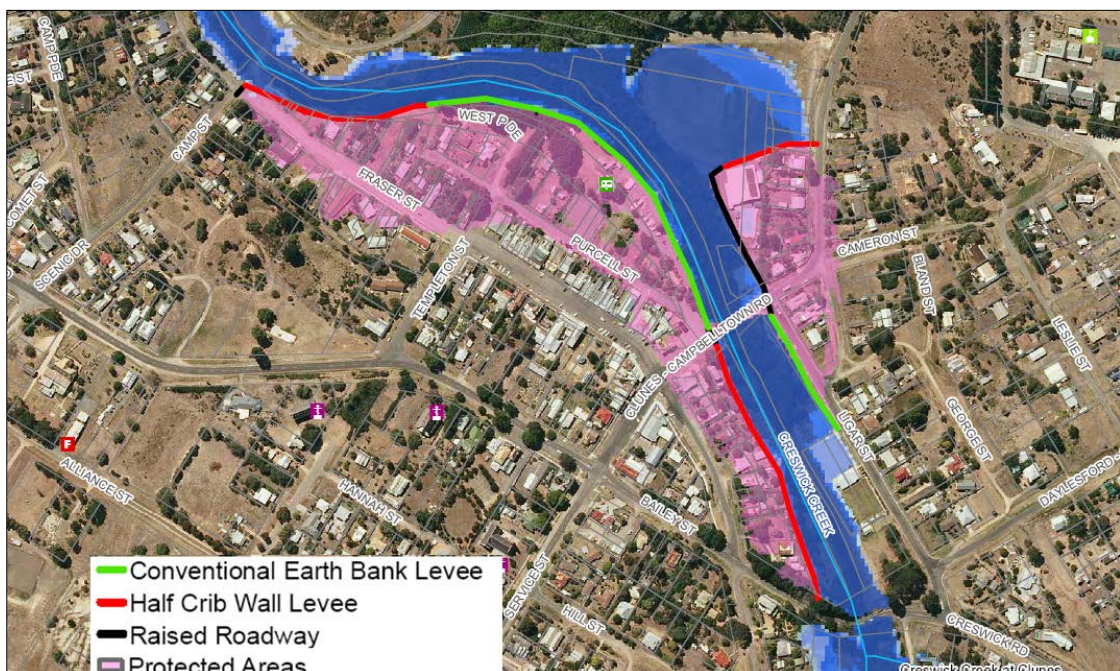
Mitigation Option 2 Works

Mitigation Option 2 was subject to numerous design constraints, primarily due to the close proximity of properties to the creek. Construction of levees over private property would be unavoidable in some sections. This option would remove flooding across the entire township for a 50 year ARI event. As with Option 1, the only property not protected would be the 'old butter factory'.

Option 1 has a total capital cost of roughly \$109,000 and a benefit cost ratio of 0.3, while Option 2 has a total capital cost of roughly \$2.16 million and a benefit cost ratio of 0.1.

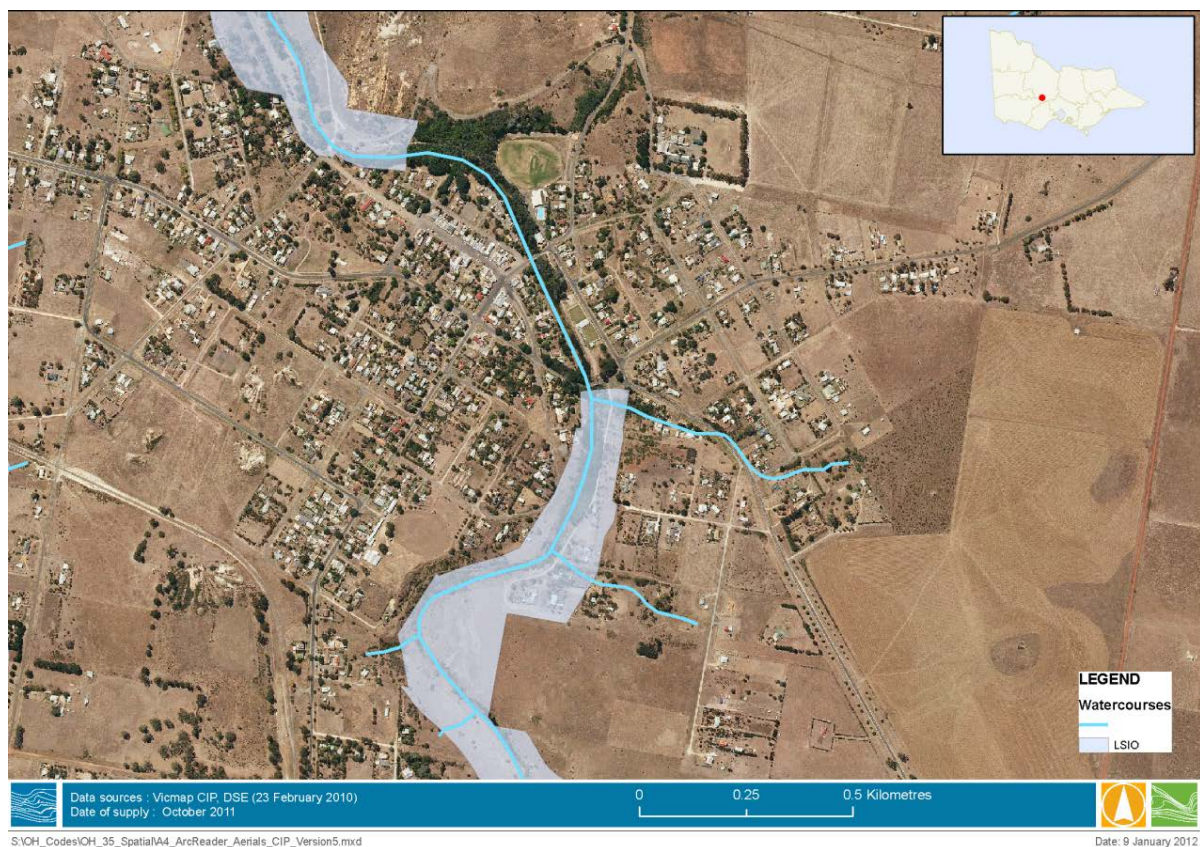
Figure 1-2 Existing Incomplete LSIO Extent

A 'Land Subject to Inundation Overlay' (LSIO) is available for Clunes; but the extent of the LSIO stops between Bailey Street and Fraser Street (Figure 1-2). This incomplete LSIO most likely represents a recent historical flood extent or a best estimate. It is unknown why the LSIO is incomplete between Bailey Street and Fraser Street, but most likely is a result of planning decision. The entire creek is zoned Public Park and Recreation and has an Environmental Significance Overlay, both of which work to restrict development in these areas.

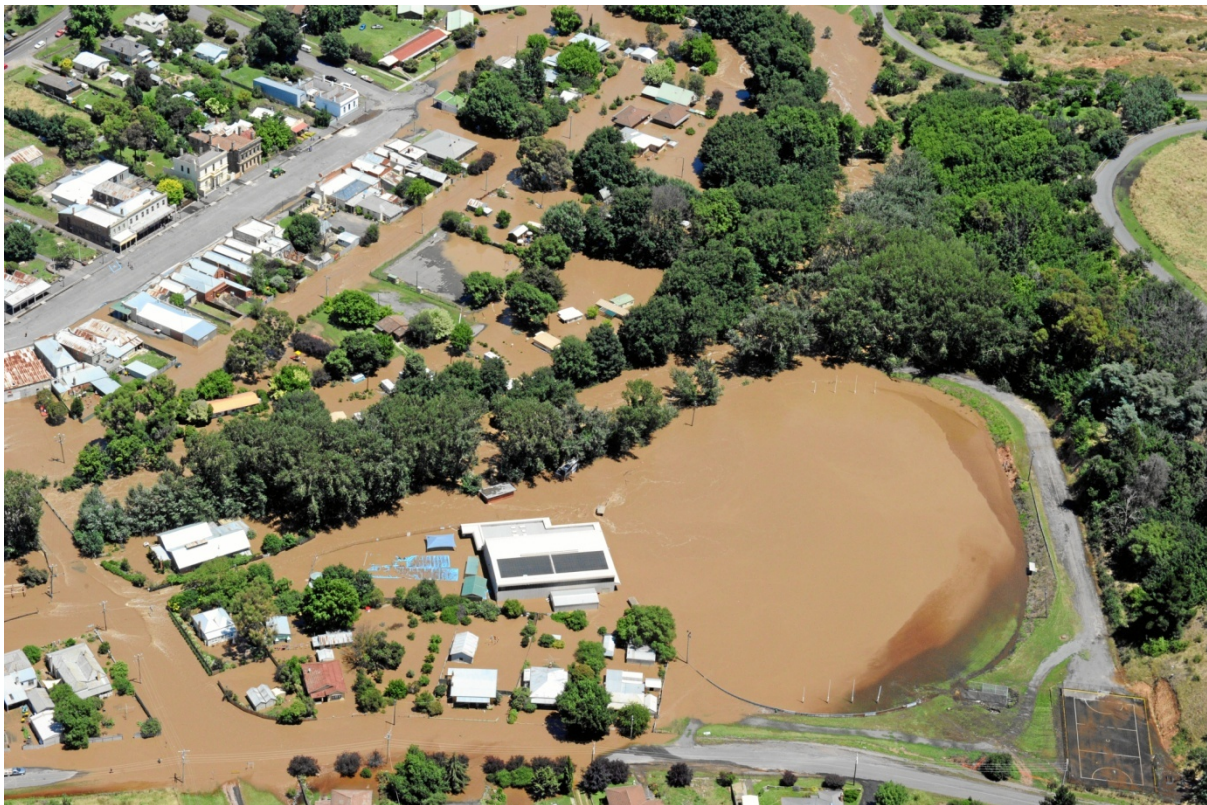
Figure 1-3 Photo of the January 2011 Flood Event

Site observations, hydrological data and aerial photos were used to provide an understanding of the flooding mechanisms in September 2010 and January 2011. Both flood events were similar given the confined nature of the floodplain; however water levels in January 2011 were much higher. An aerial photo of the January 2011 flood event (just past its peak) is shown in Figure 1-3 below.

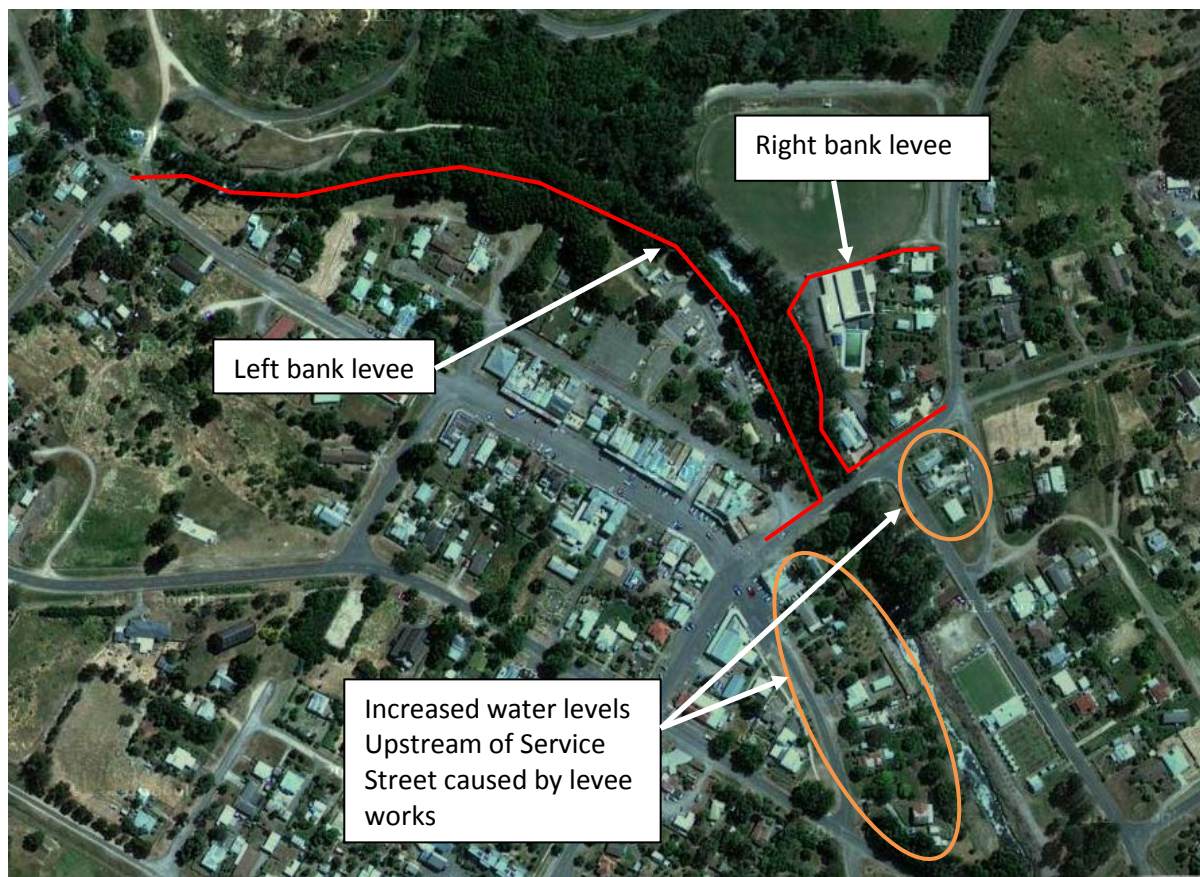
Figure 6-1 Preliminary Mitigation Option - Iteration 1

- Left bank levee extending from Service Street to Camp Street; and
- Right bank levee downstream of Service Street, protecting the properties south of the oval

During the initial 50 year ARI model run it became evident that the proposed levees were constricting the flow path and significantly increasing water levels upstream of Service Street by up to 0.9 m. This is not acceptable as there are numerous properties located upstream of Service Street which would be adversely impacted.

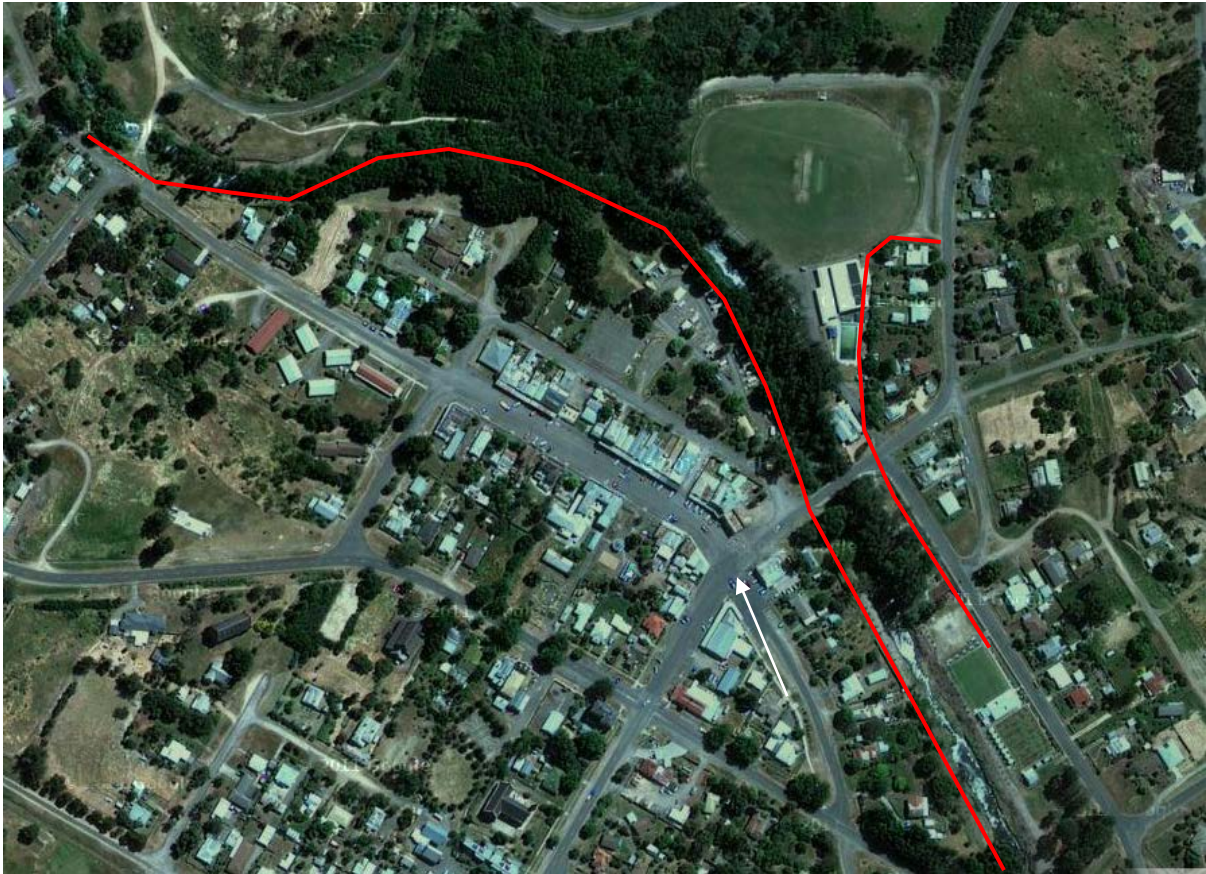
Figure 6-8 Preliminary Mitigation Option - Iteration 8

Iteration 8 (Figure 6-8)	As per iteration 7, with a left bank levee upstream of Service Street. Effectively leveeing the whole town.	All properties protected, except for the 'butter factory'.
Iteration 9 (Figure 6-9)	As per iteration 6 with the left bank levee extended to cross Fraser Street. This option also includes major channel widening to offset the increased water levels caused by the levee.	Properties downstream of Templeton Street protected from flooding. The channel widening ensures that flood levels are not increased outside the levee.

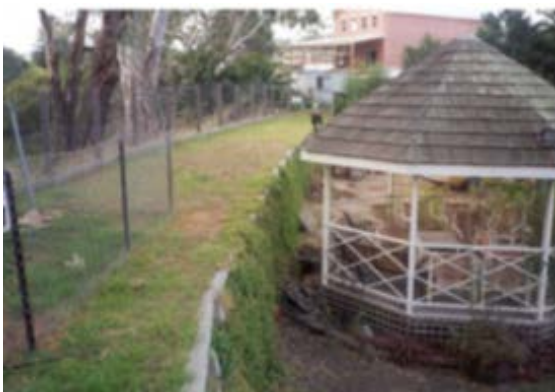
Figure 6-12 Crib Wall Levee

On the right bank, different levee types were used to deal with the lack of space and road crossing issues. A short section of right bank levee crosses Ligar Street and can be constructed by raising the road. It is proposed that the raised road section is built up to the flood level, with additional freeboard provided by sandbags during a flood event. Construction of the levee along the south corner of the oval is restricted by a lack of space. To avoid having the levee encroach onto the oval, concrete retaining walls or crib walls can be used. Examples are shown in Figure 6-12 and Figure 6-13 below. Detail design will have to consider access issues for the oval. Along Creswick Creek an earthen levee is proposed next to Ligar Street. The right bank levee alignment stops just before the old butter factory next to the creek.

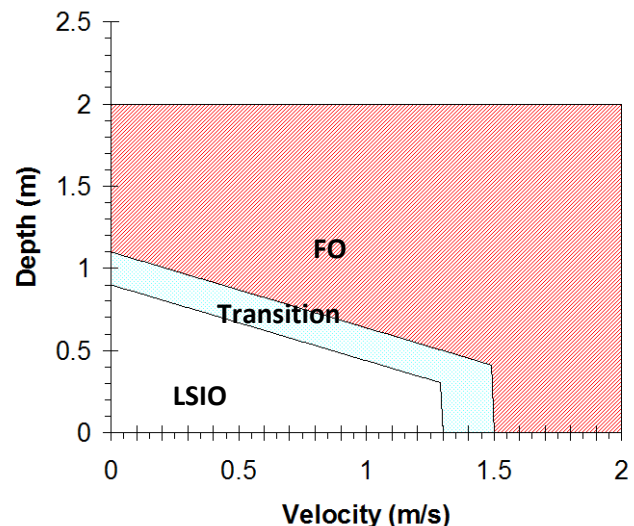
Figure 6-16 Flood Hazard Delineation of FO

Flood hazard - Combines the flood depth and flow speed for a given design flood event. The advisory notes suggest the use of Figure 6-16 for delineating the floodway based on flood hazard. The flood hazard for the 100-year ARI event was considered for this study.

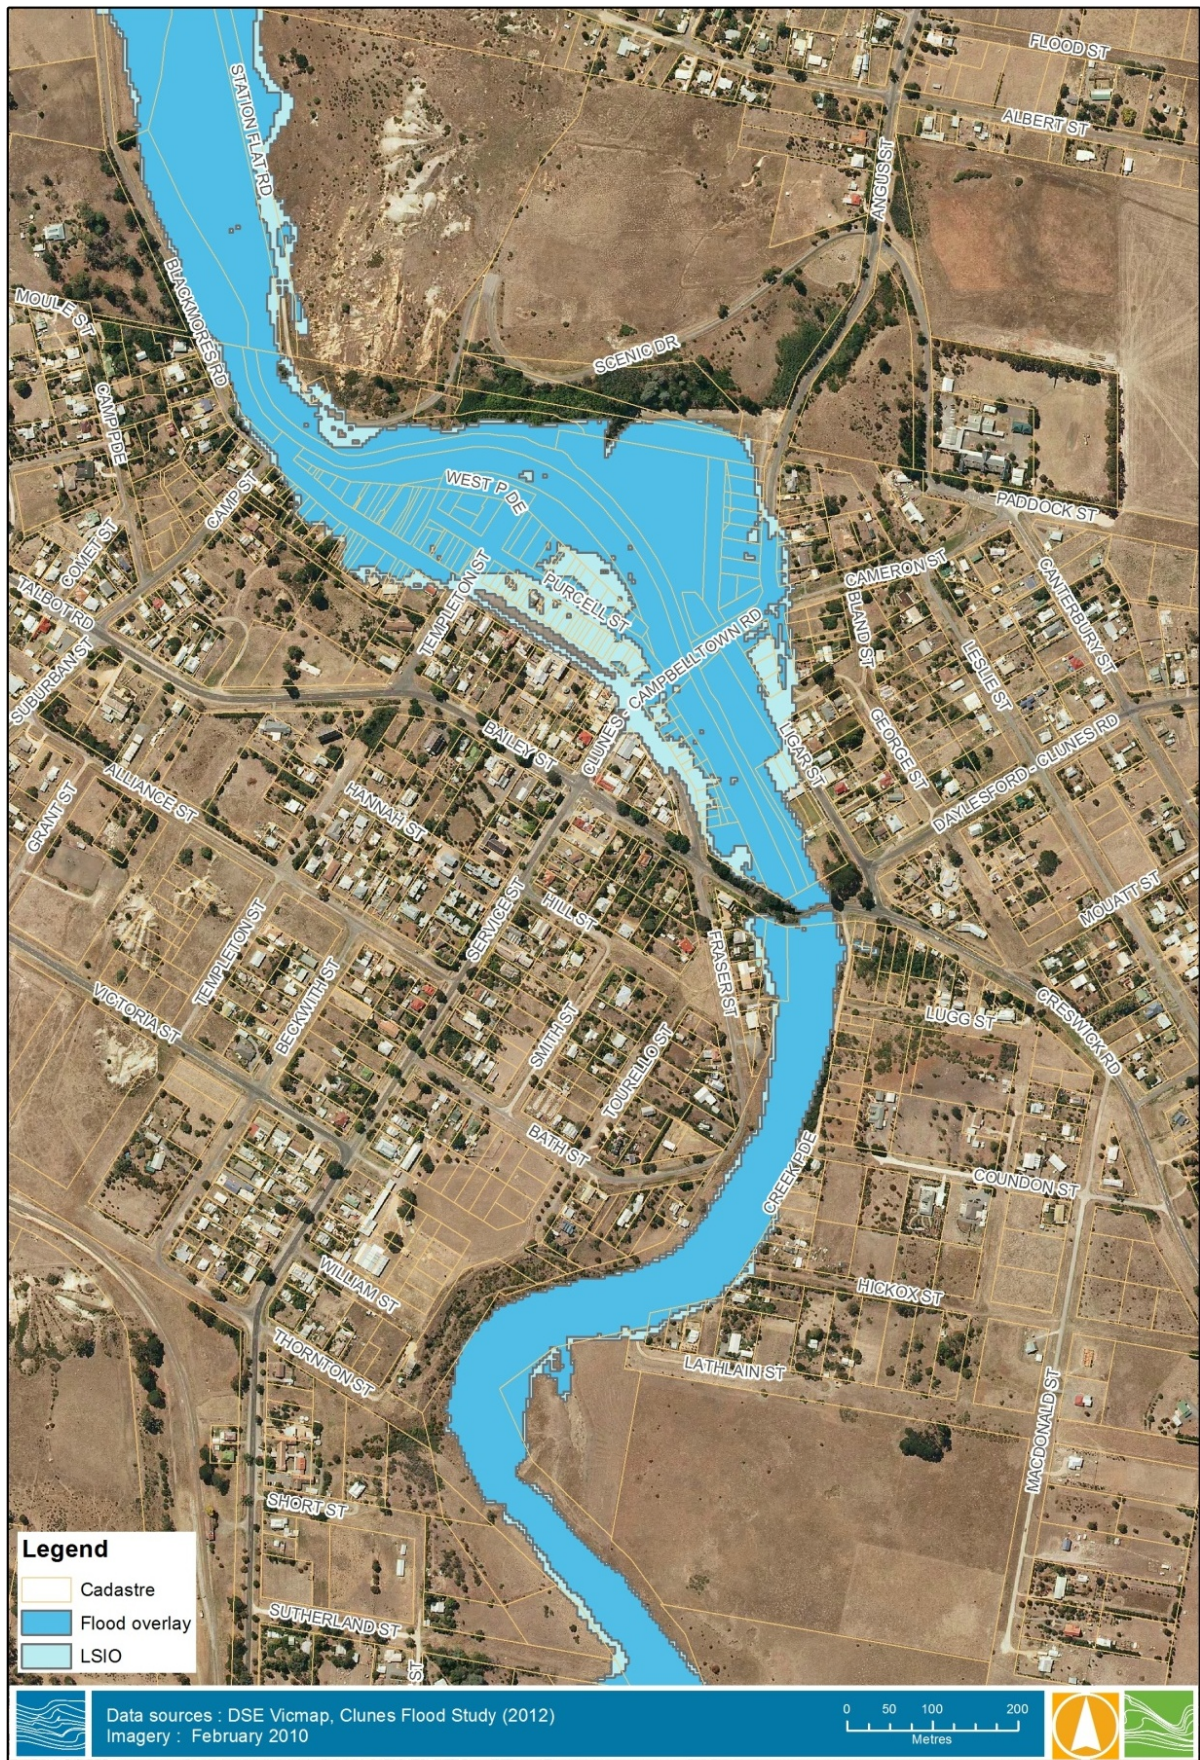
Figure 6-17 Draft LSIO and FO Map for Existing Conditions

Planning Schemes can be viewed online at <http://services.land.vic.gov.au/maps/pmo.jsp>. It is recommended that the planning scheme for Clunes is amended to reflect the flood risk identified by this project. Figure 6-17 shows proposed FO and LSIO for consideration into such an amendment. The draft planning scheme map is based on the 'Advisory Notes for Delineating Floodways' (NRE, 1998), with three approaches considered.

All three of the above flood frequency, hazard and depth maps were enveloped to provide the final proposed FO maps as shown below.

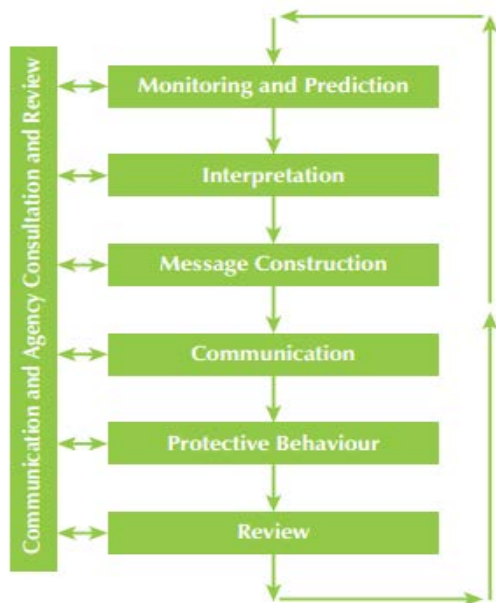
Figure 6-18 Flood Warning System Components

The basic building blocks of the Total Flood Warning System as described by the Australian Emergency Manual referred to above, is presented in Figure 6-18. All components of the Total Flood Warning System must be present for a flood warning system to be effective. If one component is neglected then the entire system is at risk of failure.

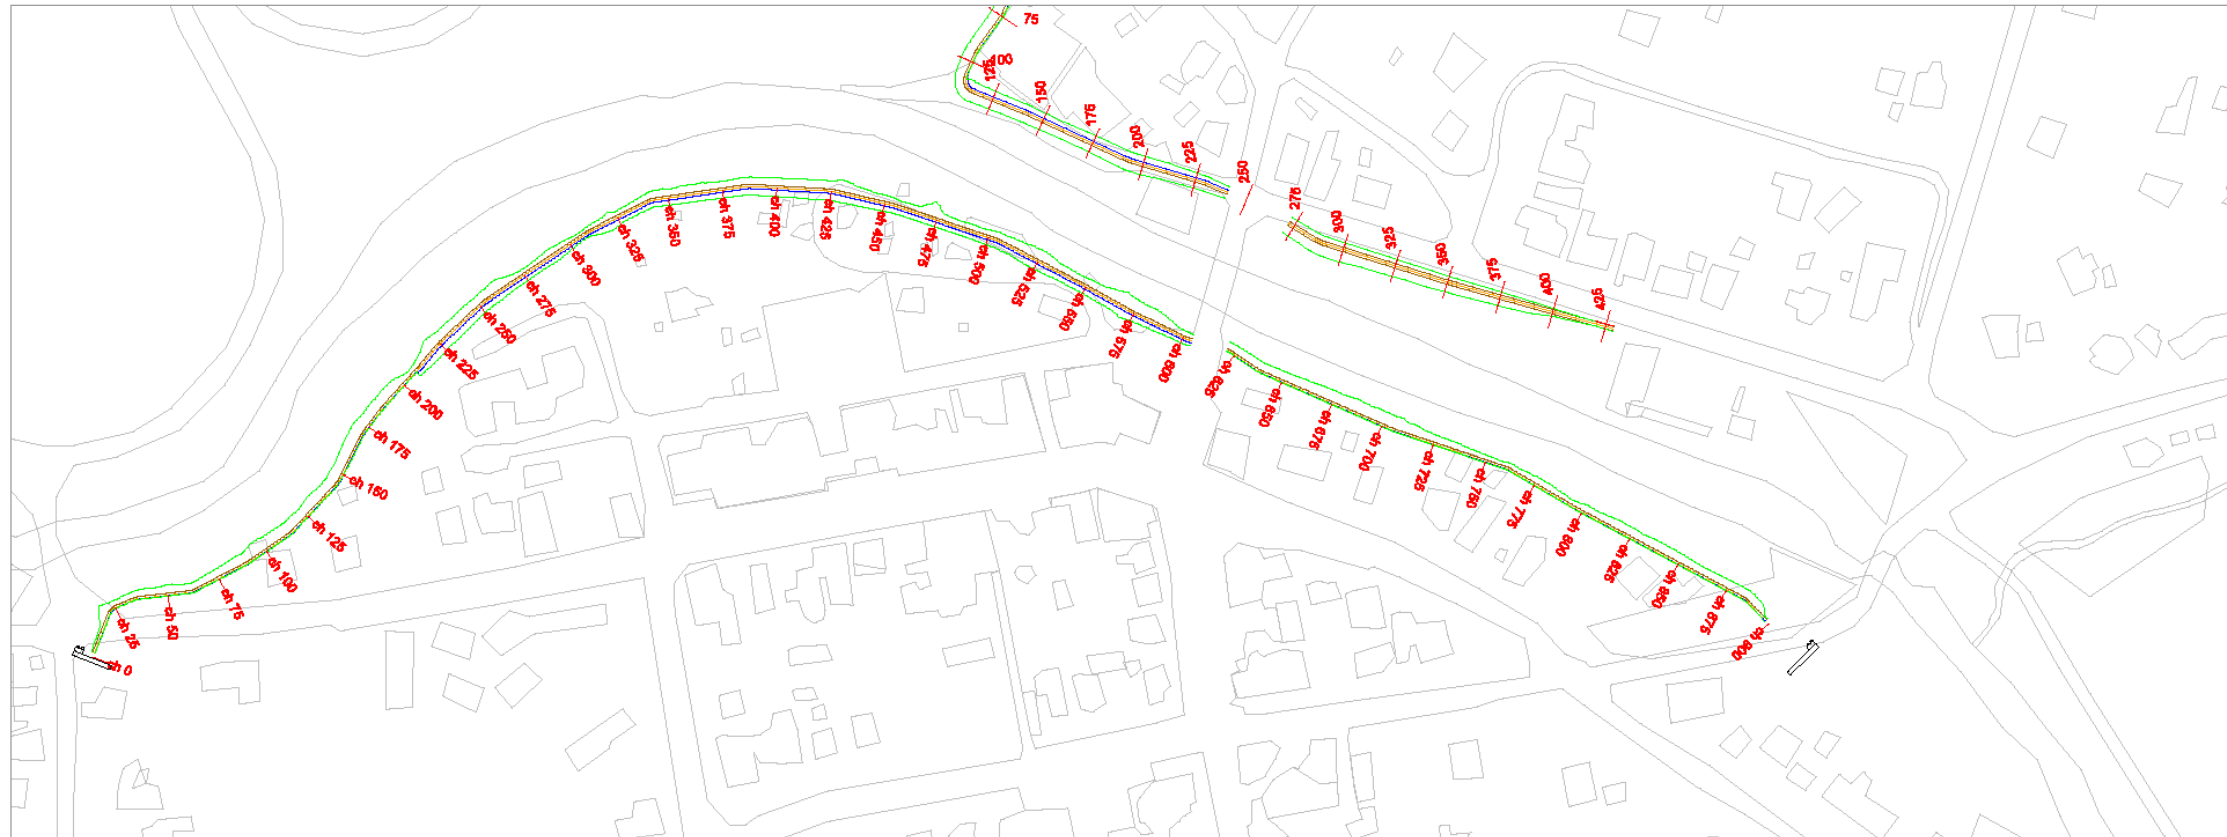
DATUM R.L.296.000

Chainages	Existing Surface	Depths	Finished Surface
0	298.45	-0.18	298.63
25	298.47	0.88	297.59
50	298.76	1.85	296.91
75	298.8	1.35	297.45
100	299.03	1.71	297.32
125	299.14	1.45	297.69
150	299.22	1.63	297.59
175	299.31	1.88	297.43
200	299.4	1.28	298.14
225	299.48	1.64	297.84
250	299.68	1.35	298.32
275	299.8	0.89	298.91
300	299.82	0.83	298.99
325	300.12	0.89	299.23
350	300.21	1.15	299.06
375	300.3	1.2	299.1
400	300.38	1.44	298.94
425	300.47	1.62	298.85
450	300.55	1.27	299.28
475	300.65	1.14	299.5
500	300.73	1	299.73
525	300.82	1.3	299.52
550	300.91	1.21	299.7
575	301	1.5	299.49
600	301.12	0.8	300.32
625	301.3	1.32	299.98
650	301.35	1.27	300.08
675	301.39	1.84	299.45
700	301.42	1.88	299.54
725	301.49	1.22	300.24
750	301.5	0.82	300.68
775	301.54	0.89	300.65
800	301.57	0.94	300.63
825	301.61	1.05	300.56
850	301.65	1.04	300.61
875	301.68	1.08	300.6
900	301.72	-0.86	302.6

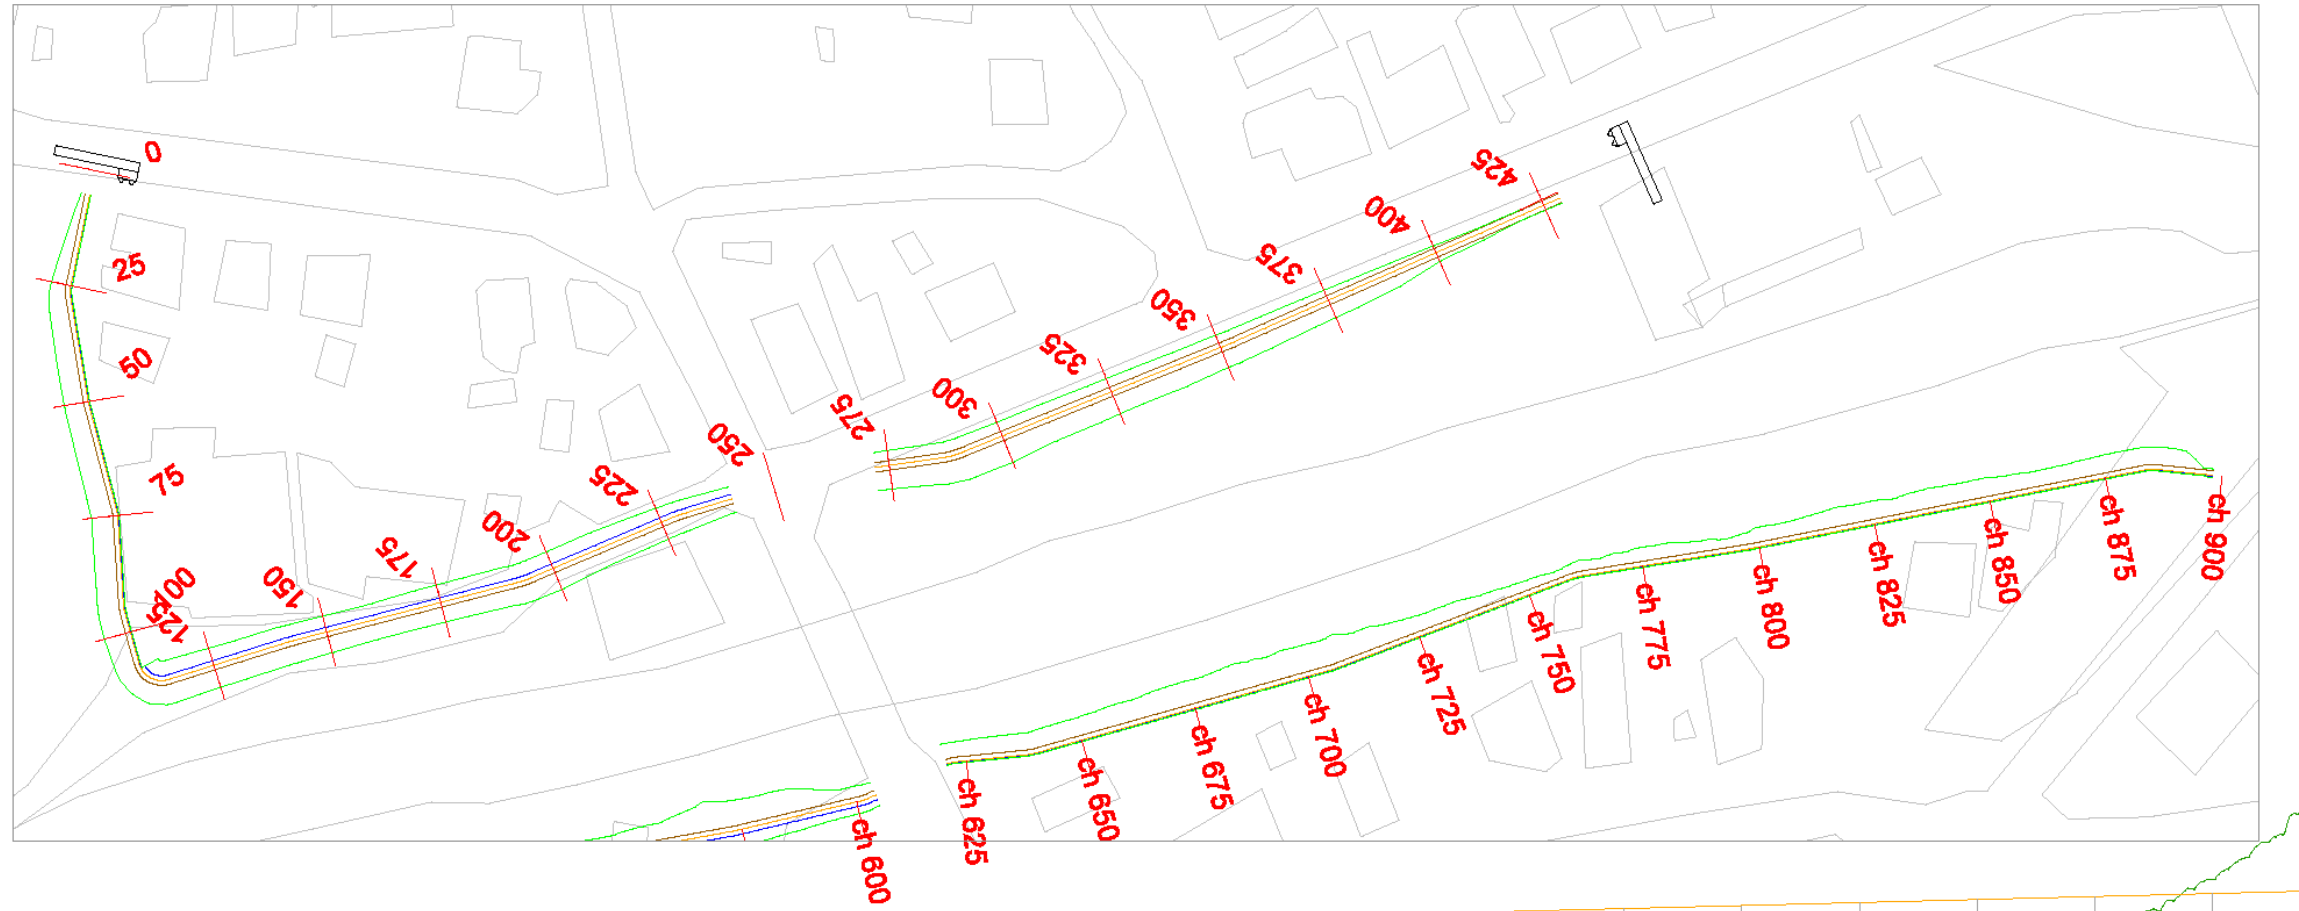
DATUM R.L. 298.000

Existing Surface	300.68	300.56	298.24	298.94	298.82	298.91	298.12	298.41	298.45	298.48	298.8	300.37	300.23	300.02	300.15	300.33	300.55	301.25	301.78	302.59
Depths	-0.02	1.31	1.8	1.63	1.63	1.46	1.25	1.31	1.37	1.14	0.71	1.21	1.44	1.35	1.2	1.01	0.34	-0.15	-0.94	
Finished Surface	300.55	300.55	300.55	300.55	300.55	300.58	300.67	300.78	300.85	300.94	301.08	301.43	301.47	301.5	301.53	301.58	301.59	301.53	301.65	
Chainages	-1.073	0	25	50	75	100	125	150	175	200	225	250	275	300	325	350	375	400	425	446.002
