# Creswick Flood Mitigation & Urban Drainage Plan Final Report

# **Creswick Flood Mitigation and Urban Drainage Plan**

## **Final Study Report**

**February 2012**

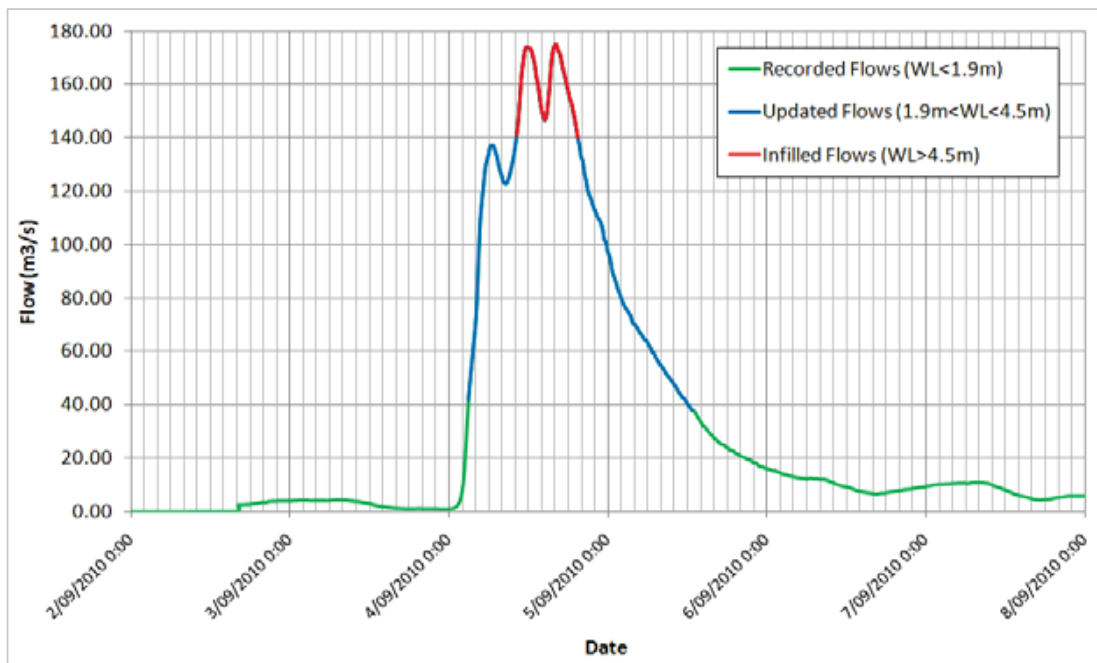
**Figure 4-6** Creswick Creek @ Clunes flow hydrograph – September 2010

The missing flows during the event peaks were calculated using the new rating curve. Additionally all recorded flows corresponding to water levels above 1.9 m were updated using the new rating curve relationship. The recorded hydrographs at Clunes for September and January events are shown in Figure 4-6 and Figure 4-7 respectively.

In September, the observed hydrograph at Clunes had three distinct peaks which occurred on Saturday, 4<sup>th</sup> September 2010. The first peak was recorded at 6:30 am Saturday morning and later on the same day two higher peaks were observed at 12:00 pm and 4:00 pm. The peaks correspond with a recorded 0.64 m drop in water level between 12:00 pm and 4:00 pm on Saturday, however no anecdotal evidence was found to confirm this.

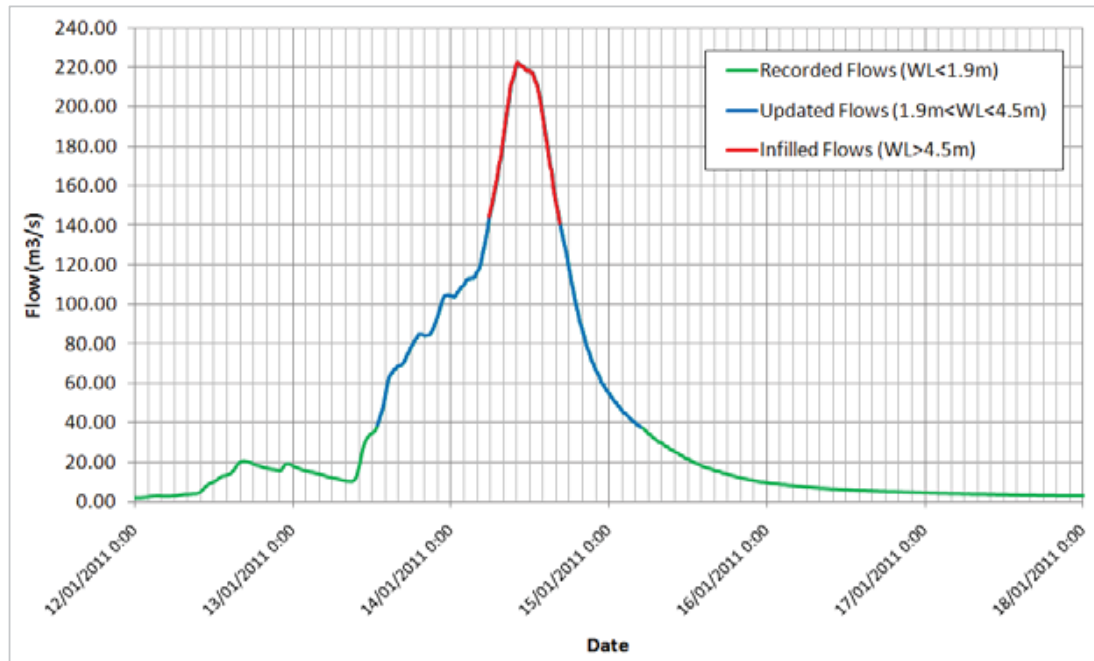
Figure 4-7 Creswick Creek @ Clunes flow hydrograph – January 2011

During the January 2011 event, the observed hydrograph at Clunes recorded two distinct peaks; a small rise on Wednesday evening, 12<sup>th</sup> January 2011, and a second much higher peak on the morning of Friday the 14<sup>th</sup> of January 2011, following successive days of heavy rainfall.

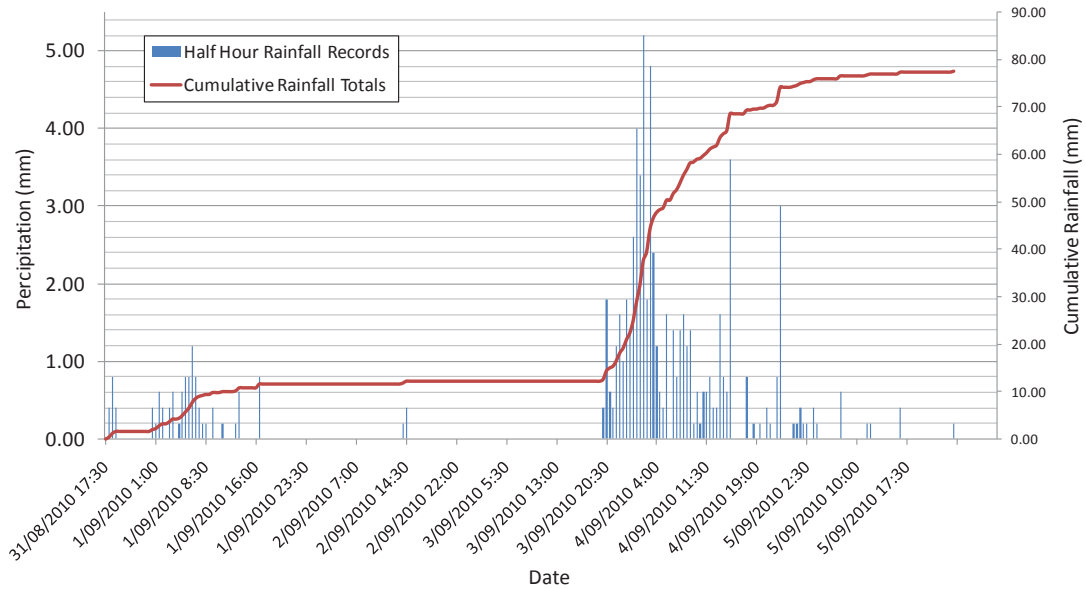
**Figure 4-8 Ballarat Aerodrome (089002) pluviograph – September 2010**

The temporal rainfall distribution was determined using the rainfall pattern from the Ballarat pluviograph. Figure 4-8 and Figure 4-9 display the pluviographs for the September 2010 and January 2011 events. As the Ballarat gauge is on the other side of the divide, there is some uncertainty in the appropriateness of this temporal pattern for the Creswick Creek catchment, however this is the nearest and considered to be the best available data for the study area.

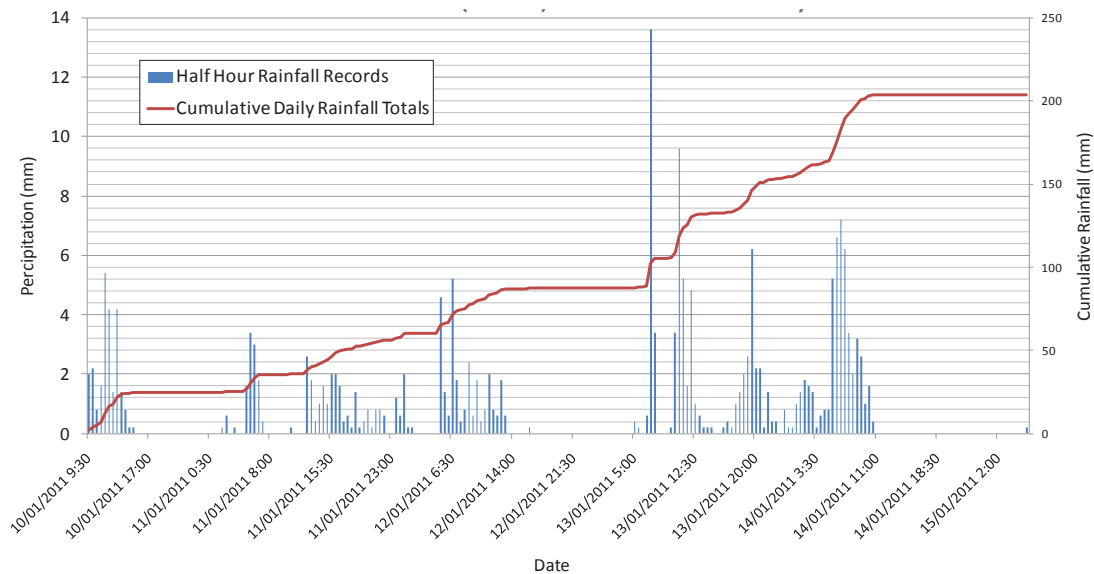
**Figure 4-9 Ballarat Aerodrome (089002) pluviograph – January 2011**

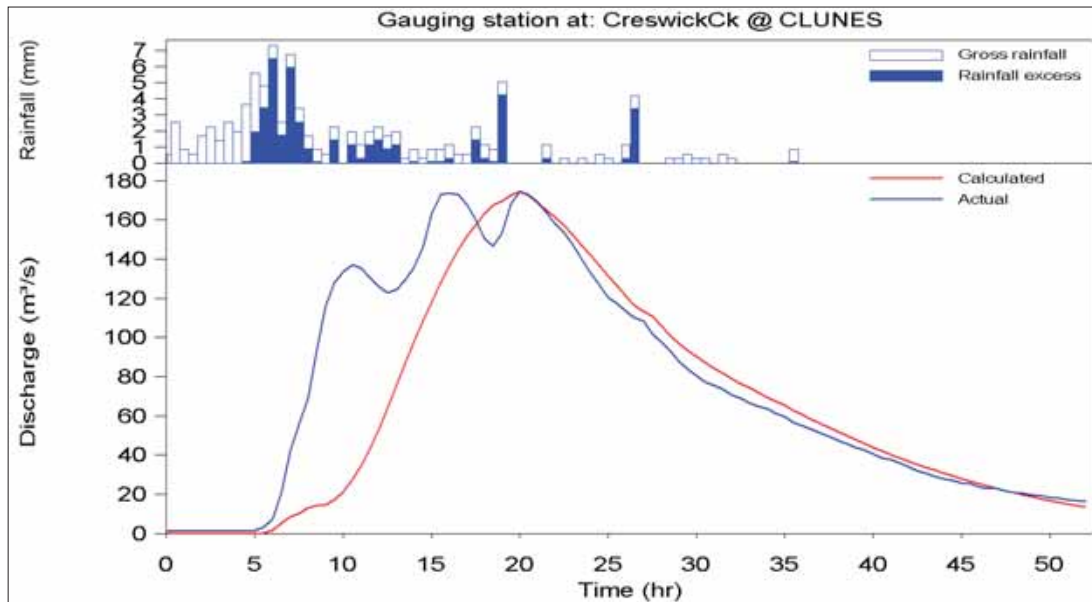
Figure 4-10 RORB model calibration hydrograph – September 2010

The calibration results are summarised in Table 4-2 and Table 4-3. Figure 4-10 and Figure 4-11 display the modelled and observed flood hydrographs for the calibration events at the 'Creswick Creek @ Clunes' gauge.

For the September 2010 event, the calibration of the modelled hydrograph to the observed hydrograph provided a match to peak flow but failed to reproduce the multiple peaks observed at Clunes. The multiple peaks at Clunes were most likely associated with isolated thunderstorms across the catchment, which is not reflected in the available pluviograph at Ballarat. It is extremely difficult to reproduce these multiple peaks without spatial and temporal rainfall data inside the catchment. Also there is some doubt as to whether the two higher peaks actually occurred. There is no record of this in any discussions with residents or media articles suggesting that the creek dropped 0.6 m then rose again. This was investigated with North Central CMA and Hepburn Shire Council staff, and no one could verify if this multiple peak actually occurred.

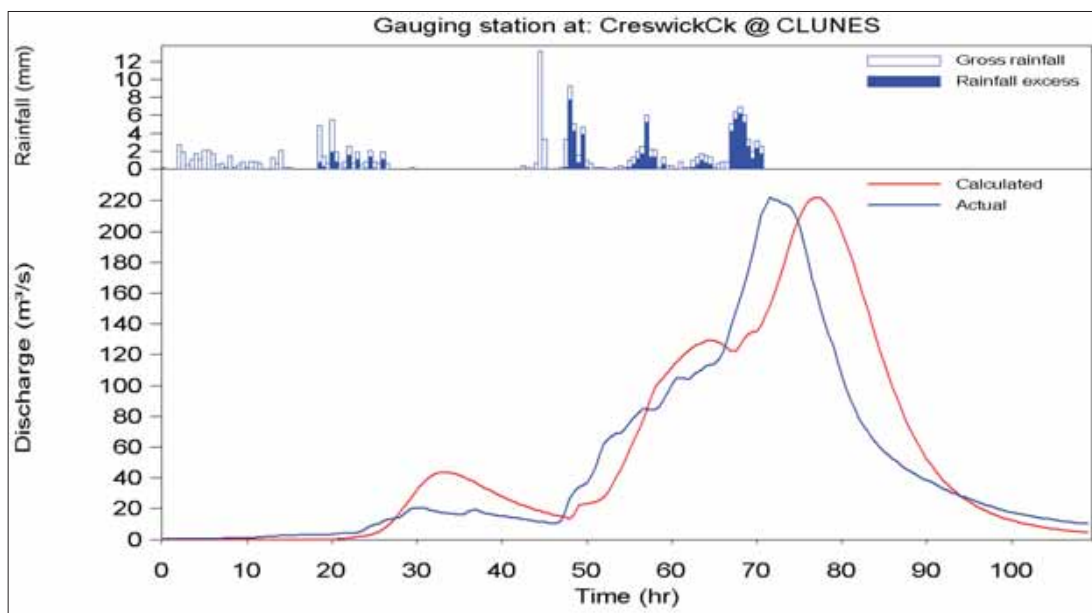
Figure 4-11 RORB model calibration hydrograph – January 2011

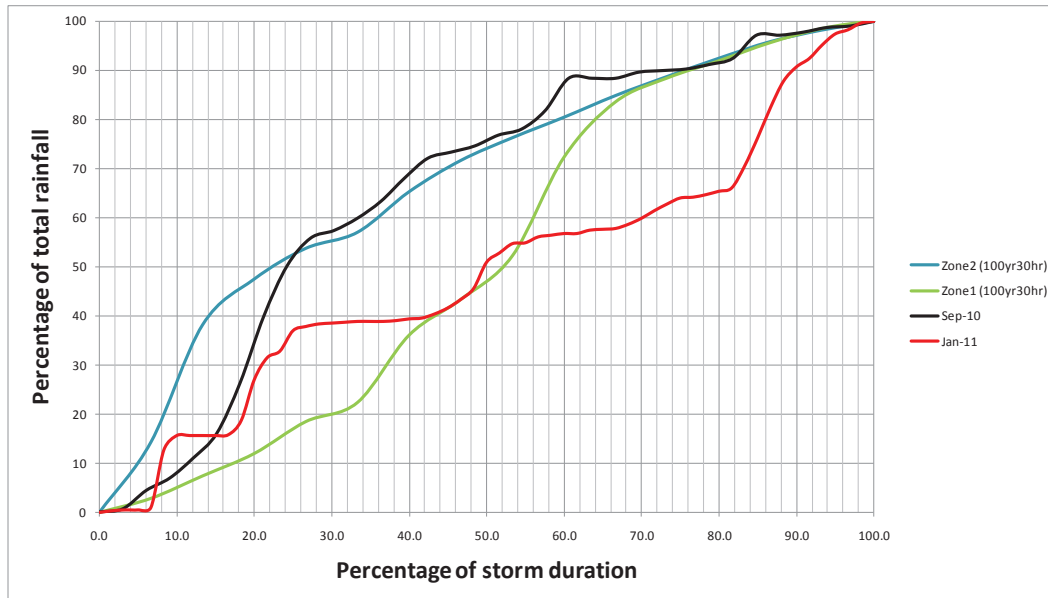
**Figure 4-14 Design and observed temporal pattern comparison**

Both observed events had varying temporal patterns. The results showed that the Zone 2 temporal pattern matched the September 2010 temporal pattern reasonably well, but neither design temporal patterns matched the January 2011 flood event.

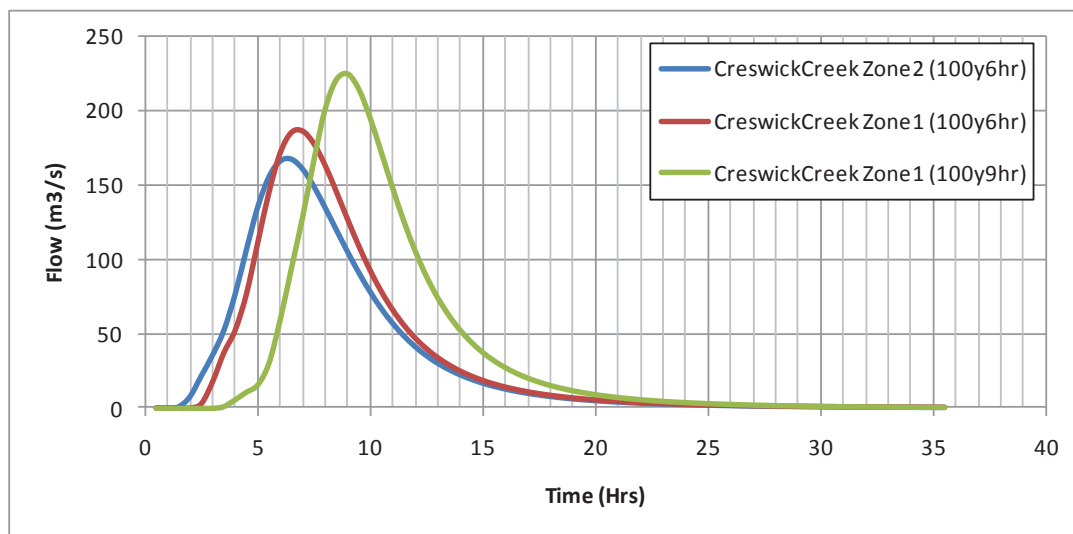
**Figure 4-15 Temporal pattern hydrograph comparison**

As a further test, the RORB model was rerun using Zone 1 temporal patterns. A comparison of flood peaks resulting from the two temporal patterns is shown in Table 4-7. Zone 1 temporal patterns resulted in a 34% increase in peak 100 year flows at Creswick compared to Zone 2 peak flows. In addition the hydrograph shapes and critical durations were different for both temporal patterns. Zone 1 temporal patterns produced a hydrograph that peaked later compared to the Zone 2 hydrograph (Figure 4-15).

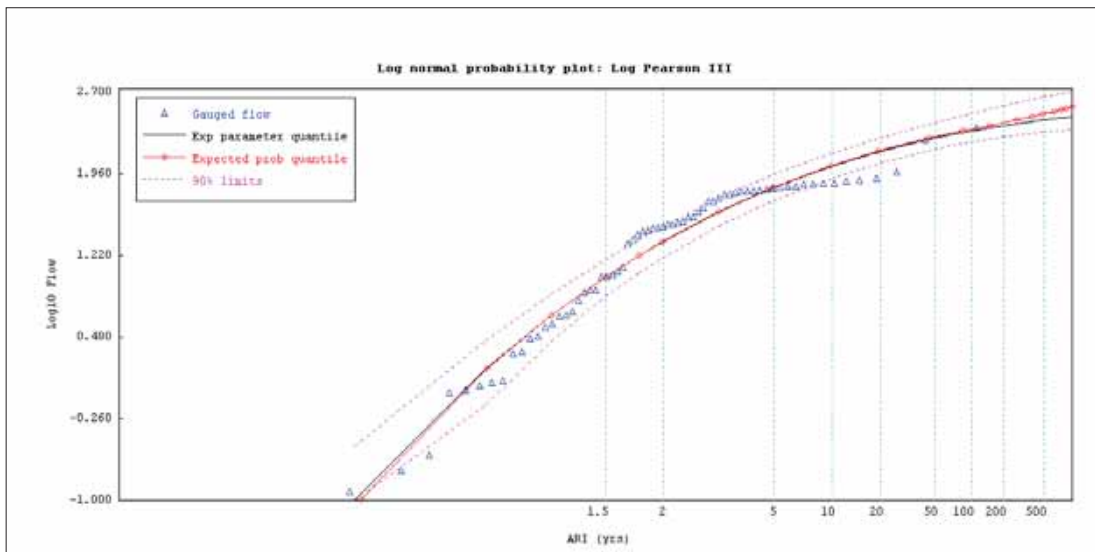
**Figure 4-16 Log Pearson III flood frequency analysis – Creswick Creek @ Clunes**

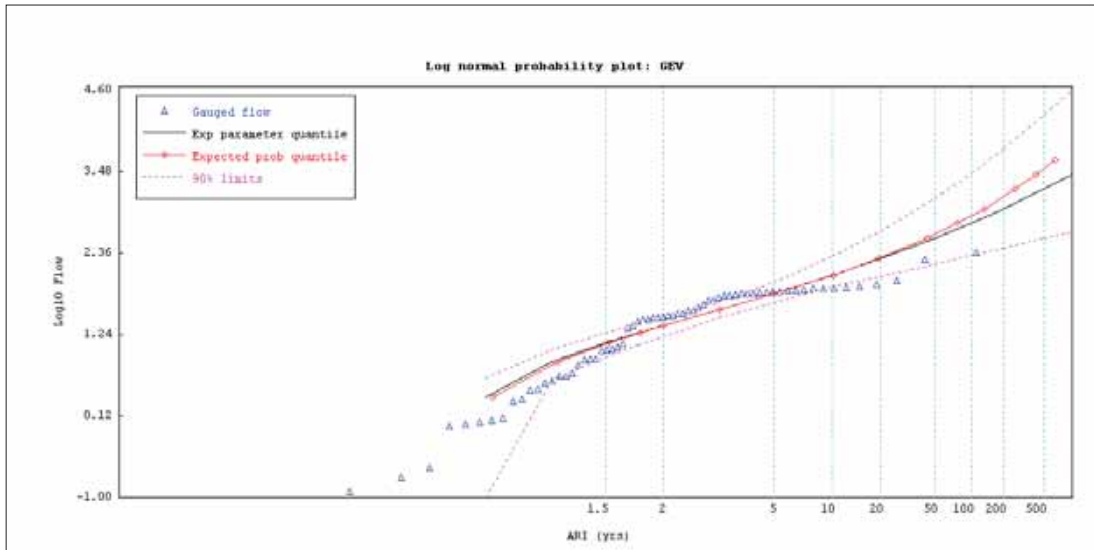
Figure 4-17 Generalised Extreme Value flood frequency analysis – Creswick Creek @ Clunes

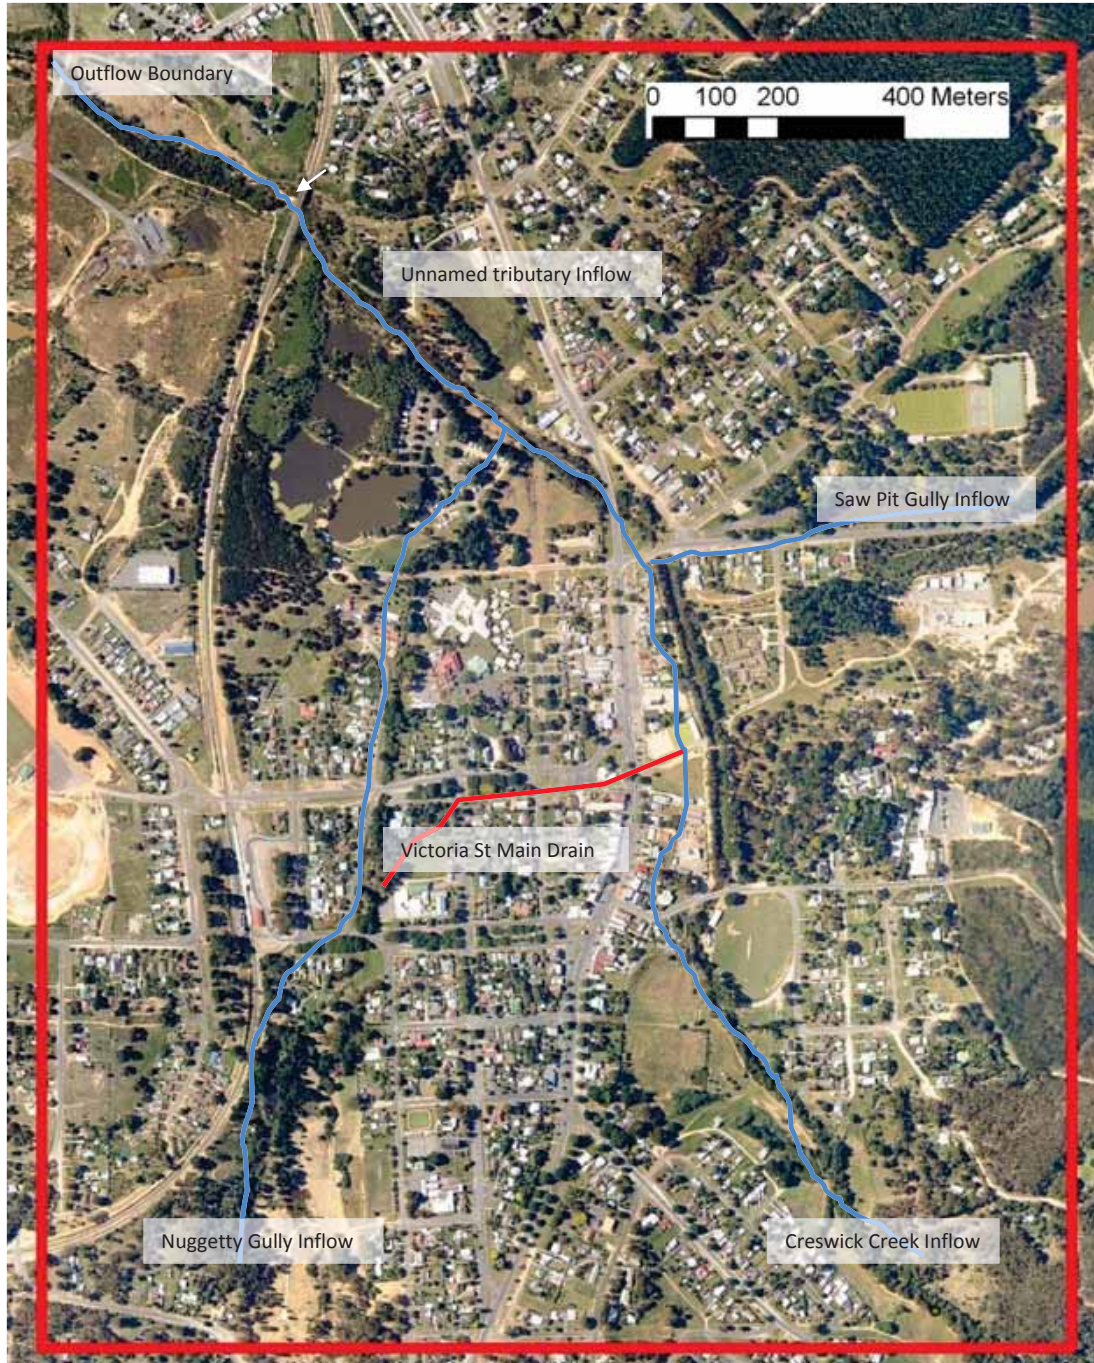
Figure 5-2 Conceptual hydraulic model extents and boundary locations

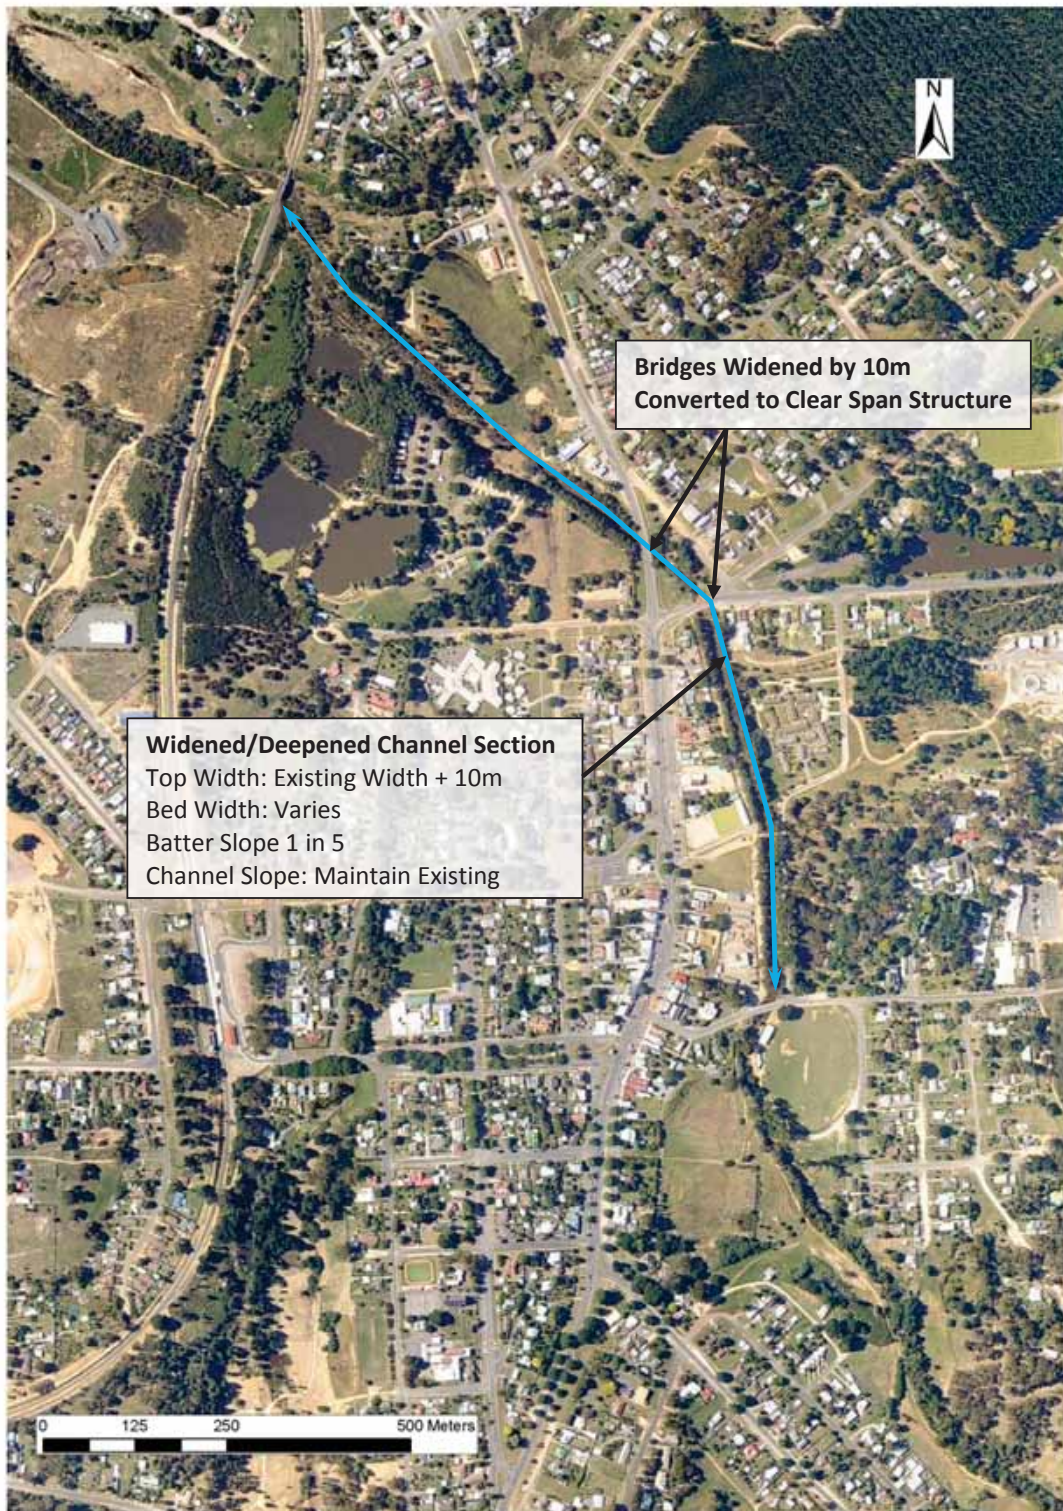
Figure 6-3 Proposed structural mitigation option 2

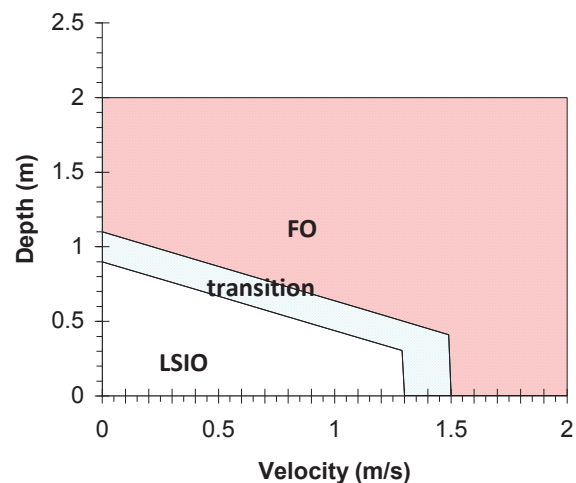
Figure 6-12 Flood hazard delineation of FO

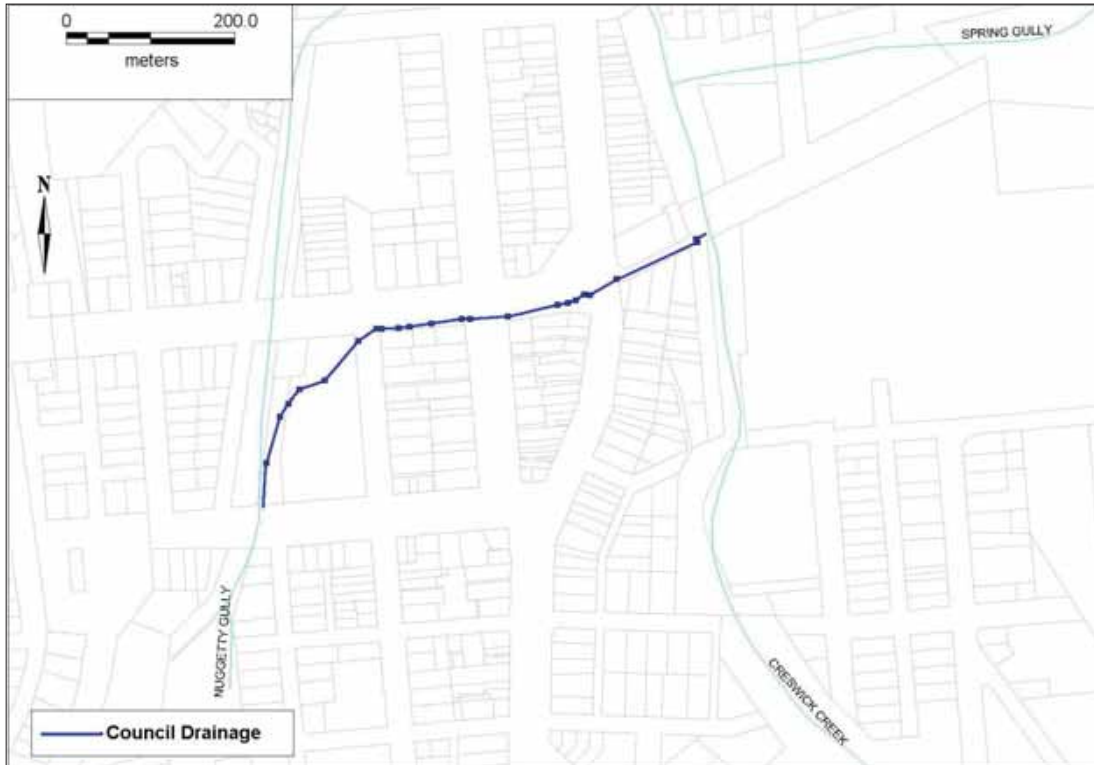
**Figure A 1** Location of key pipe network in Creswick included in the hydraulic model

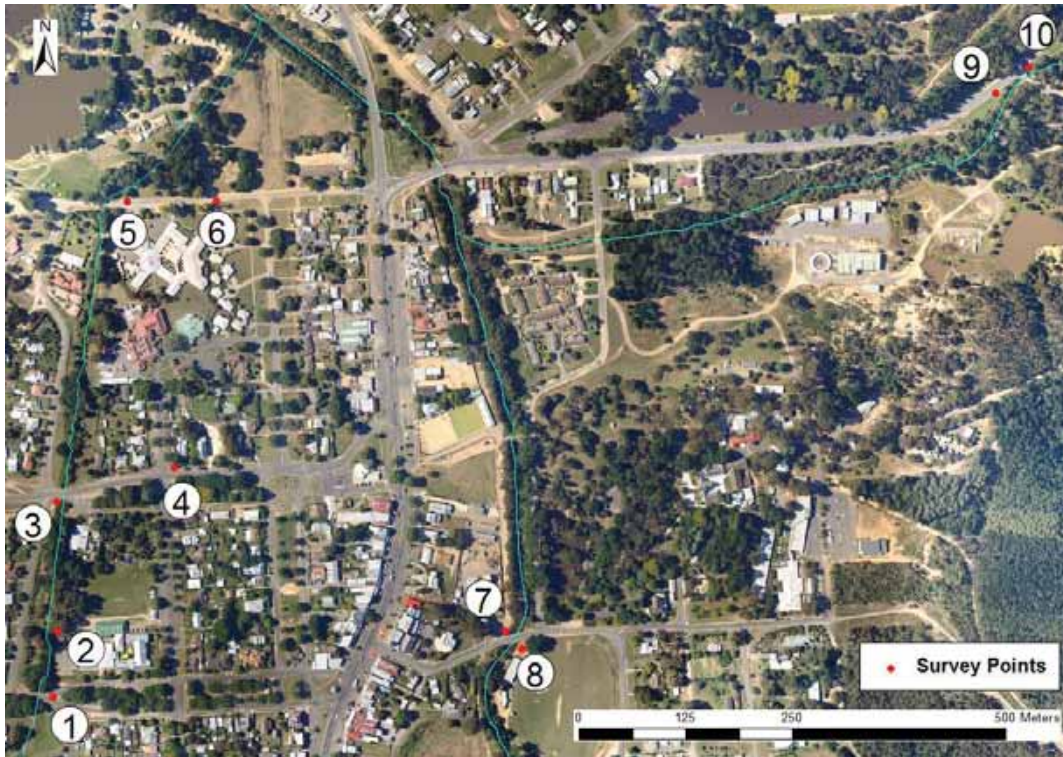
Figure B 1 Location of Surveyed Points

Ground survey was used to check the vertical accuracy of the LiDAR. Spot heights were taken at 10 locations in Creswick as shown in Appendix B. Overall the LiDAR was found to compare well (within +/- 100 mm) with the survey data of the floodplain outside the channel banks. Differences (up to +/- 300 mm) were found at two of the locations, at the channel banks near Water Street and Raglan Street.

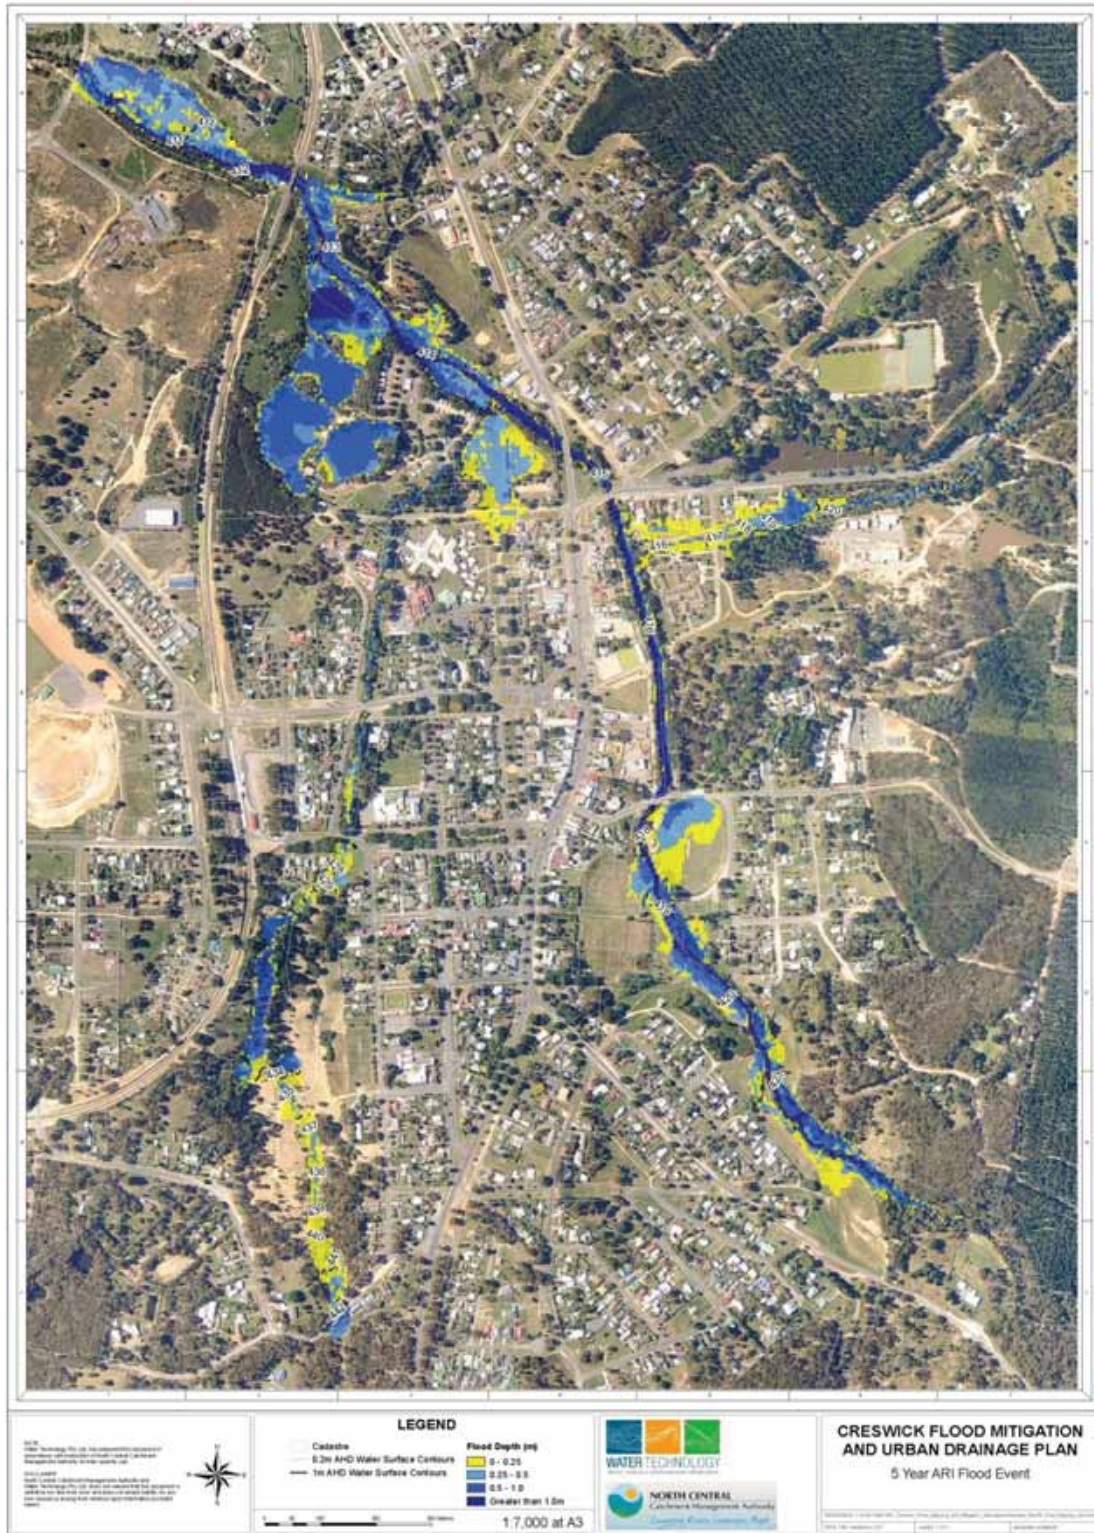
Figure C-9-1 5 Year ARI Flood Event

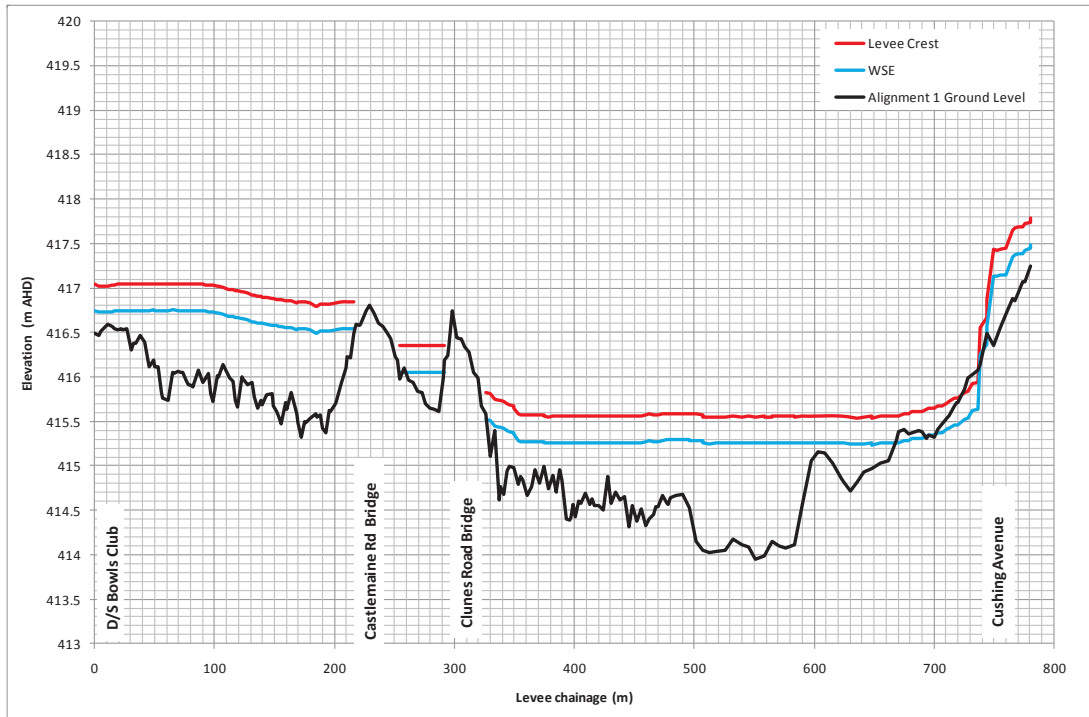
Figure D-1 Creswick Creek Levee - Long Section Plot

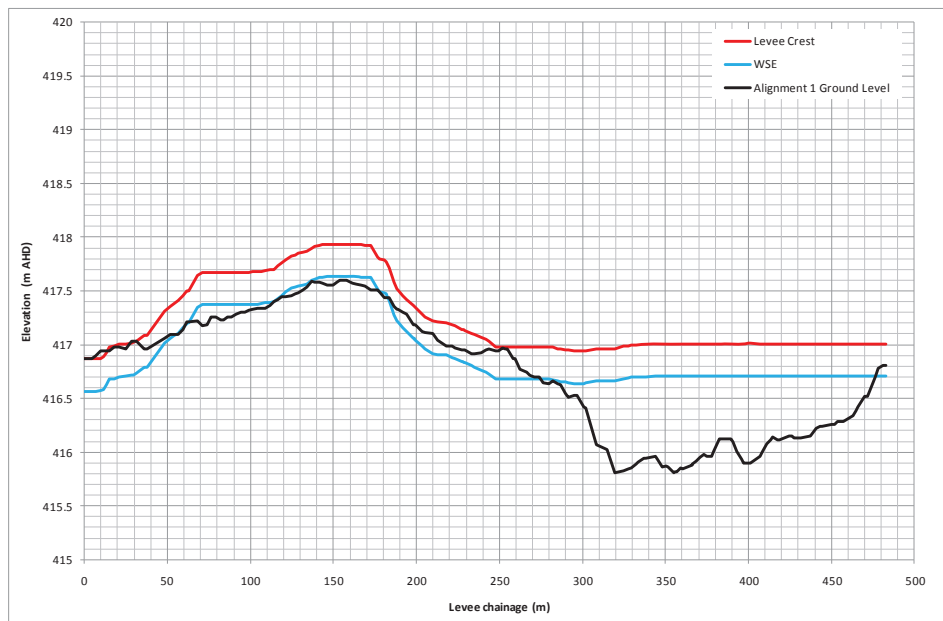
**Figure D-3 Semmens Village Levee - Long Section Plot**

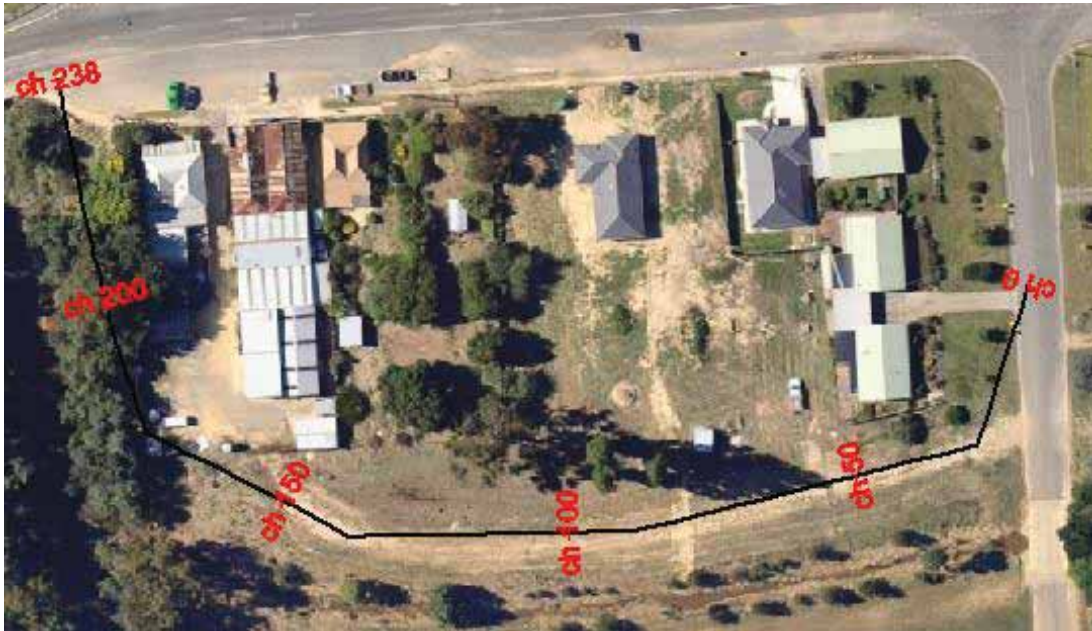
Figure D-4 Saw Pit Gully Levee Alignment

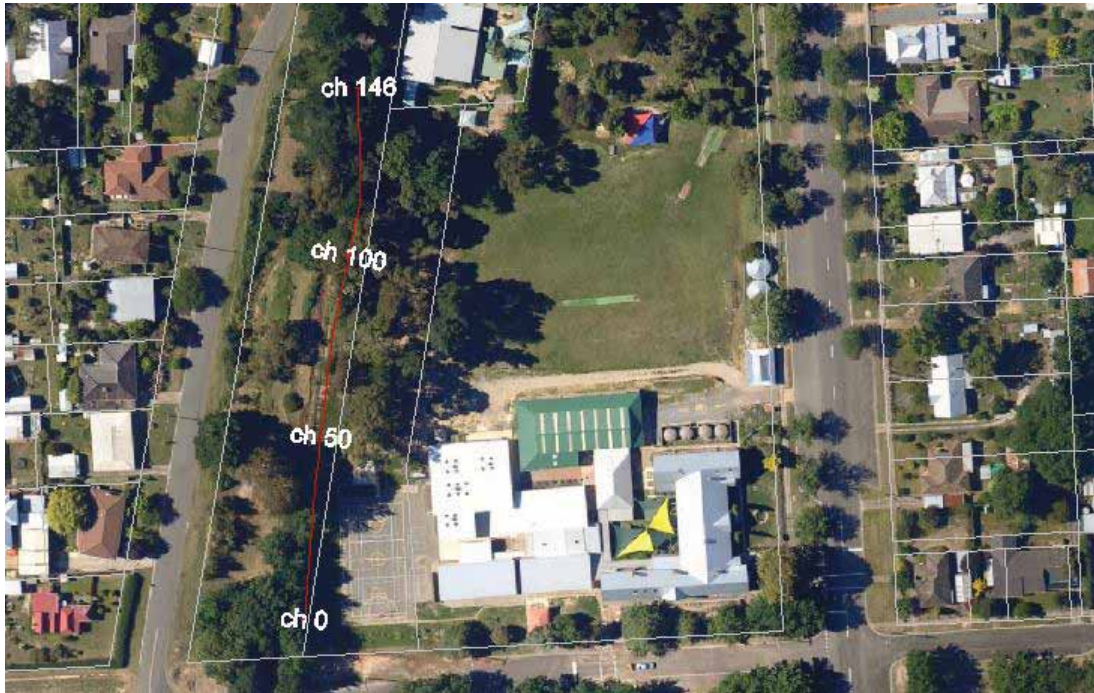
Figure D-6 Primary School Raised Wall Alignment

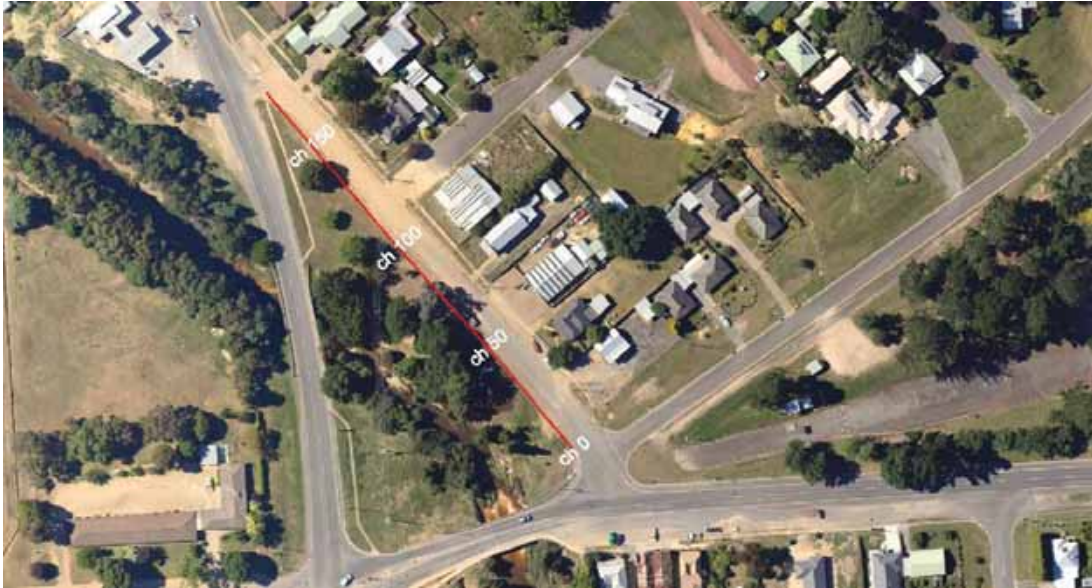
Figure D-8 North Parade Levee Alignment
