North Central Catchment Management Authority

Donald Flood and Drainage Management Plan

May 2014

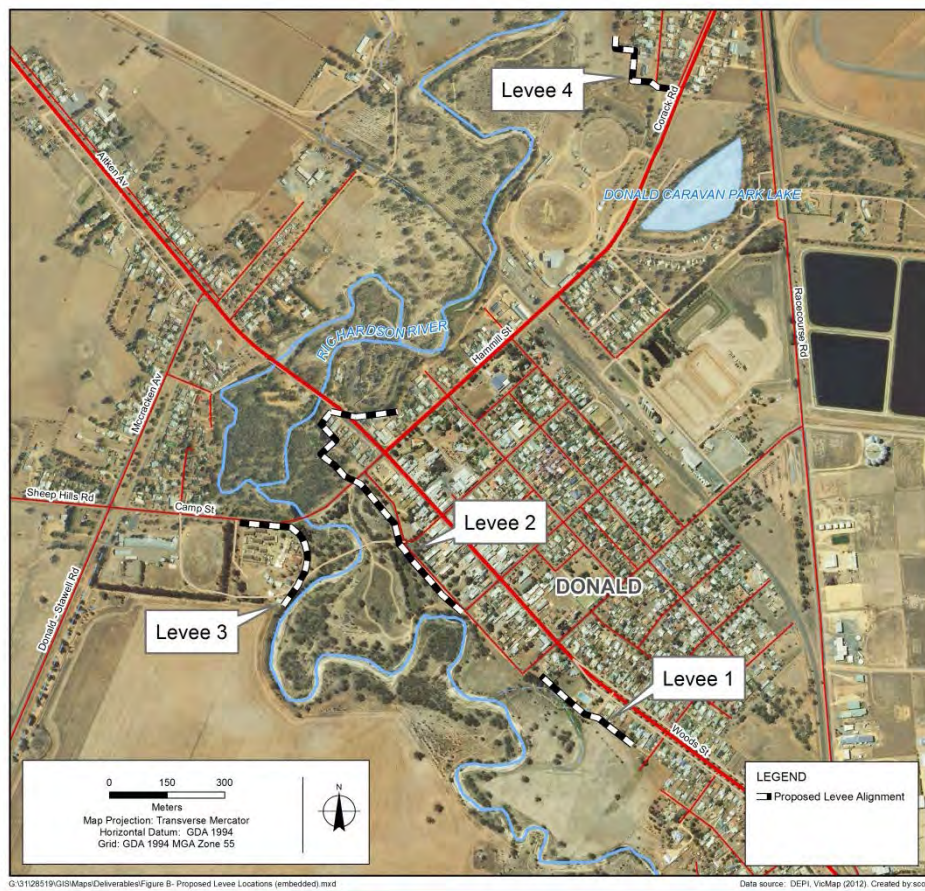
Figure B Proposed Levee Locations

- Construction of Levee No. 4 (refer to Figure B for location). With the construction of Levee 4 consideration should be given to improving the economic viability of the levee by:
 - Providing a lower level of service (in terms of AEP event); and
 - Reaching an agreement with the landowner in regards to maintenance.

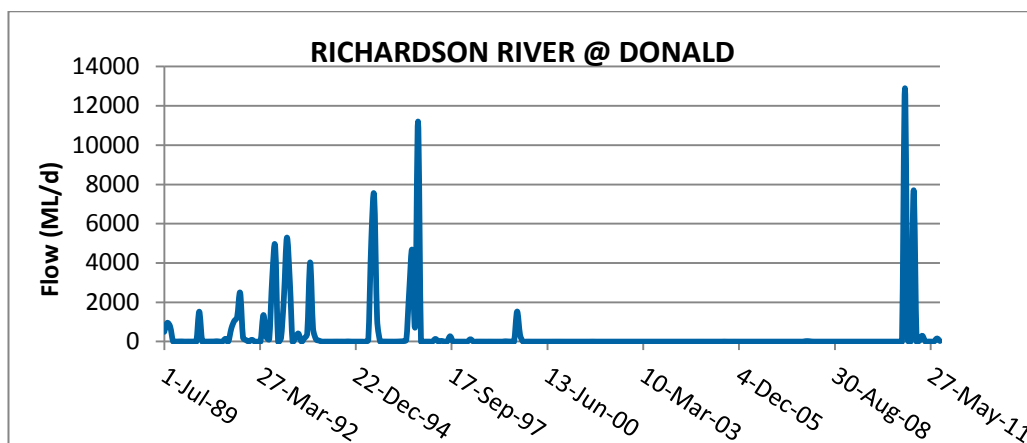
Figure 5 Flows Recorded at 415257 (Richardson River @ Donald)

The January 2011 was larger than all of the events listed above, however, no streamflow data is available for this event at 415257 (Richardson River @ Donald). The calibrated RORB model was used to estimate the flow at Donald for the January event. This is discussed in further detail in Section 4.4.

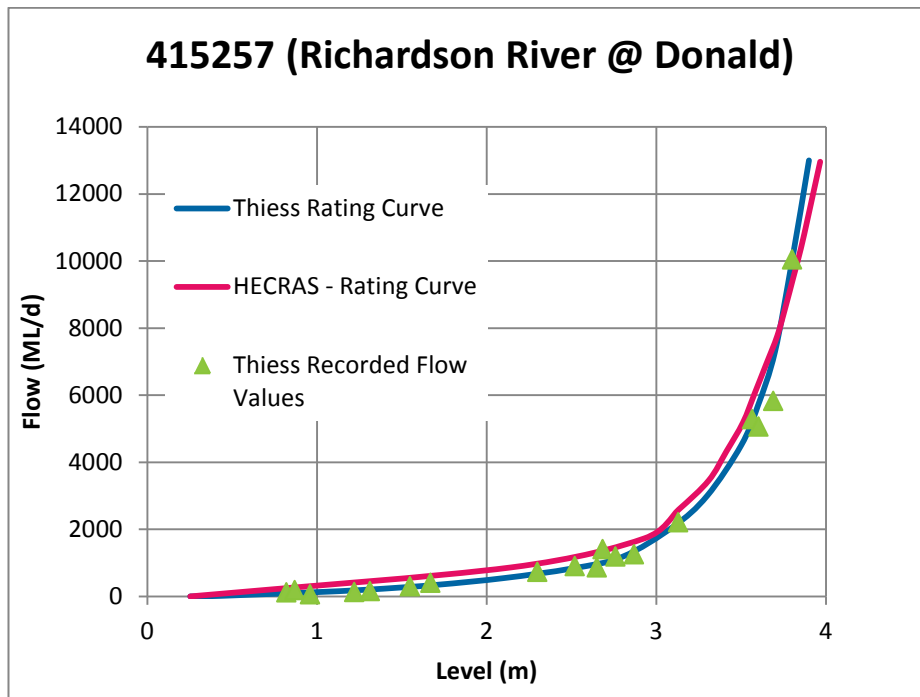
Figure 10 415257 (Richardson River @ Donald)

To validate this conclusion a simple one-dimension model (HECRAS) was established at each of the stream gauge stations to determine an elevation discharge relationship (rating curve) at each site and compare this to that provided by Thiess. The rating curves produced using the HECRAS model are not designed to replace the existing curves but to verify which one we have more confidence in. Discussion with Thiess indicated that there is uncertainty around the extension of the rating curve for both gauges. The cross sections used in the hydraulic model were taken from GWMW 2 metre DEM. The roughness values in the HECRAS model were adjusted to match the recorded flow levels. The results from the HECRAS model are shown in Figure 9 and Figure 10 for 415259 (Richardson River @ Banyena) and 415257 (Richardson River @ Donald) respectively. Figure 9 indicates that the hydraulic model matches the recorded flows reasonably well up to a level of approximately 3.8 m. Above a level of 3.8 m the flow begins to break the banks of the river at 415259 (Richardson River @ Banyena) and it is at this point that the HECRAS model indicates that more flow is passing the gauge for the same height when compared to the Thiess rating curve.

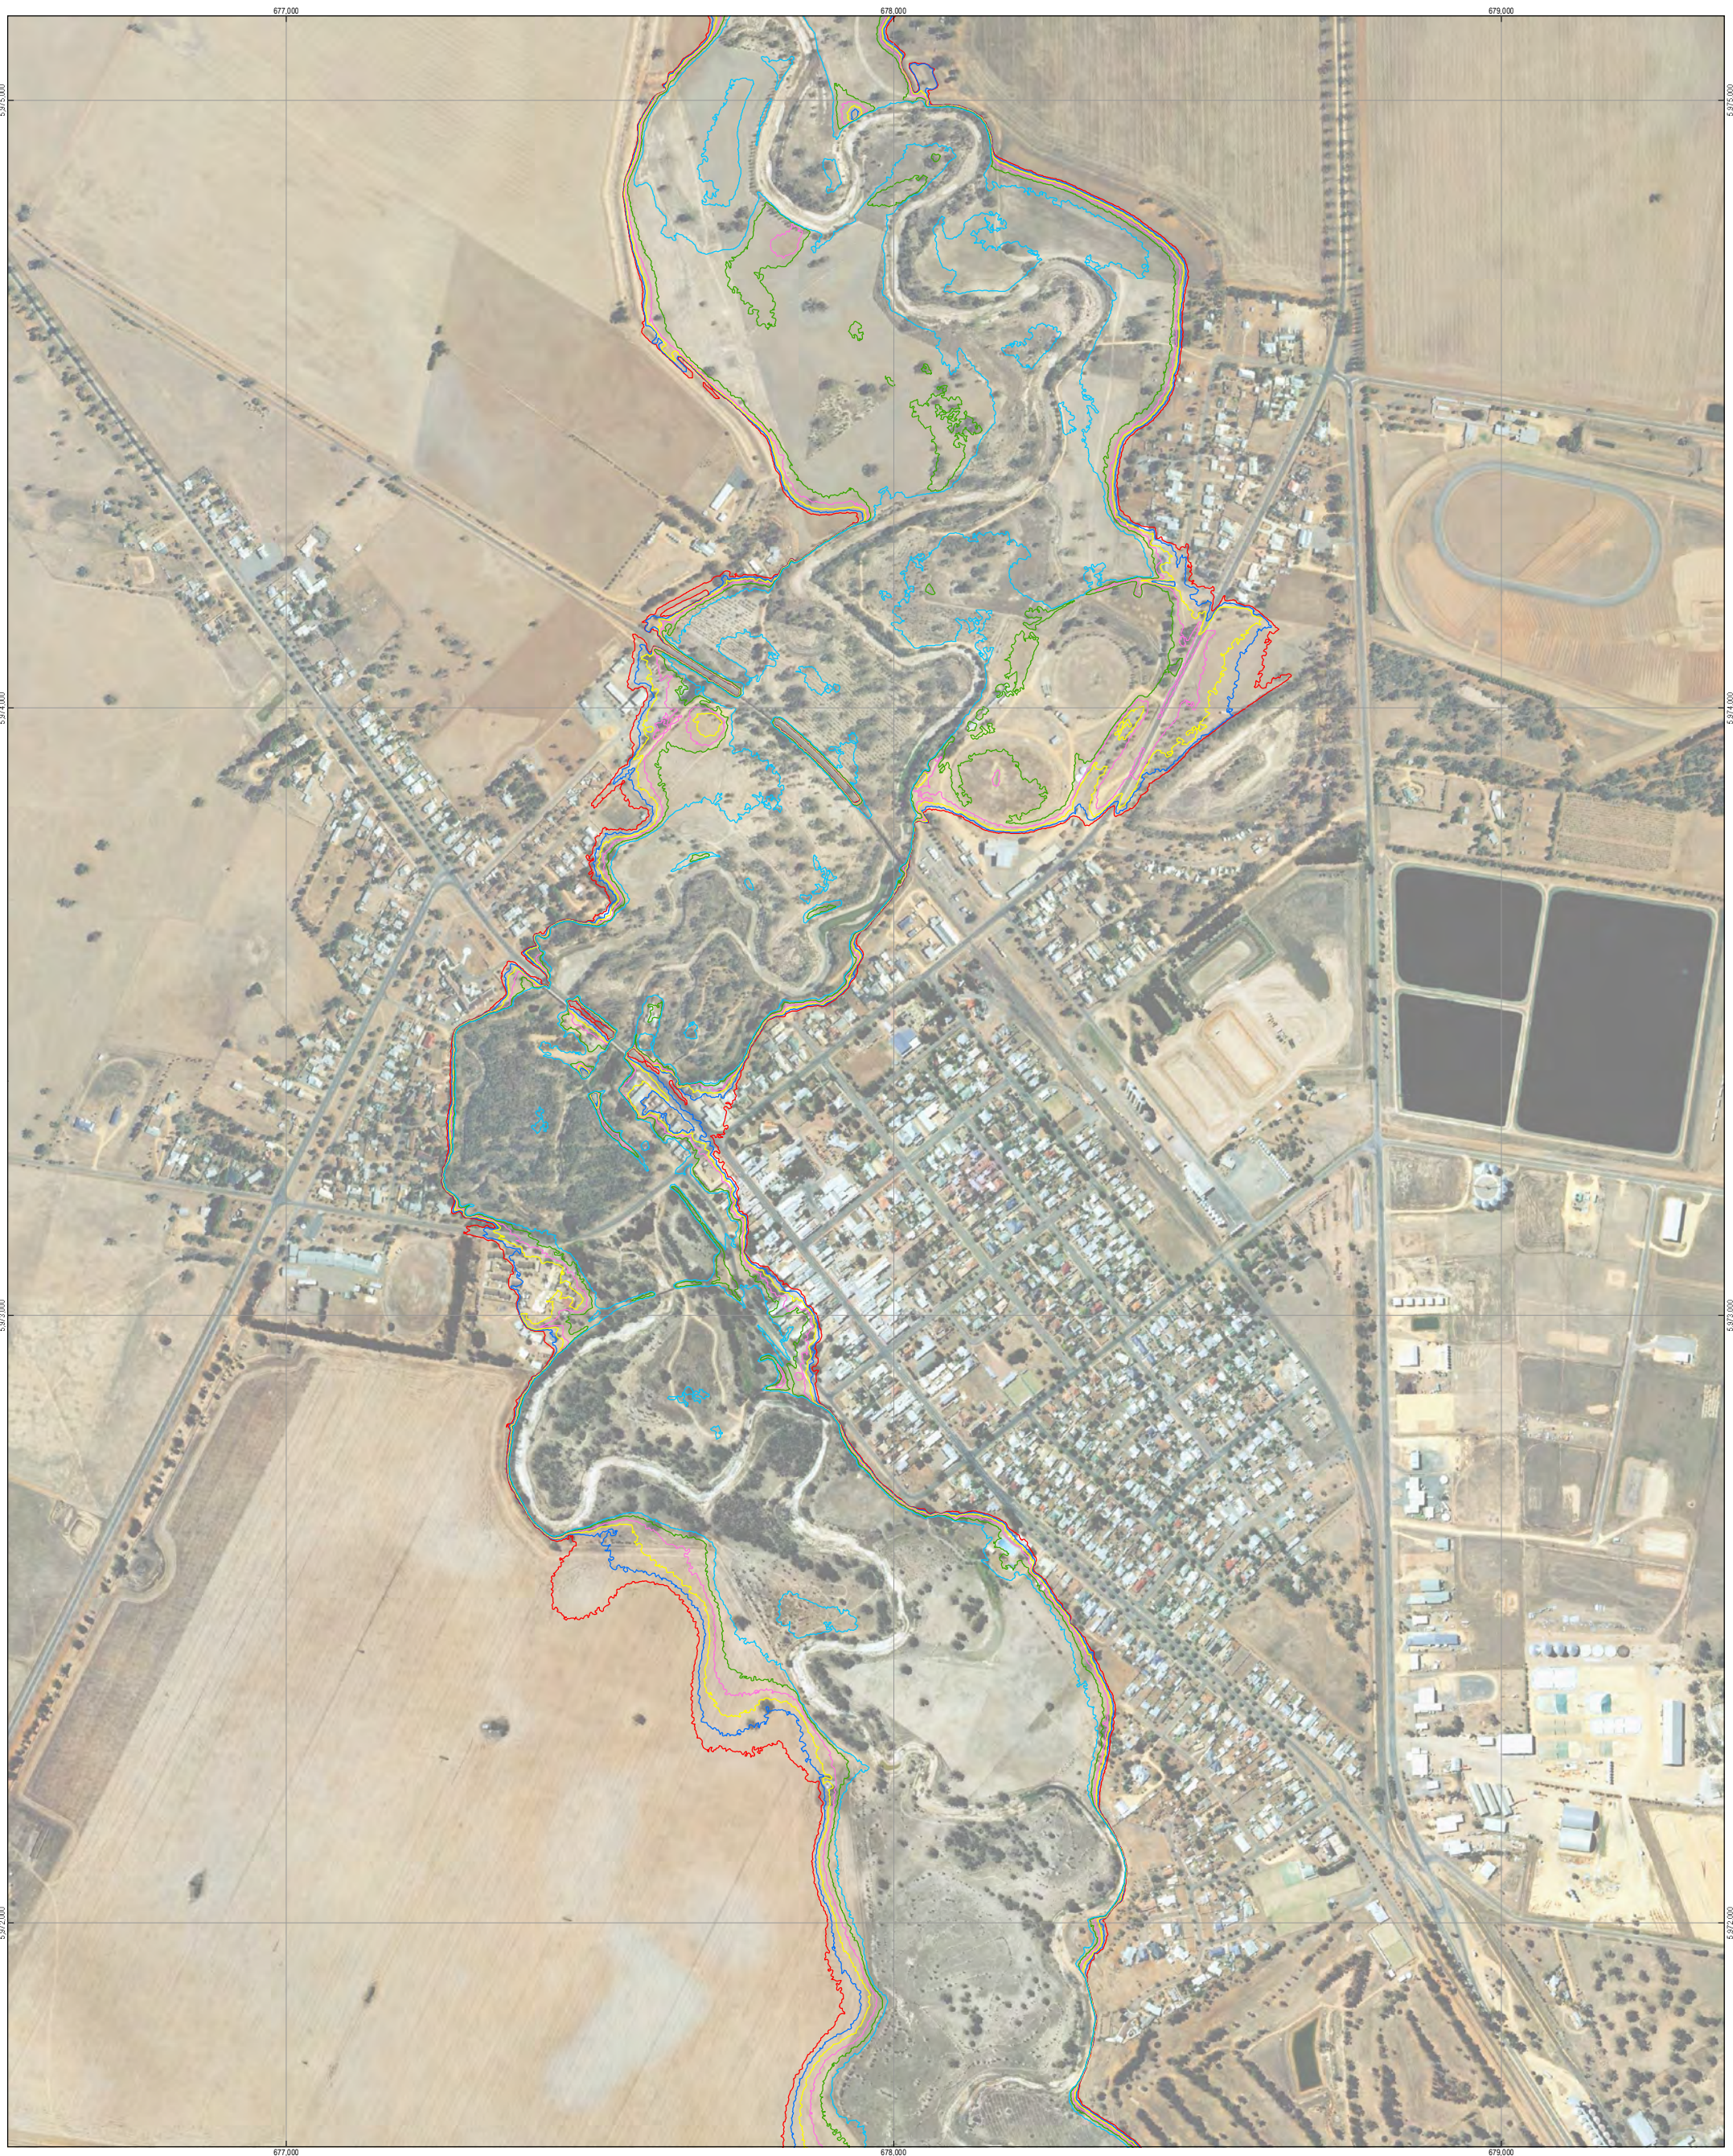
The calibrated hydraulic model was used to generate design flood extents for riverine flooding for the 5, 10, 20, 50, 100 and 200 year ARI event. Each ARI event was run for the 12 hour, 18 hour, 24 hour, 30 hour, 36 hour, 48 hour and 72 hour (shorter duration design storms were not run as they are not critical for the Richardson River catchment) design storm events and the maximum value from each duration adopted. The flood extents for each ARI event are shown in Figure 12.

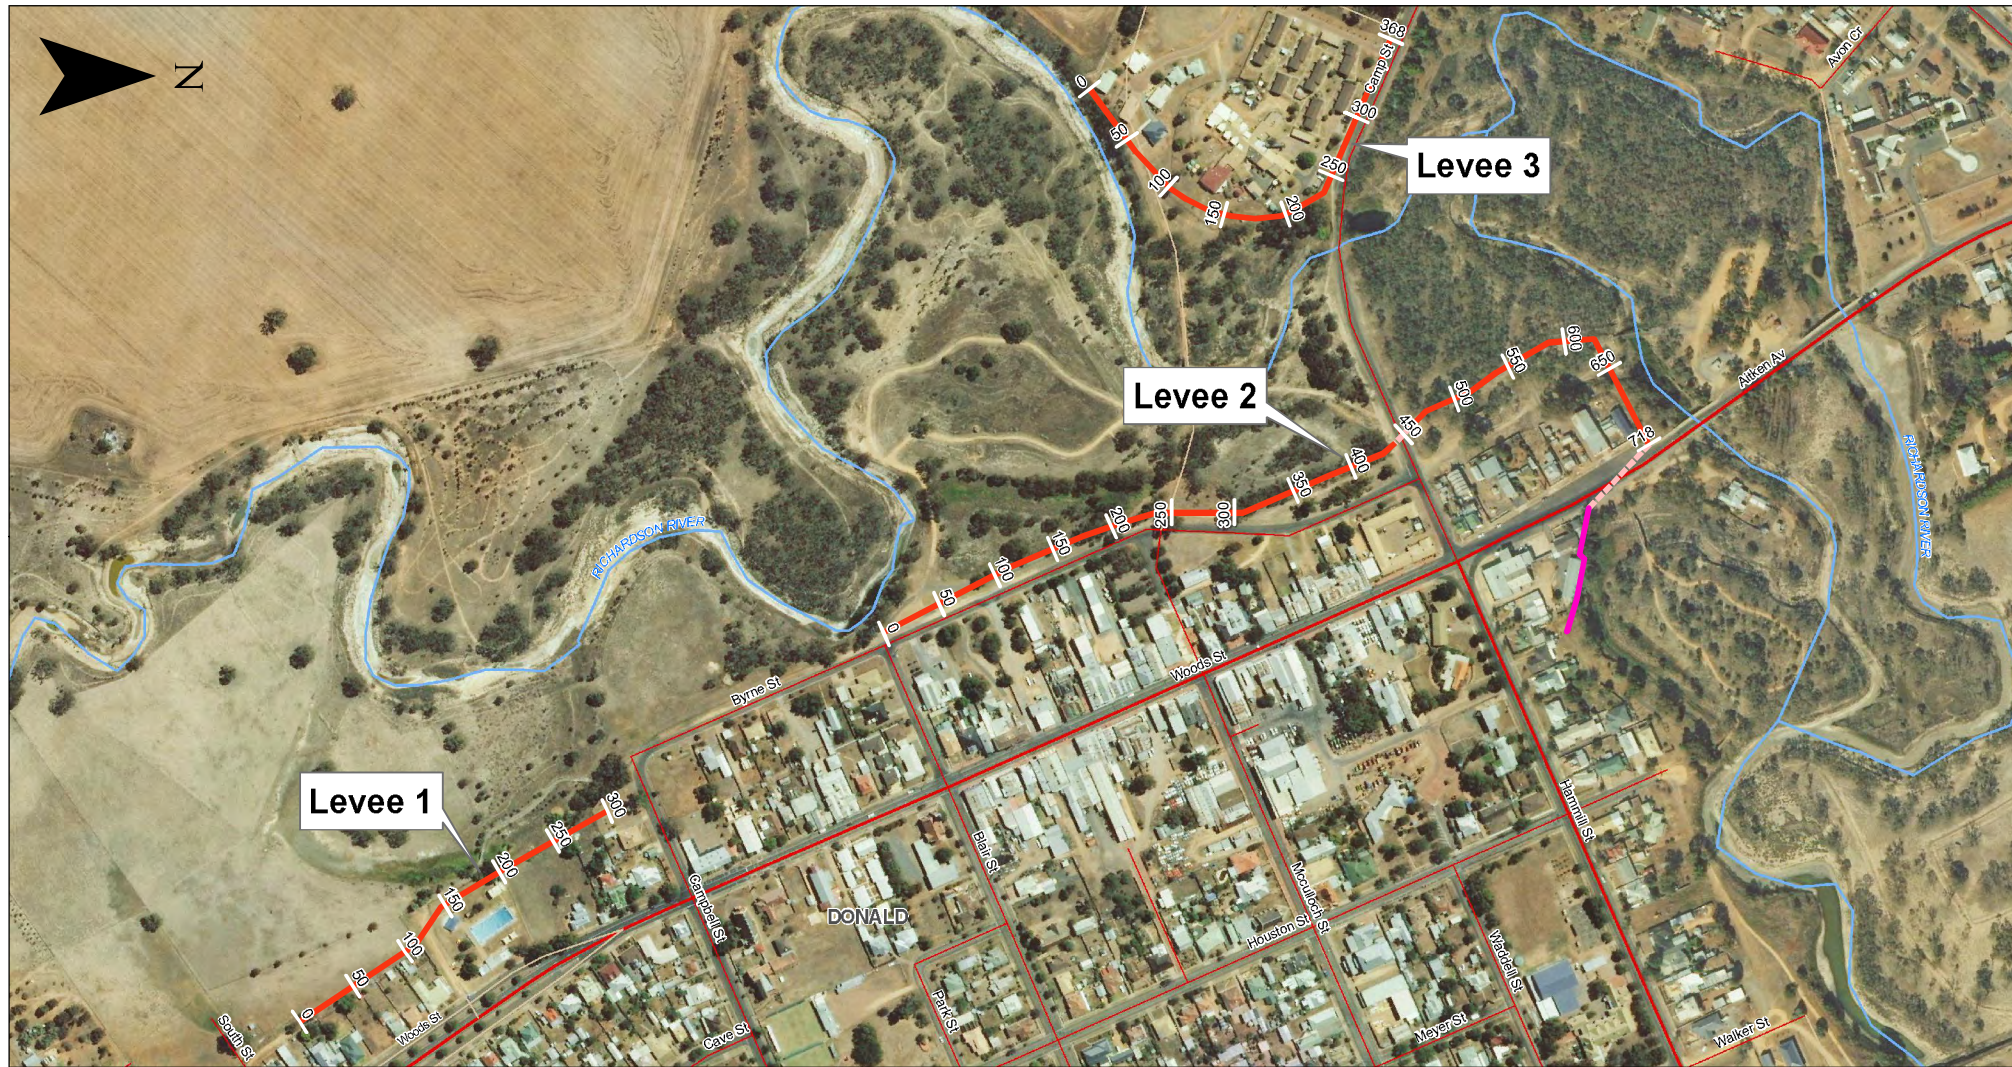
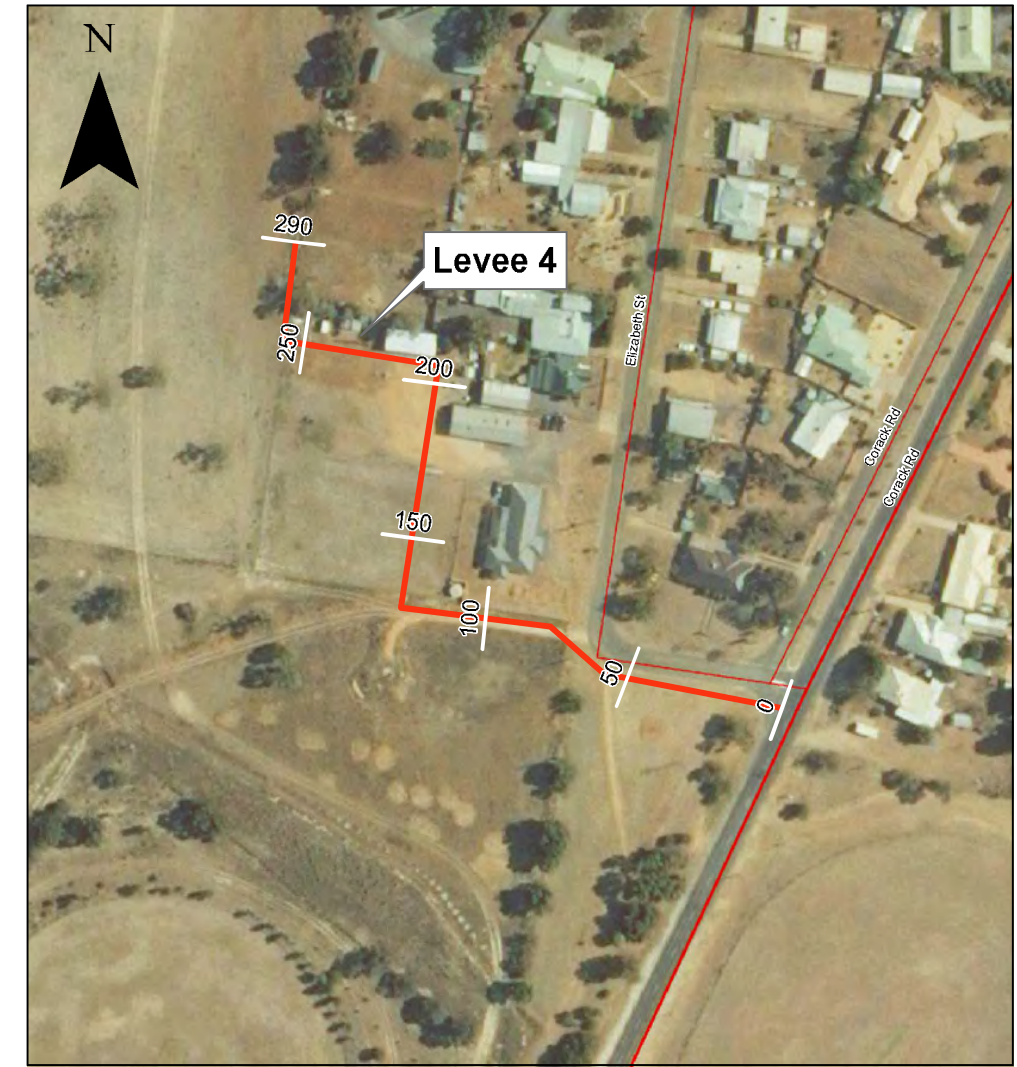
Figure 13

Proposed Levee Locations

Description	Length (m)	Average Height (m)
Levee 1 – Donald Swimming Pool	290	1.8
Levee 2 – Township Levee	900	1.8
Levee 3 – Goodwin Village	370	0.9
Levee 4 – Elizabeth Street	290	1.3

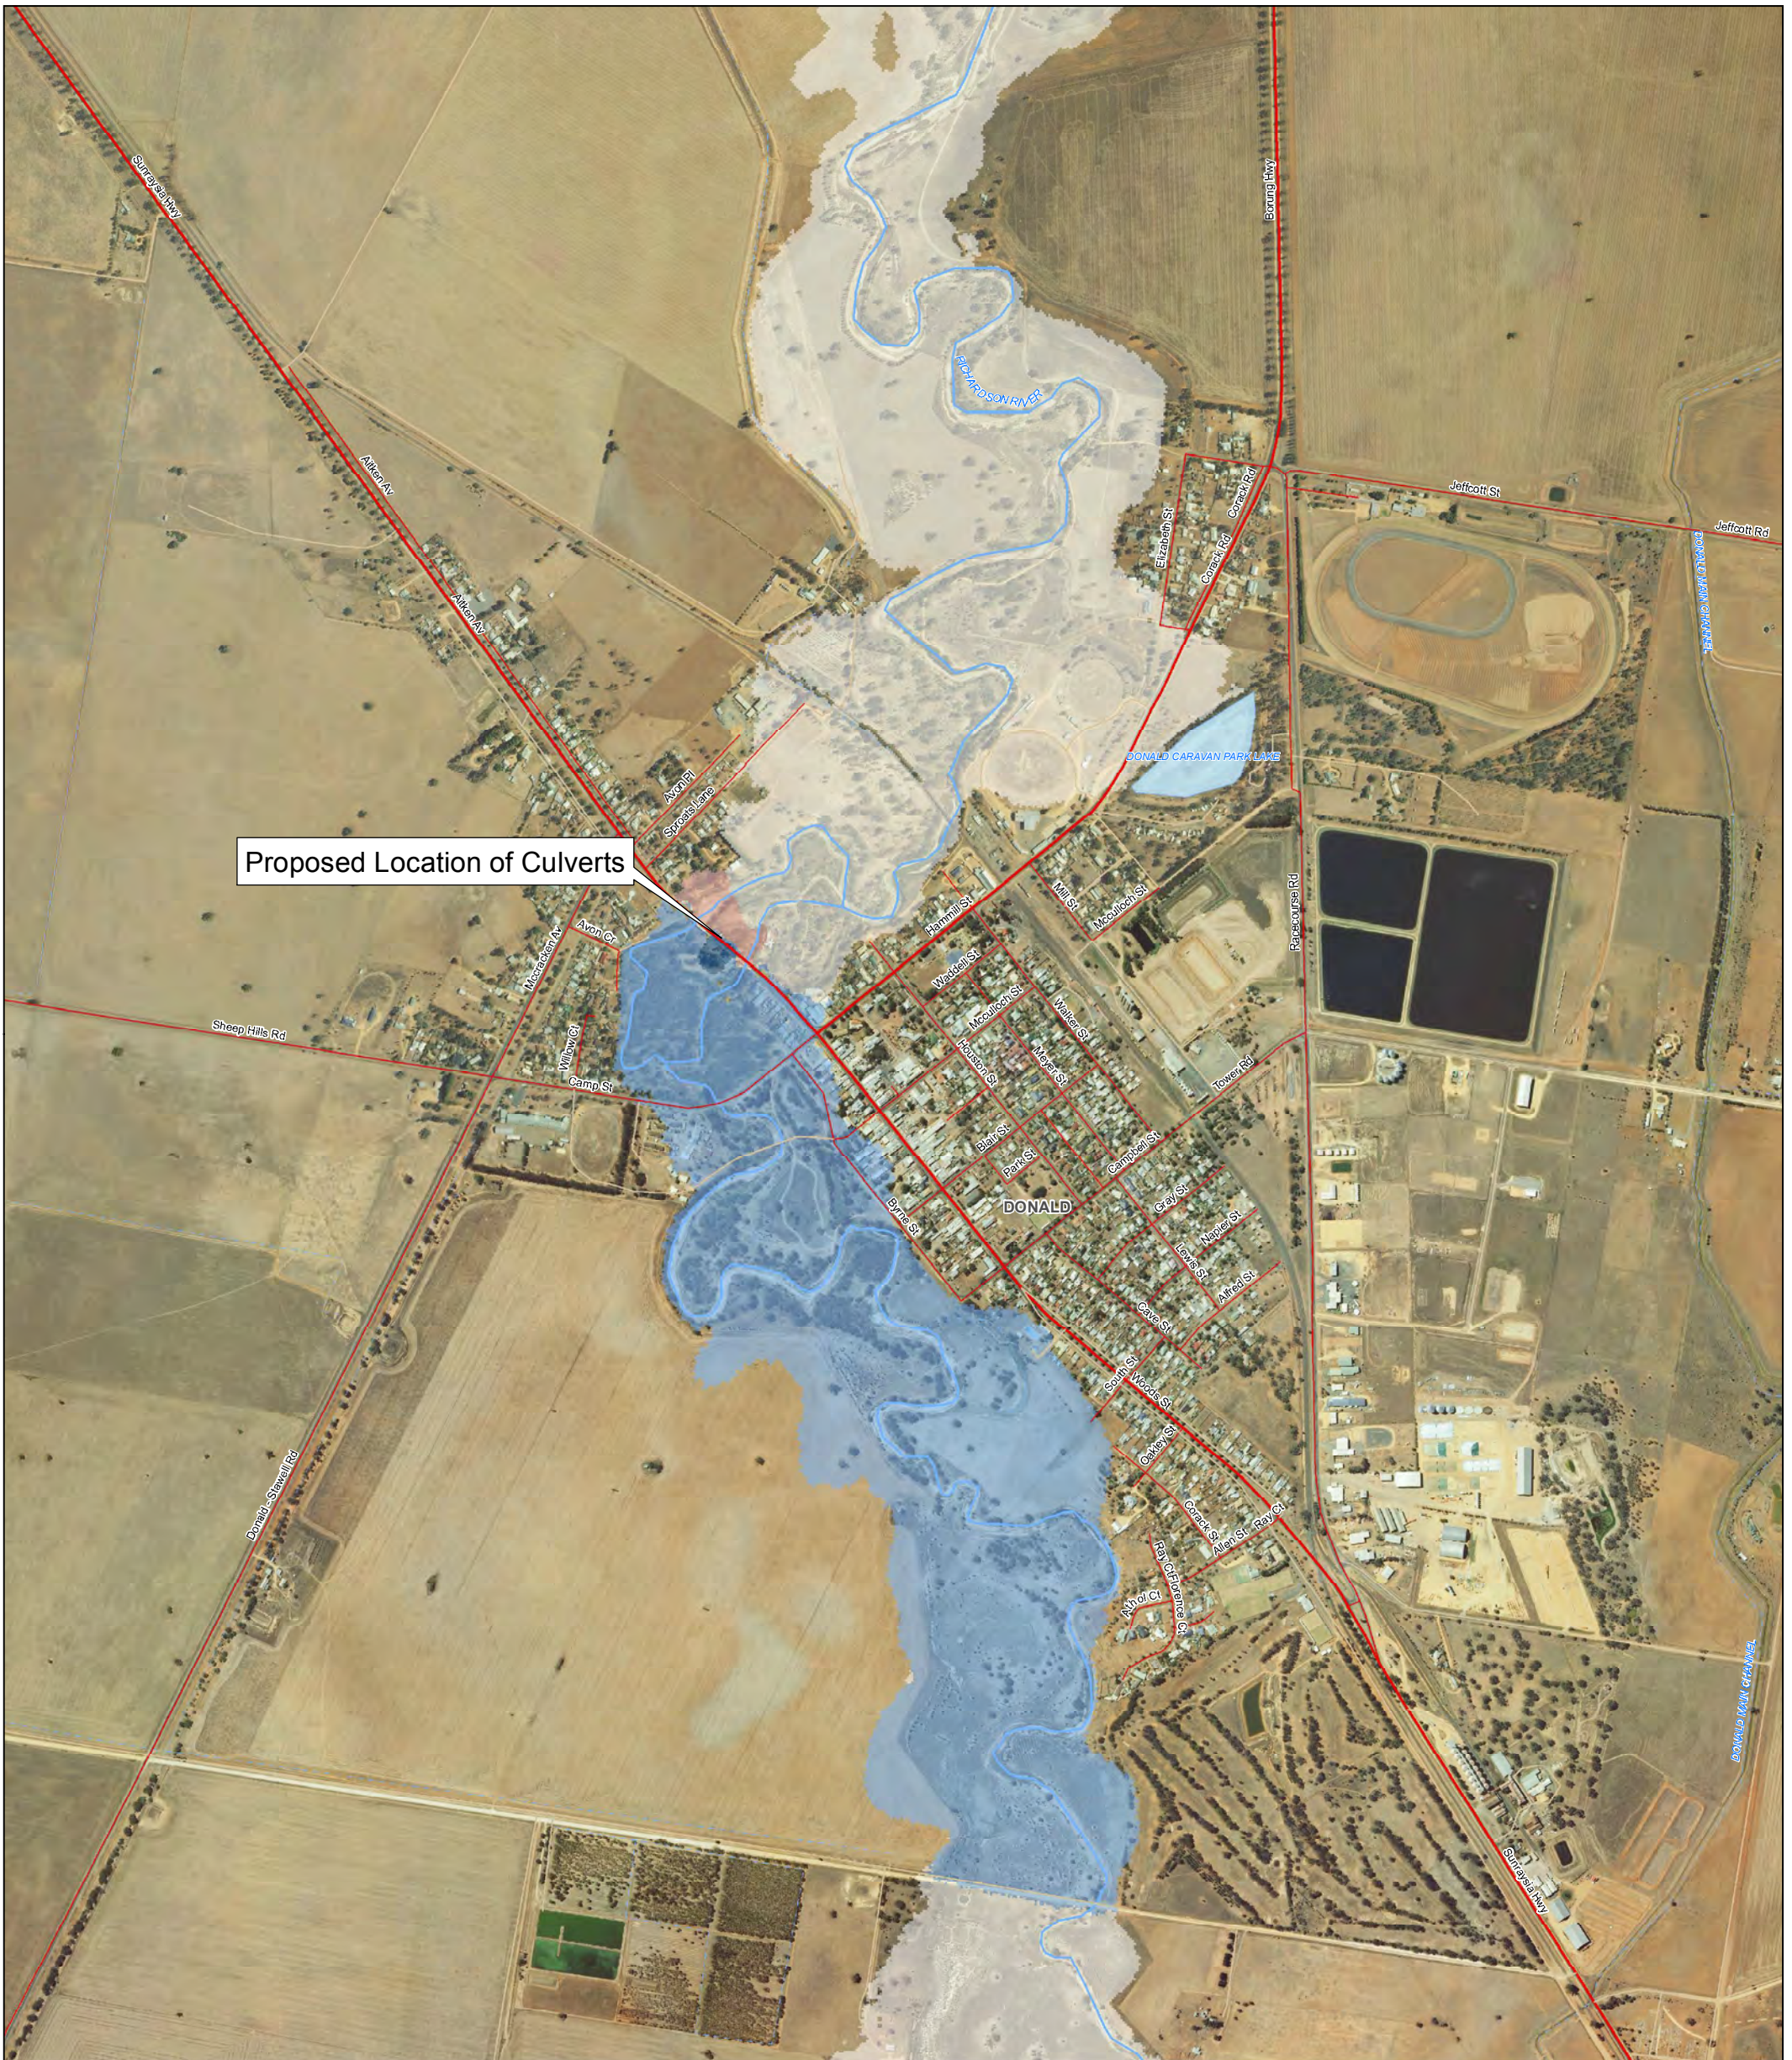
Figure 18 shows the difference in water level (afflux) with the mitigation option in place compare to existing conditions. A negative number indicates that the flood levels would be lower with the mitigation option in place for the same flow event. Additional events are shown in Appendix O.

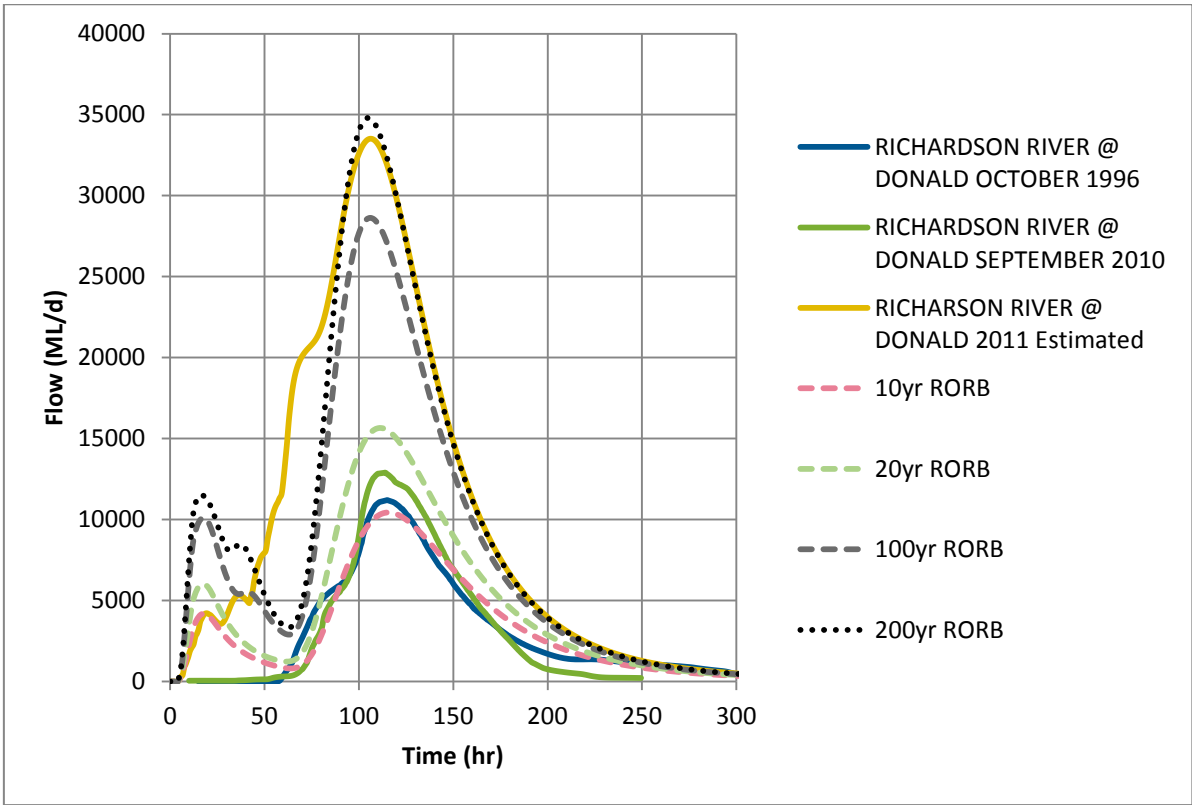
Appendix I – Design Hydrographs versus Historical Hydrographs at 415257 (Richardson River @ Donald)

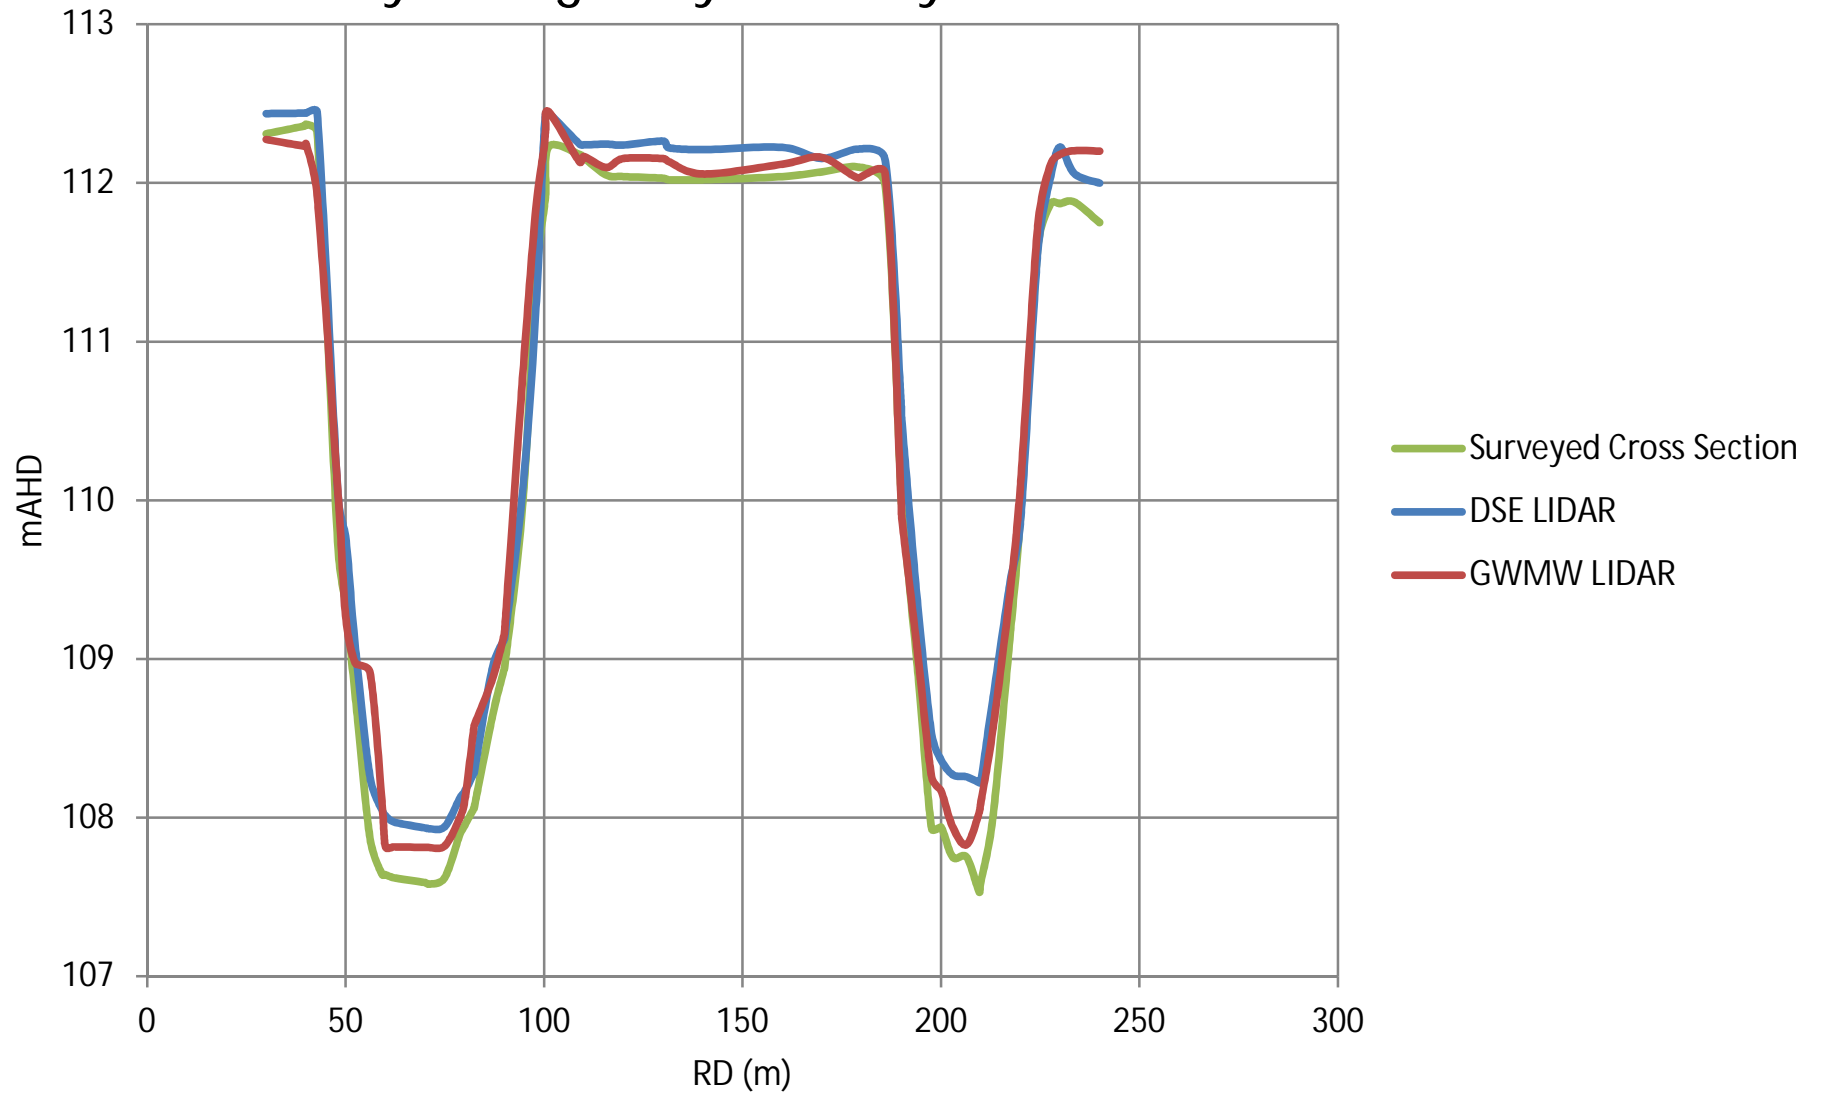
Sunraysia Highway - Survey v LIDAR

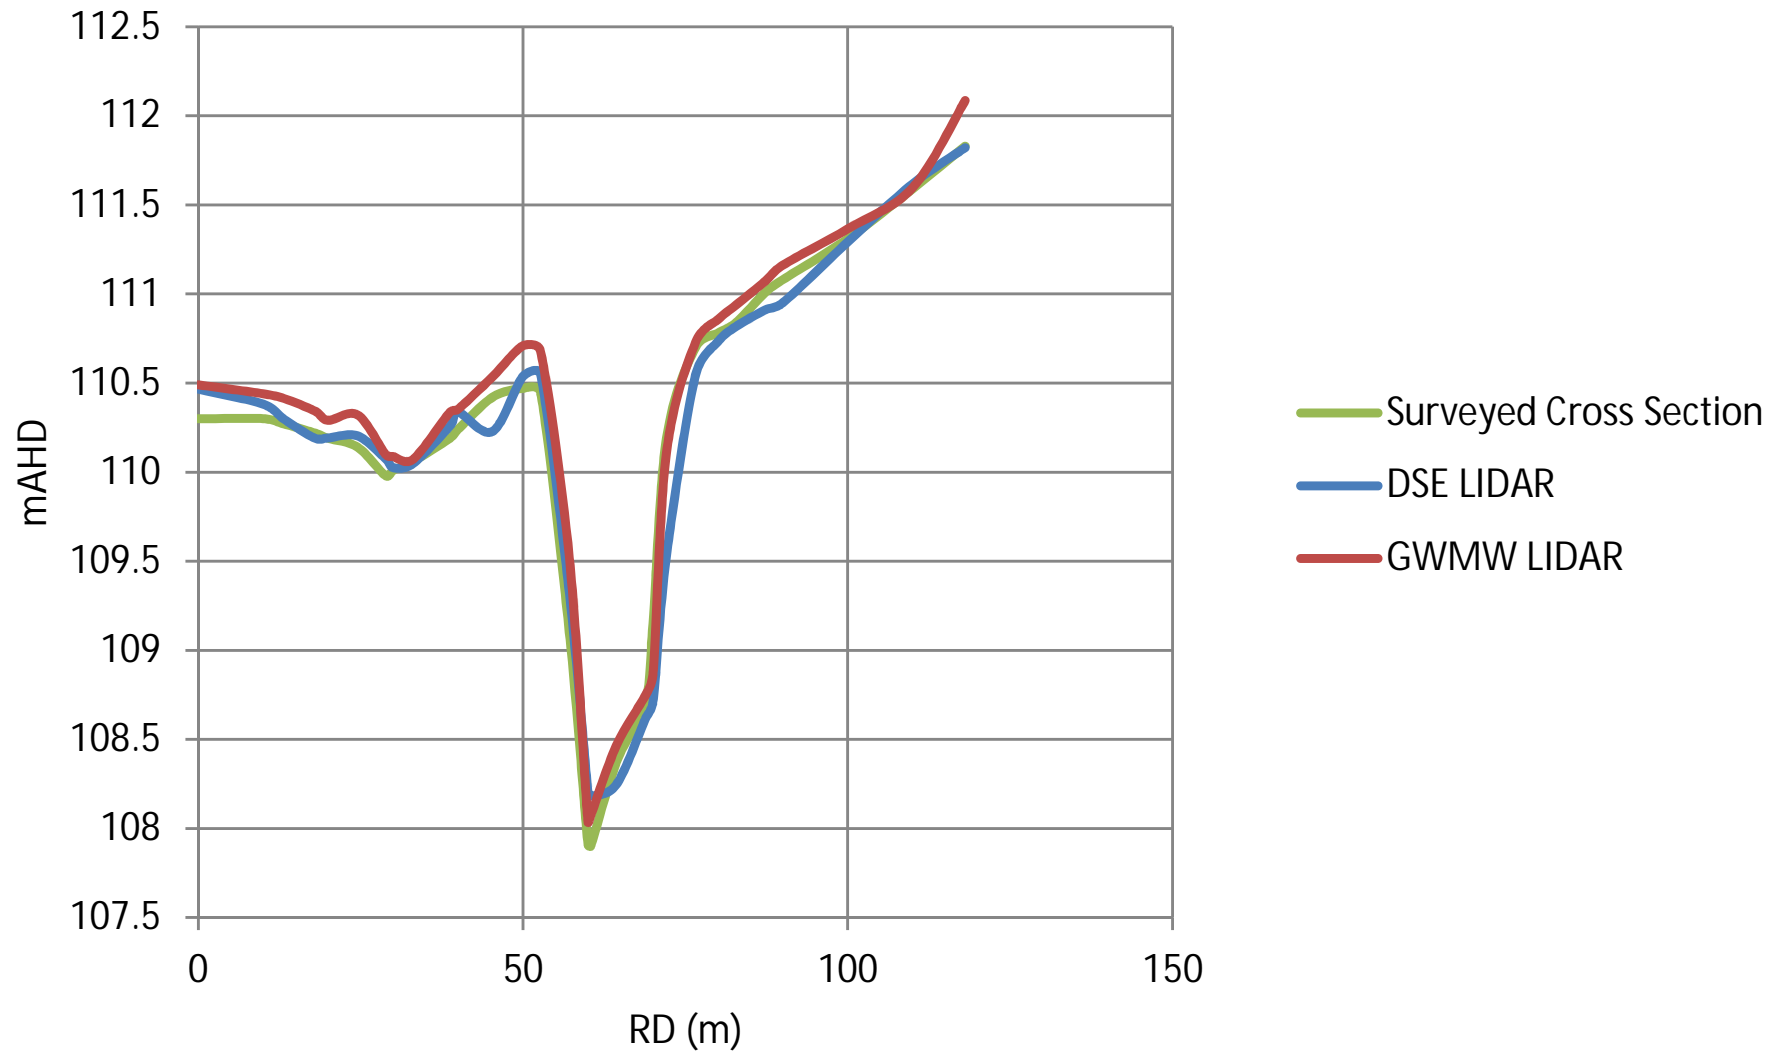
Huston Street - Survey v LIDAR

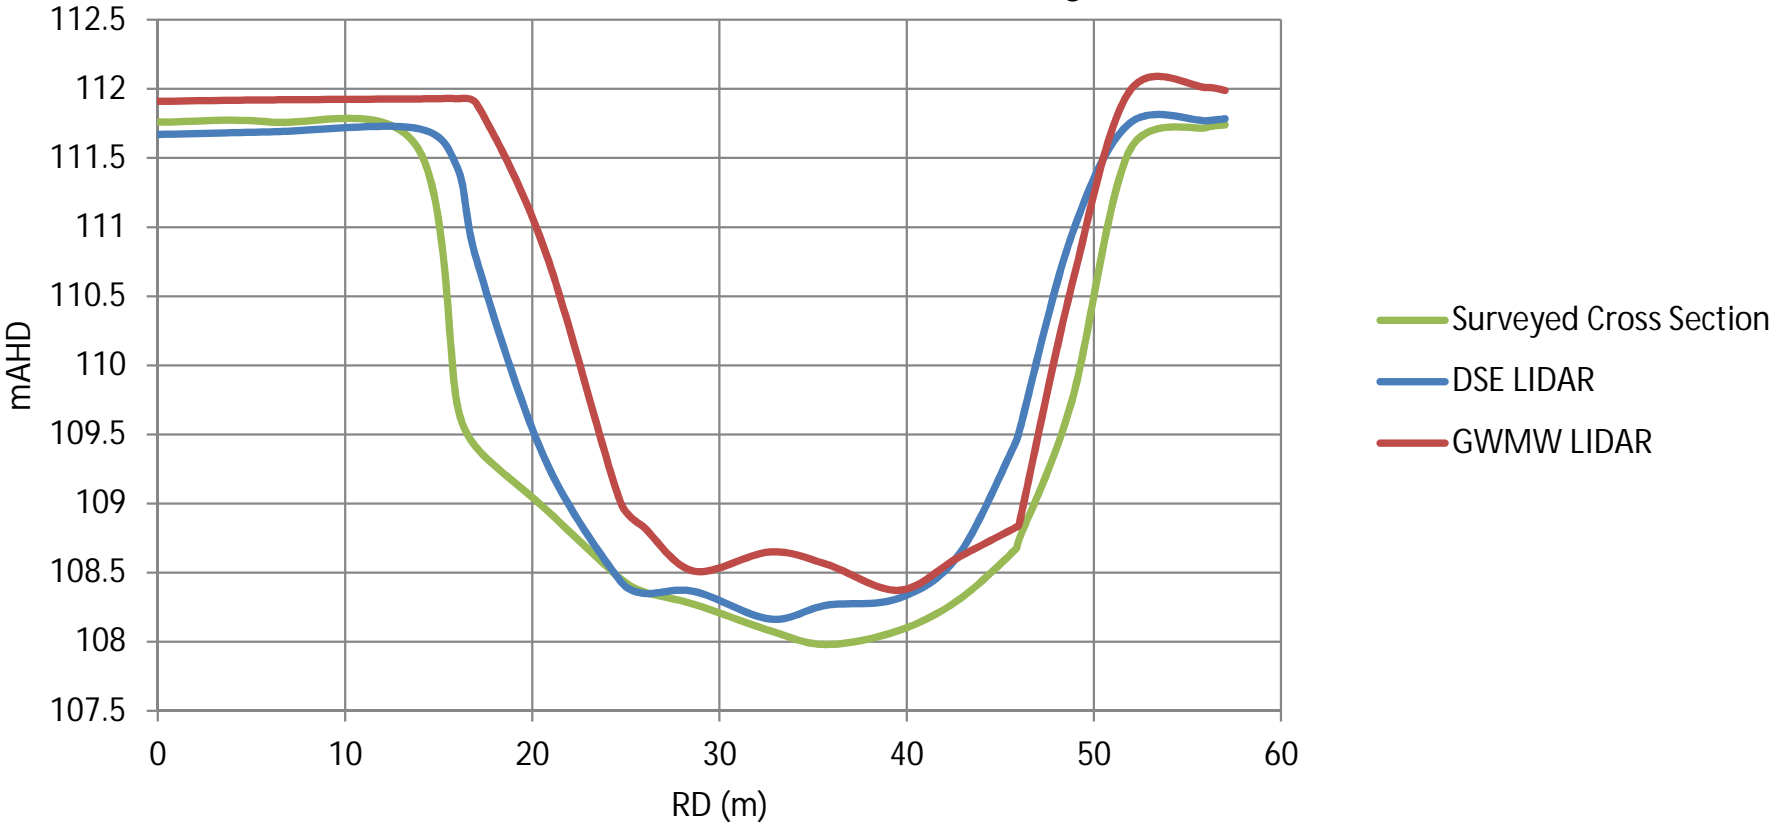
McCulloch Street - Survey v LIDAR

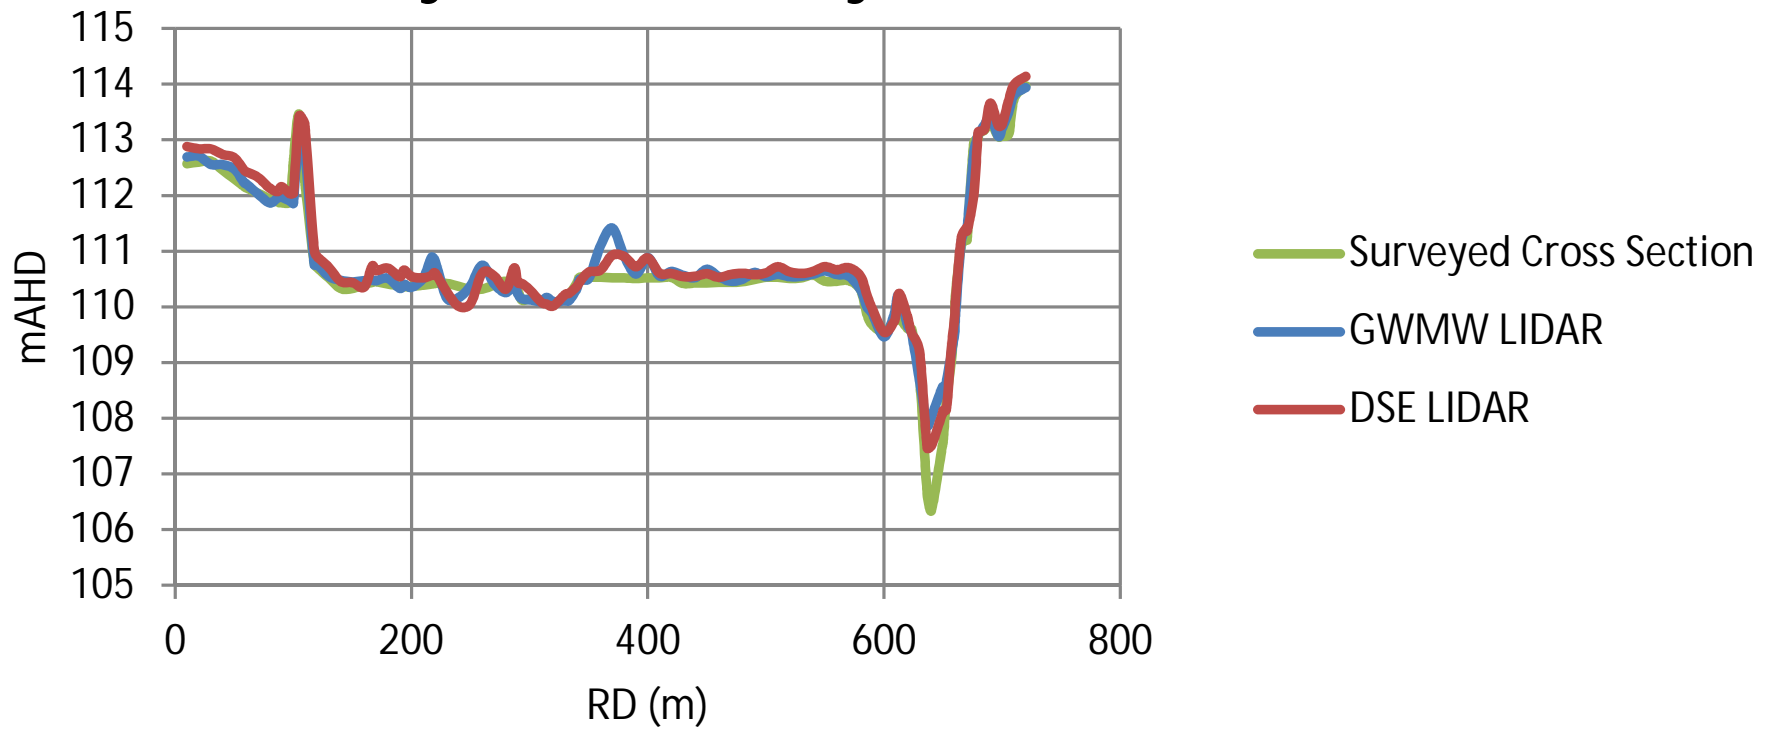
Railway Line - Survey v LIDAR

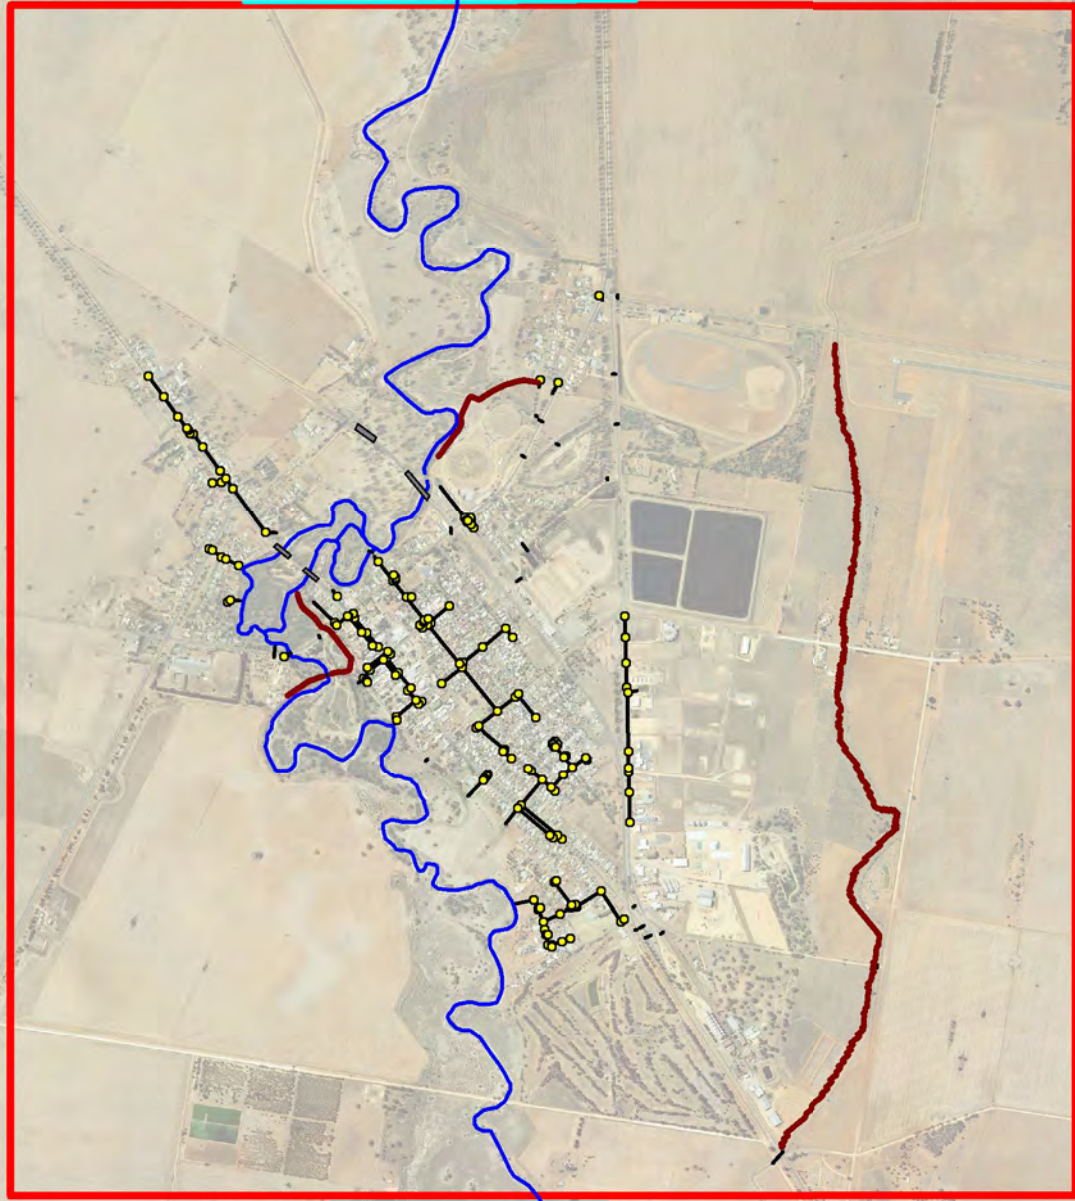
Appendix K – TUFLOW Model Layout

For clarity northern cross sections (extending to Lake Buloke) not shown
