North Central Catchment Management Authority

Donald Flood and Drainage Management Plan

May 2014

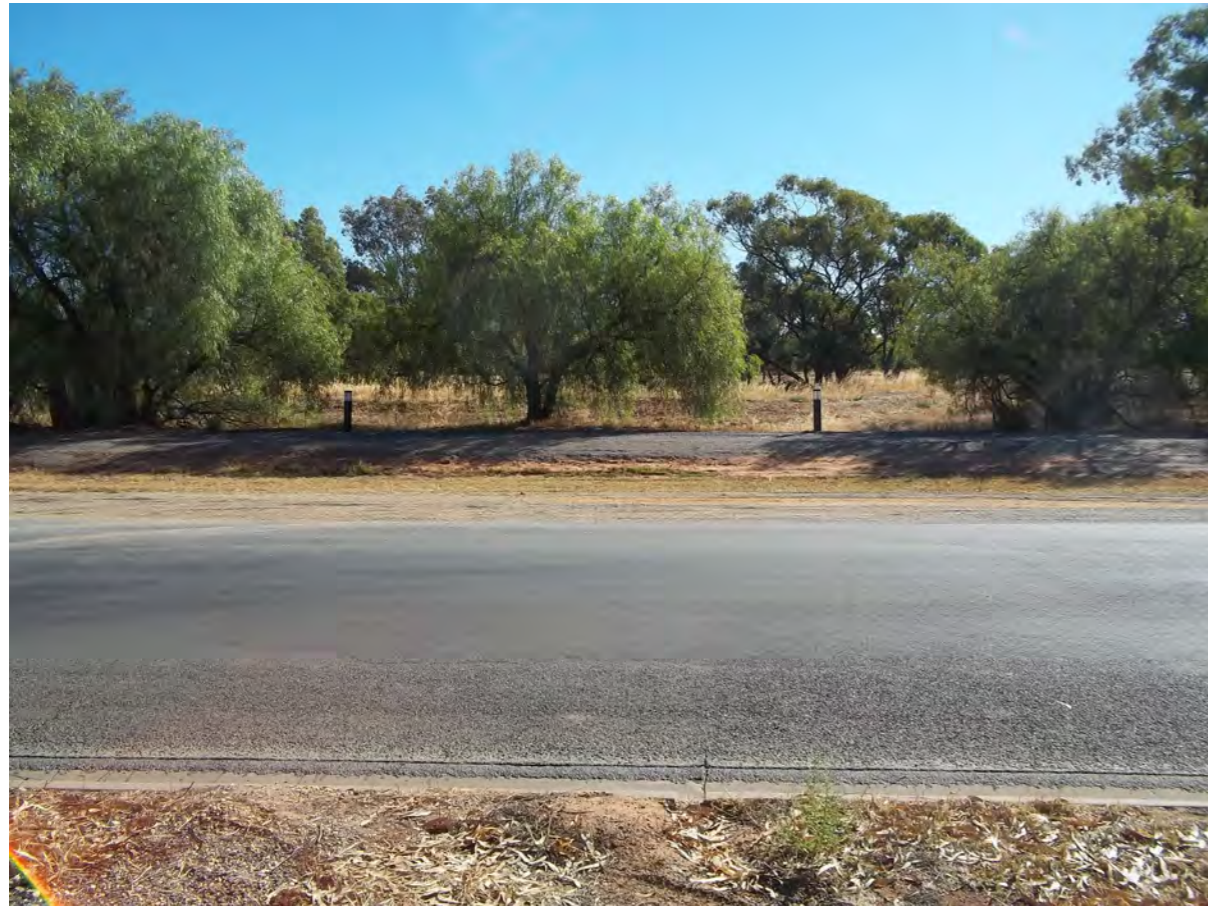
EXISTING CONDITIONS - VIEW 1 LOOKING WEST ALONG BYRNE ST

NOTE: The images are an artists' impression of the proposed levee and are for indicative purpose only.

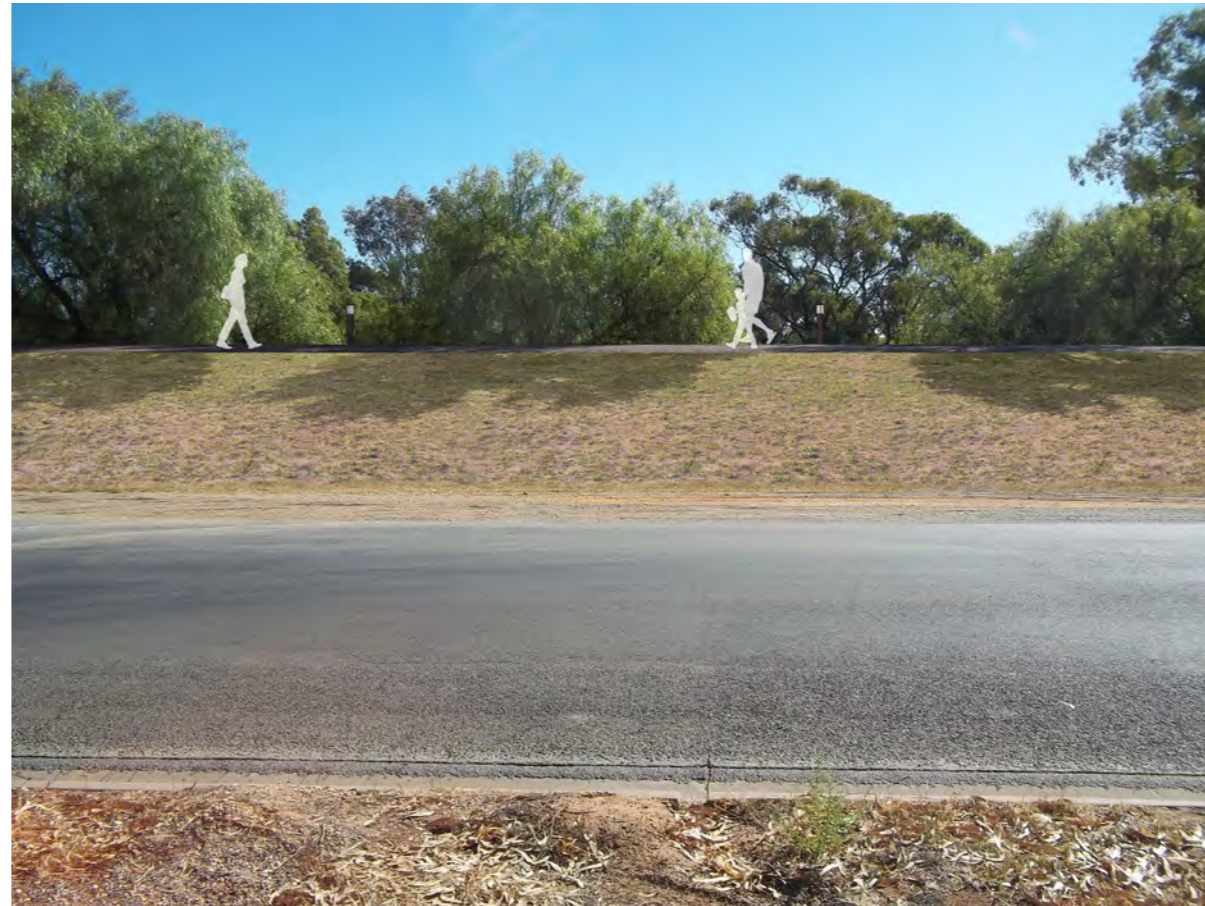
LEVEE 2 - VIEW 1 LOOKING WEST ON BYRNE ST

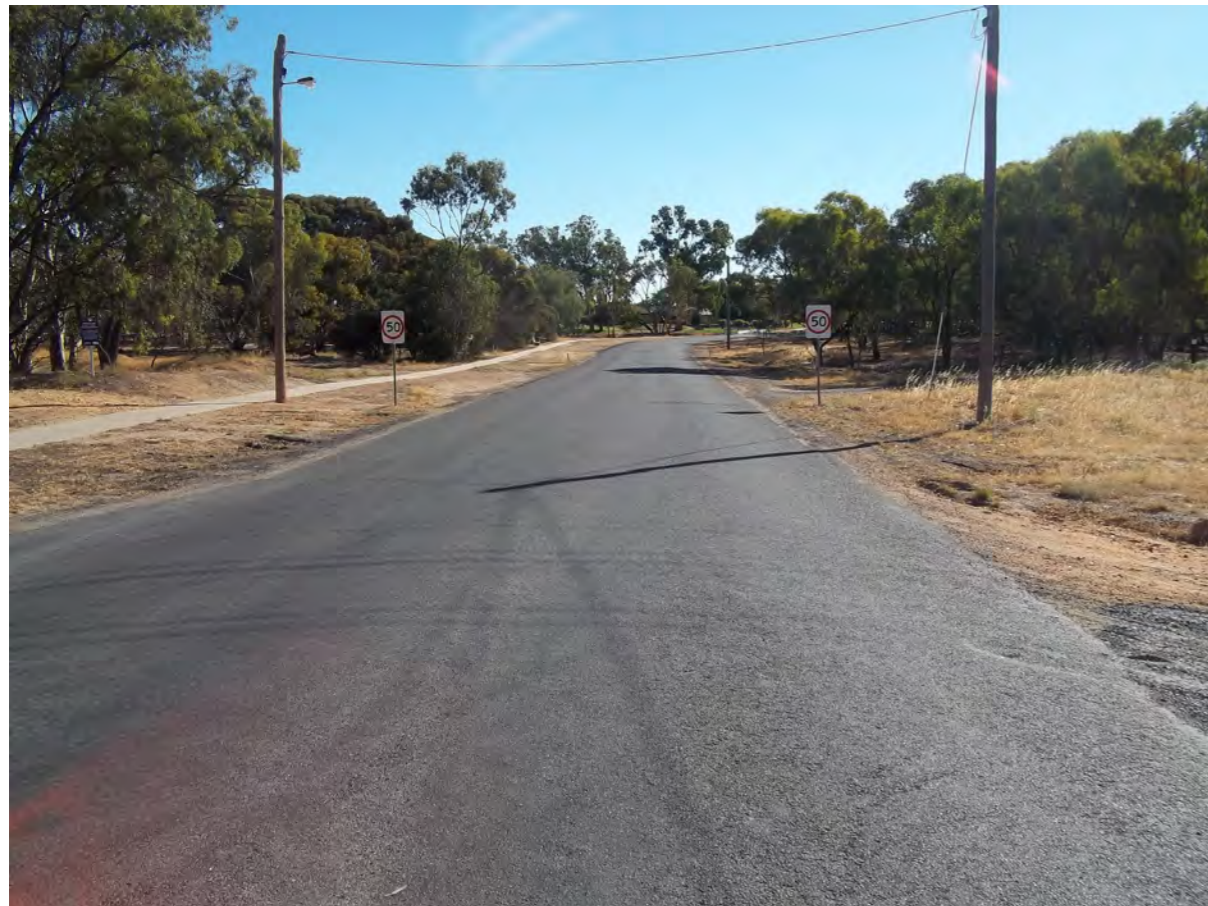
EXISTING CONDITIONS - VIEW 2 LOOKING WEST ON CAMP ST

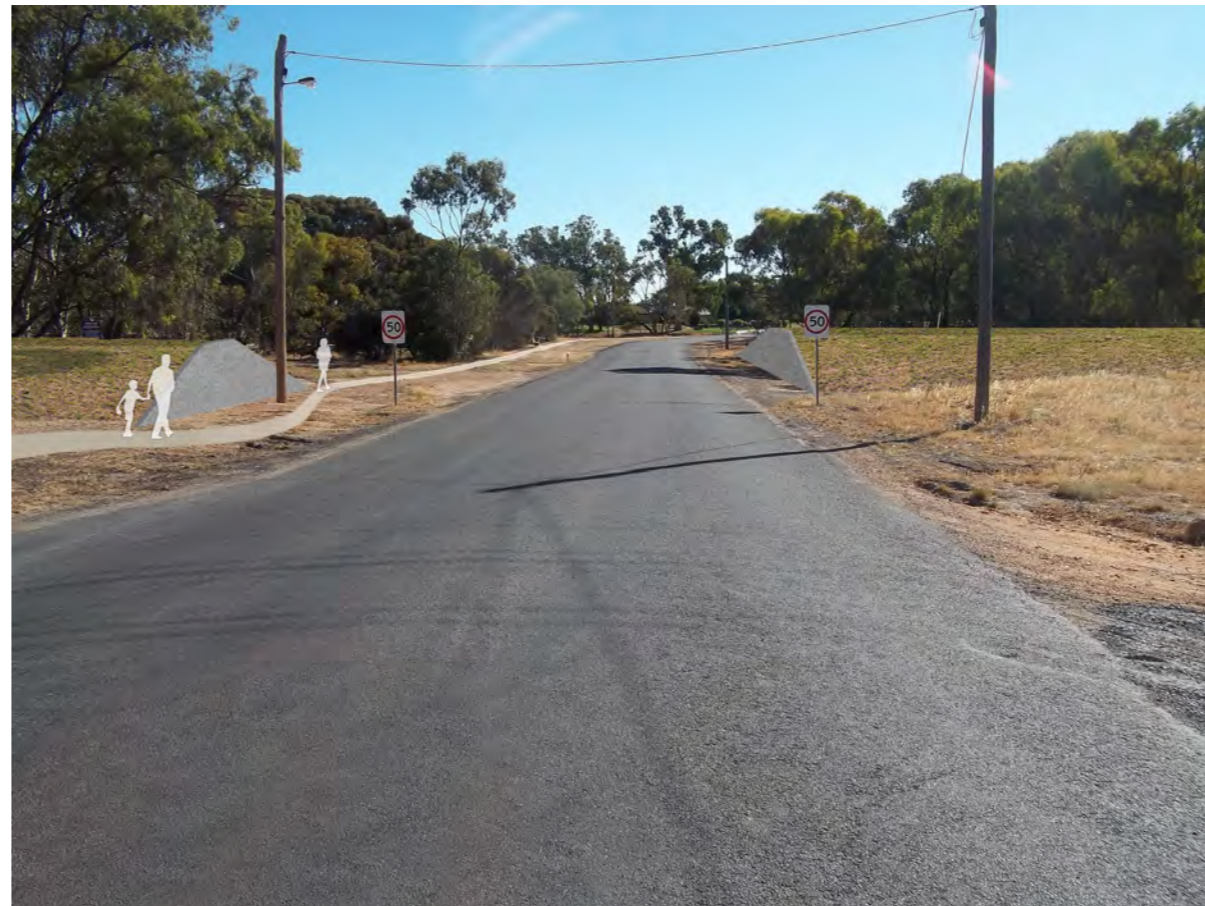
LEVEE 2 - VIEW 2 LOOKING WEST ALONG CAMP ST
