Quambatook Flood Management Plan

April 2014

Project Name	Quambatook Flood Management Plan
Client	Gannawarra Shire Council & North Central CMA
Client Project Manager	Stuart Patterson
Water Technology Project Manager	Kathy Russell
Report Authors	KLR, BT
Job Number	2824-01
Report Number	R01
Document Name	2824-01_R01v02_Study_Report.docx

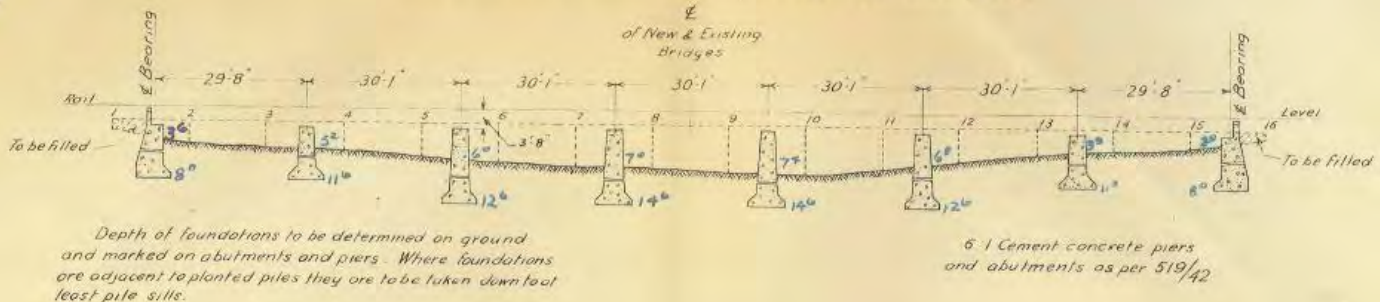
<p>ELEVATION</p> <p>CROSS-SECTION</p>
5	Rail Bridge 344.651 km	<p>Superstructure to be reconstructed as per F 380A; 2 N° R.S.J's per ope</p> <p>of New & Existing Bridges</p>

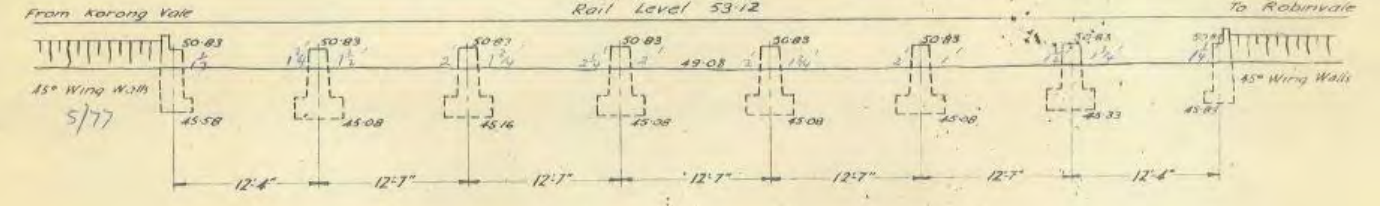
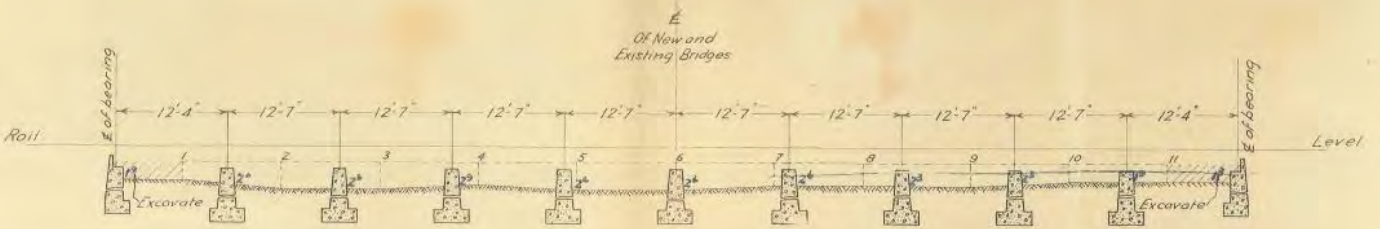
10	Rail Bridge 346.682 km

<p>Depth of foundations to be determined on ground and marked on abutments and piers. Where foundations are adjacent to planted piles they are to be taken down foot least pile sills.</p> <p>6:1 Cement concrete piers and abutments as per 519/42</p>
7	Rail Bridge 340.736 km	<p>From Kerong Vale</p> <p>Rail Level 53.42</p> <p>To Robinvale</p>

<p>45° Wing Walls</p>

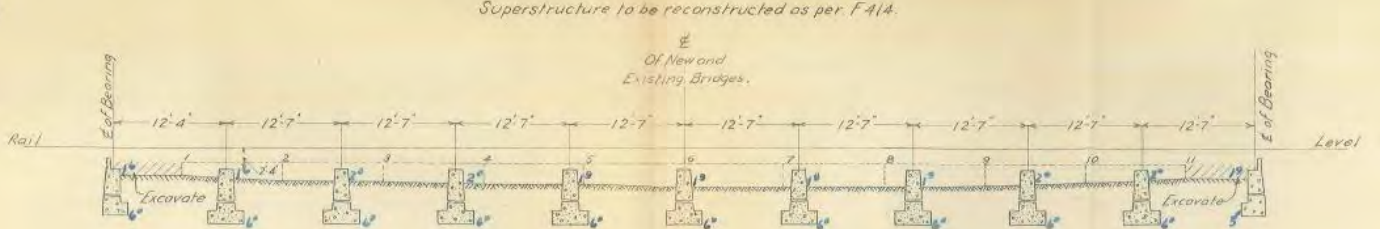
<p>Depth of foundations to be determined on ground and marked on piers and abutments. Where foundations are adjacent to planted piles they are to be taken down to at least pile sills.</p> <p>6:1 Cement concrete abutments and piers as per F428.</p>
12	Rail Bridge 348.018 km	<p>Superstructure to be reconstructed as per F414.</p>

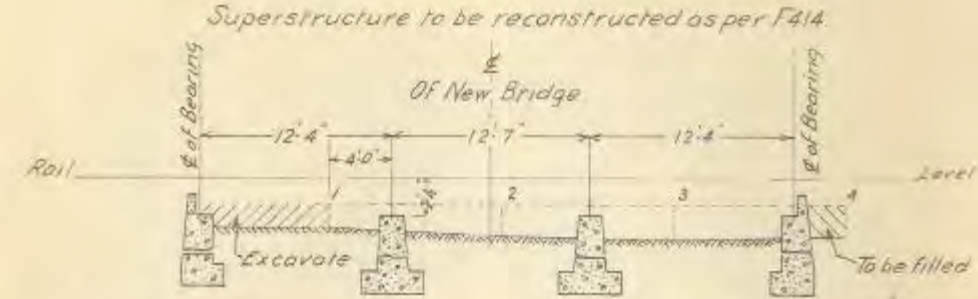
<p>Depth of foundations to be determined on ground and marked on piers and abutments. Where foundations are adjacent to planted piles they are to be taken down to at least pile sills.</p> <p>6:1 Cement concrete abutments and piers as per F428.</p>
13	Rail Bridge 348.956 km	<p>Superstructure to be reconstructed as per F414.</p>

<p>Depth of foundations to be determined on ground and marked on piers and abutments. Where foundations are adjacent to planted piles they are to be taken down to at least pile sills.</p> <p>6:1 Cement concrete abutments and piers as per F428.</p>

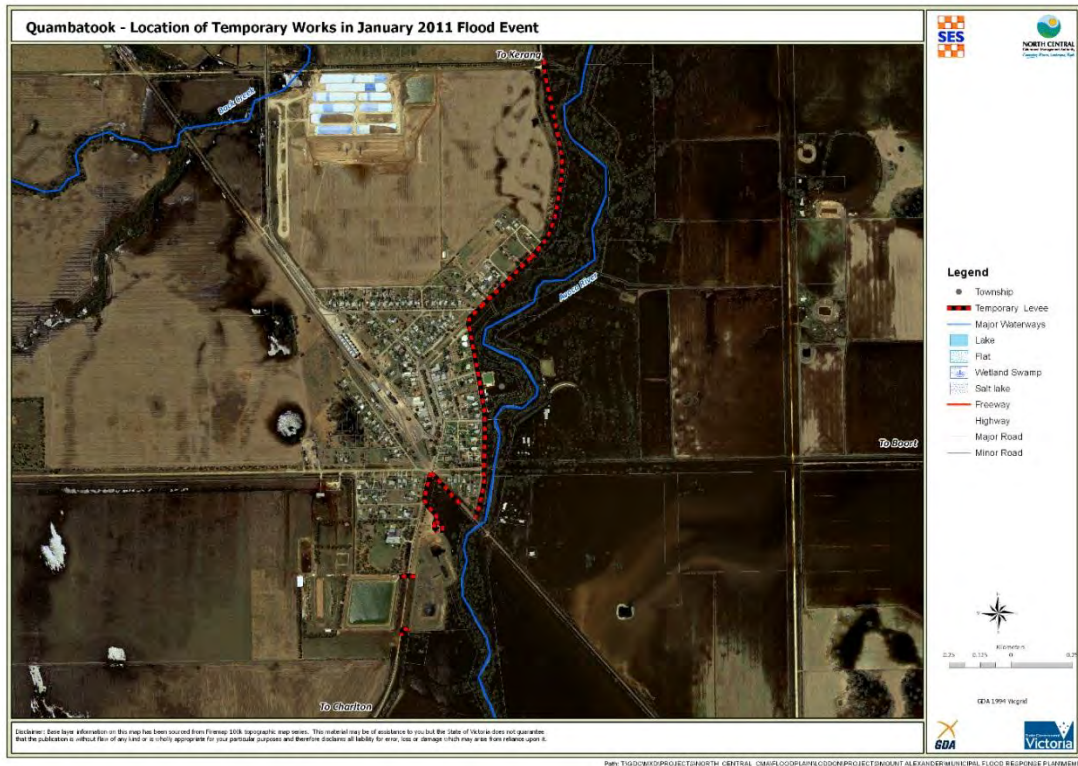
Figure 2-5 Temporary levees in Jan 2011 event

A map of the temporary works undertaken in the January 2011 event was provided by NCCMA (Figure 2-5).

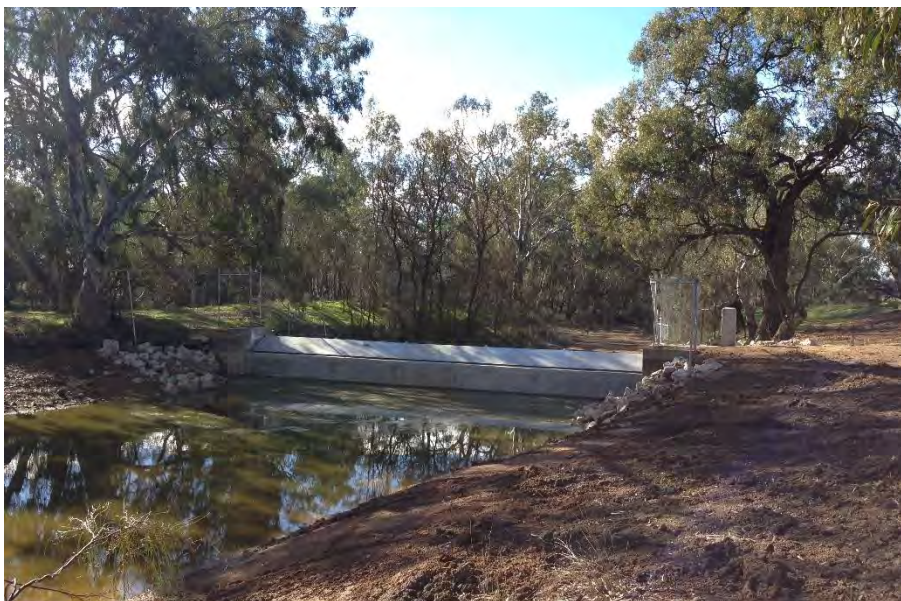
The Quambatook weir was recently replaced with a new structure. The replacement weir was observed during the site visit on 2 July 2013 (Figure 2-6). The weir has the same width and crest height as the old weir. The weir is 14.33 m wide with a variable crest level. For all flood modelling it was assumed the crest level was lowered to its minimum level (89.02 m AHD) during flood events.

Figure 2-6 New Quambatook weir, 2 July 2013

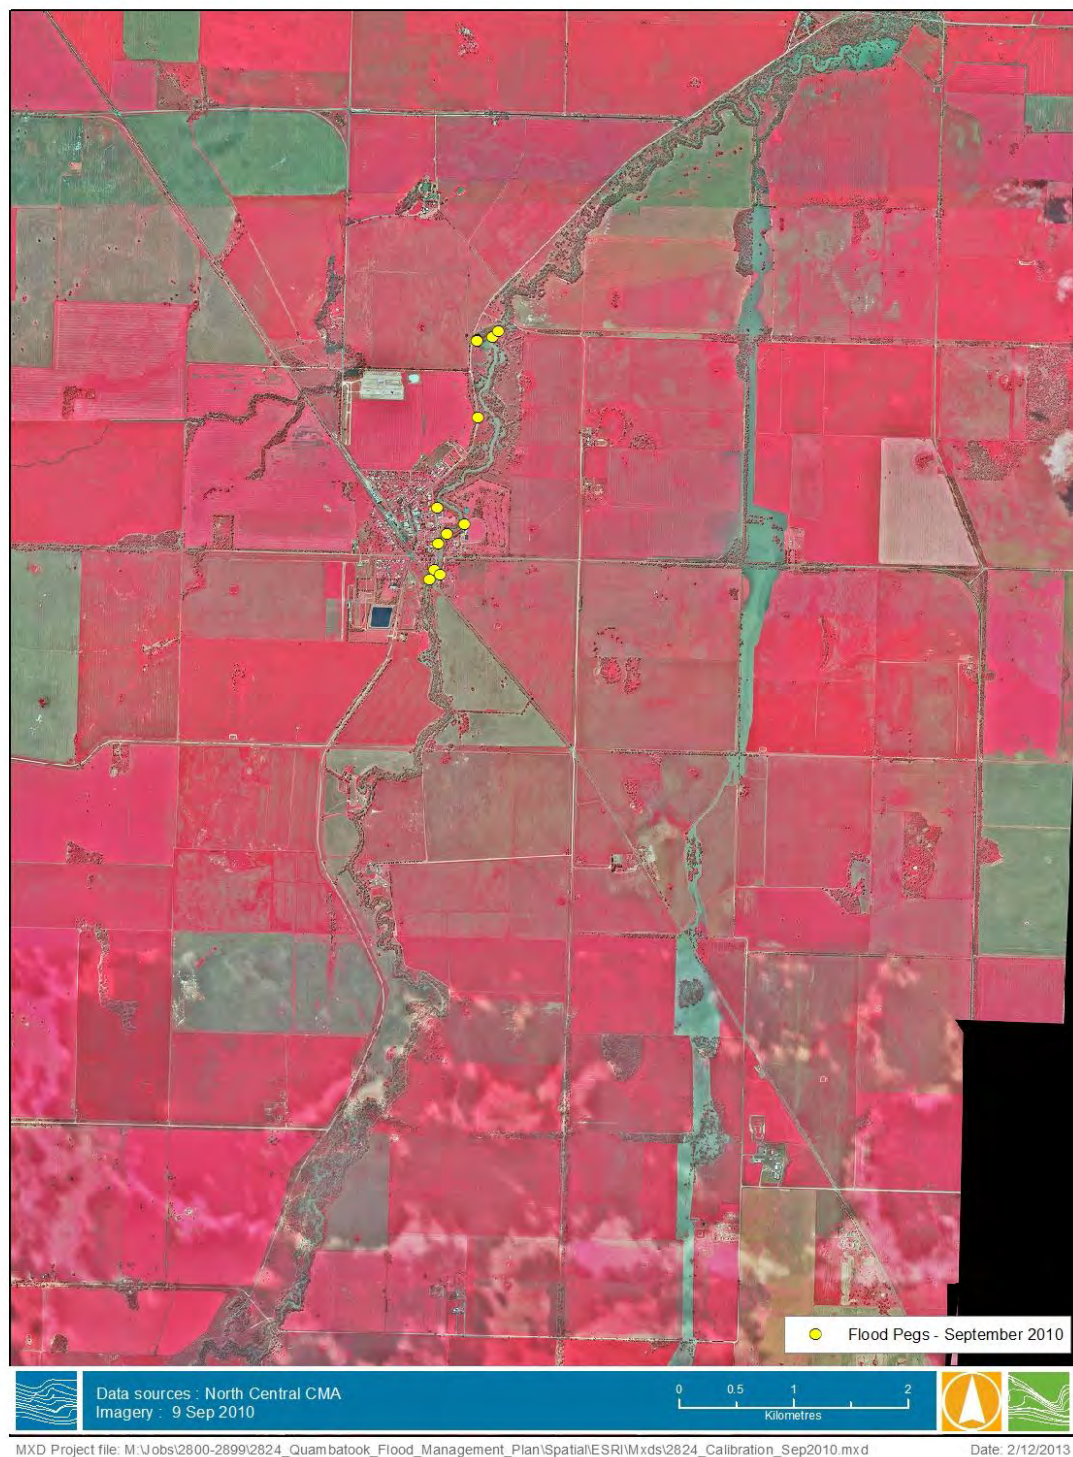
Figure 2-8 Flood pegging and colour infrared aerial photography – 9 September 2010

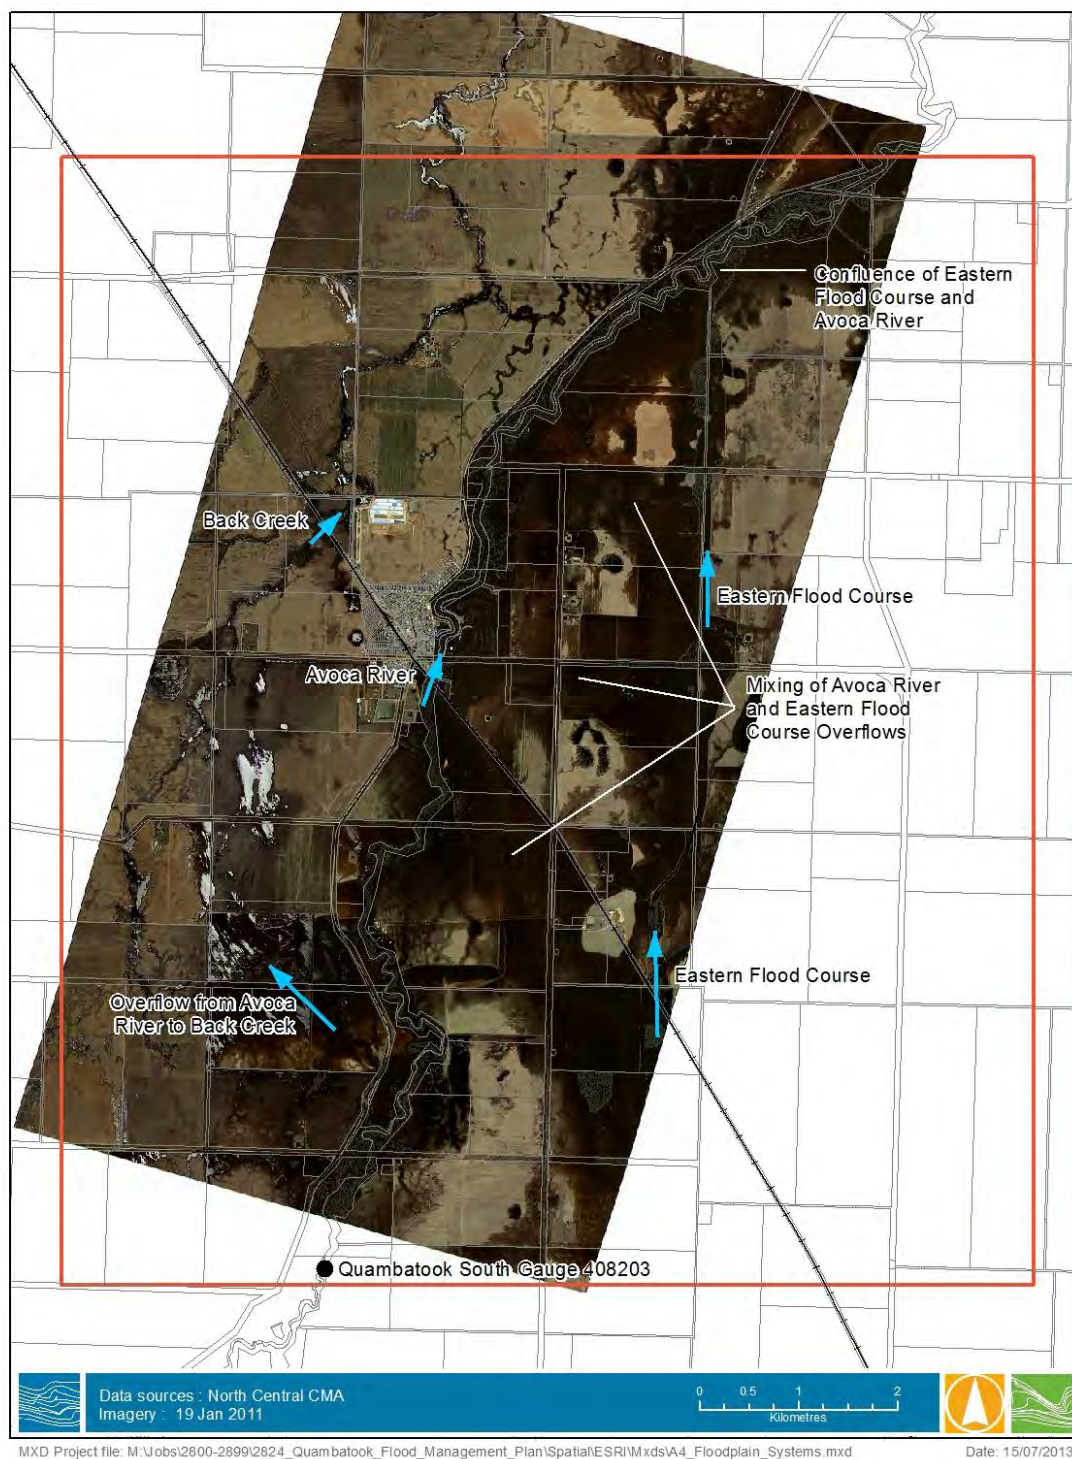
Figure 4-1 Floodplain and channel systems within study area, 19 January 2011 aerial imagery

Under moderate flow conditions, flow is restricted to the three distinct flow paths of Back Creek, Avoca River and Eastern Flood Course. Under extreme flows such as the January 2011 event, the three flow paths interact, through overflows from the Avoca River into Back Creek, and through overflows from Avoca River and the Eastern Flood Course meeting at various points in the floodplain.

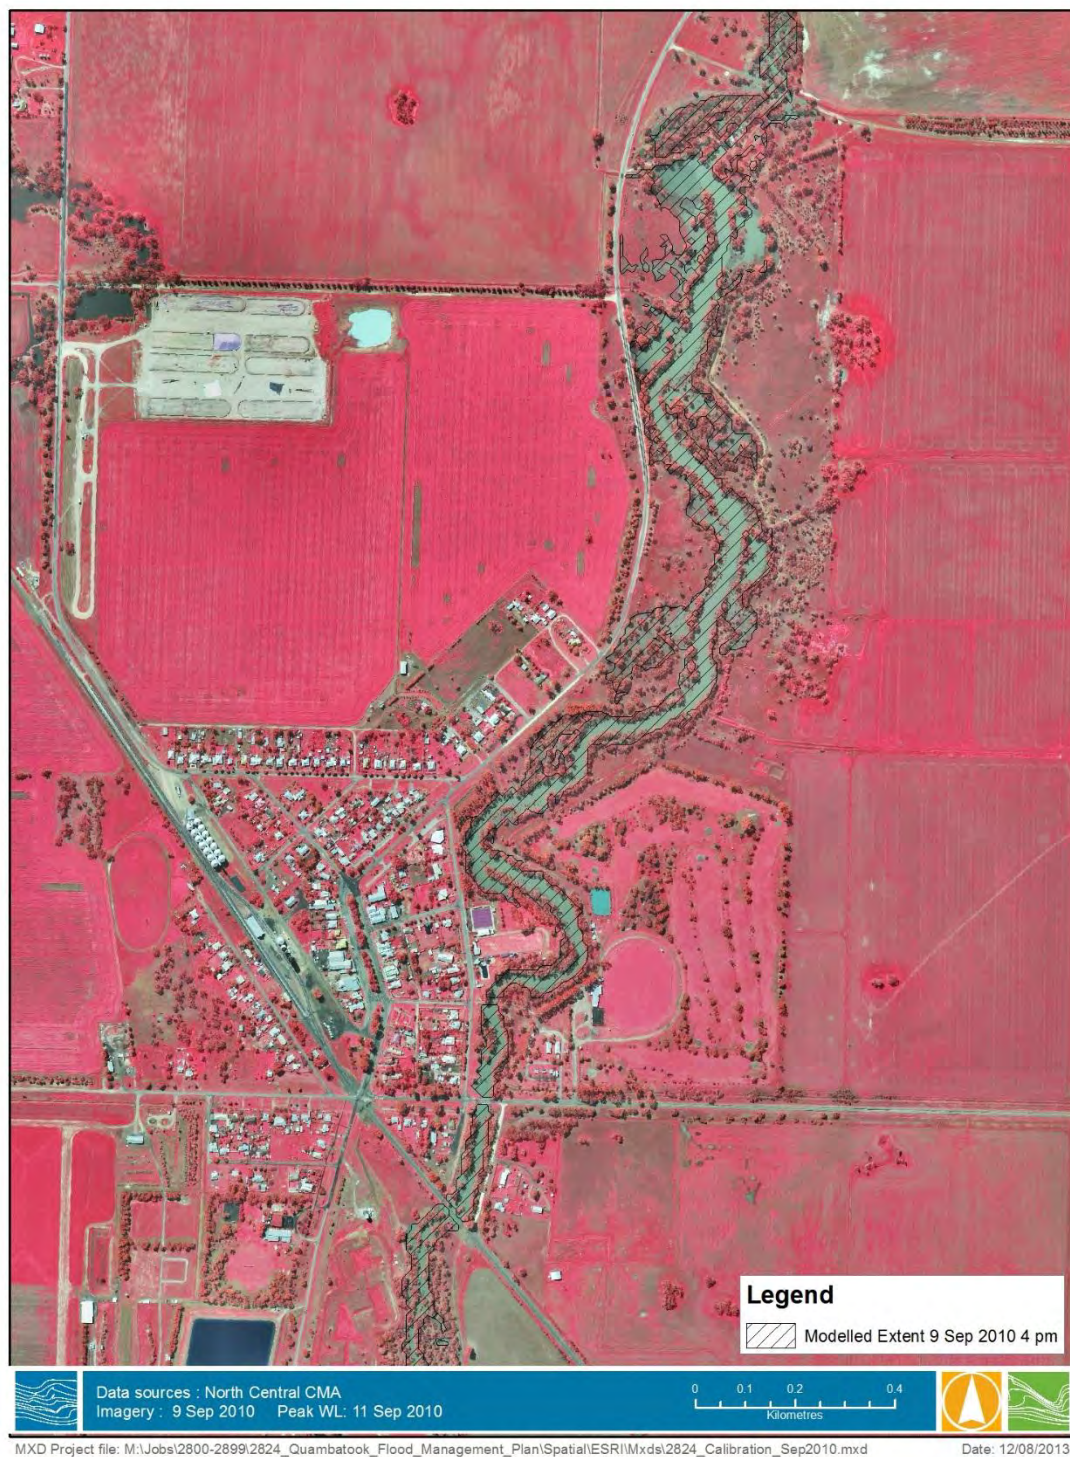
Figure 5-7 Comparison of aerial photographs with modelled flood extent (9 Sep 2010) over township

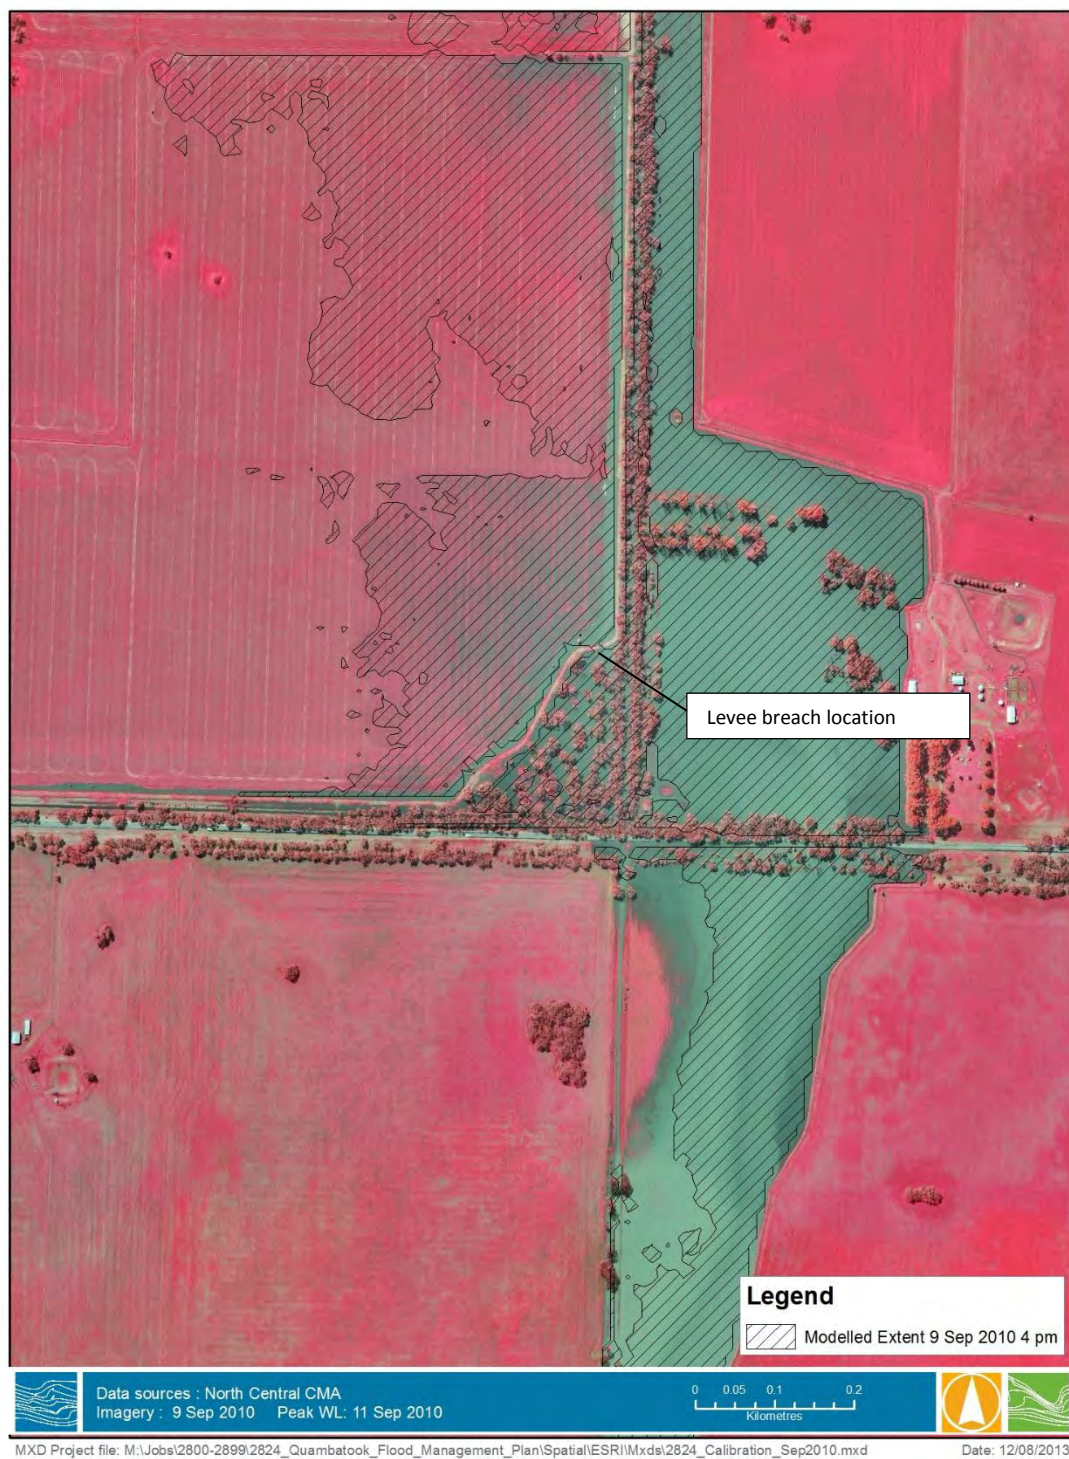
Figure 5-8 Comparison of aerial photographs with modelled flood extent (9 Sep 2010) at breached levee
