Water sample collection, Little Murray River

North Central Waterwatch
River Health Snapshot Report
RiverScan Citizen Science Project 2018

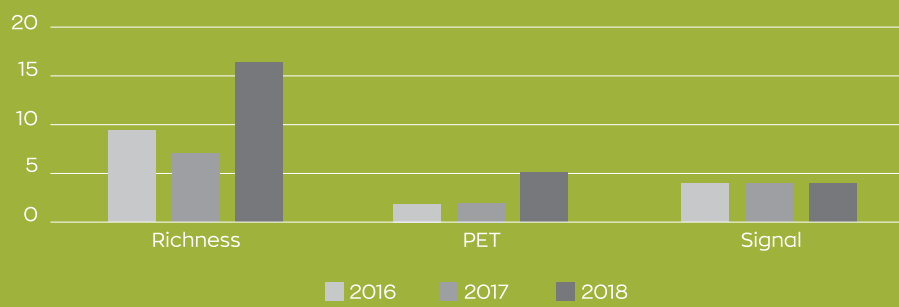
Little Murray Waterbugs

Waterbug Taxa Richness	ALT EPT	Signal Score	EC (µs/cm)	pH	Turbidity (NTU)	Phos (Mg/L)
16.5	5	3.8	247	8.2	43	0

Data from 2018 indicated the Little Murray River was in good ecological condition. Objectives were reached in two of three ALT indices and there was an overall improvement from previous years. The taxon richness and PET indices more than doubled since the 2016 RiverScan survey. The increase could be attributed to improved flows and the addition of instream woody habitat. Furthermore, the water quality scores for the Little Murray River indicated the river had good quality water.

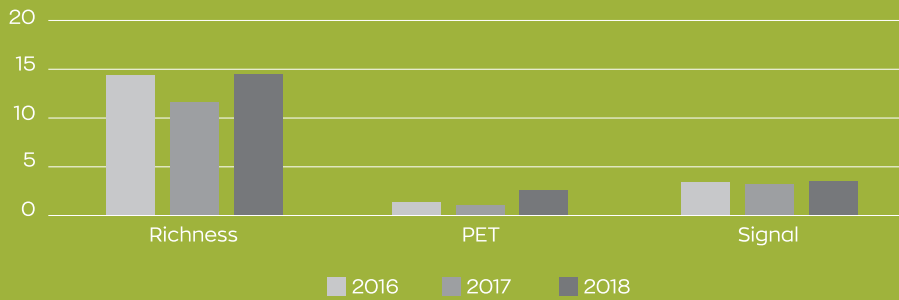
Loddon River Waterbugs

Waterbug Taxa Richness	ALT EPT	Signal Score	EC (µs/cm)	pH	Turbidity (NTU)	Phos (Mg/L)
14.8	2.8	3.4	0.03	7.8	310	91

The Loddon River was in moderate condition. Although ALT signal scores remained relatively stable, taxa richness and PET indices increased markedly in 2018. Taxa richness and ALT signals indicate moderate condition, while the PET index was poor. The increase in ALT scores may be a result of improved instream habitat (e.g. aquatic vegetation) from the delivery of water for the environment, complemented by fencing and revegetation. In addition, the water quality scores for the Loddon River indicated good quality water. Loddon River indicated good water quality for all parameters except for turbidity. It is anticipated that ecosystem health recovery in the lower Loddon River will be slow due to the highly disturbed nature of this system; historic alteration of flows and siltation of instream habitats.

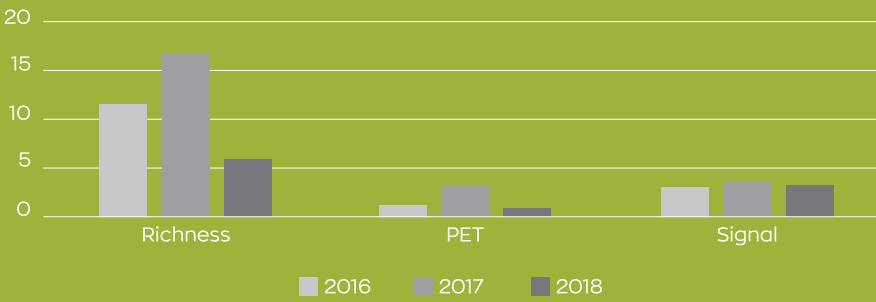
Box-Pyramid Creek Waterbugs

Waterbug Taxa Richness	ALT EPT	Signal Score
6	0.8	3.2

In 2018 Box-Pyramid Creek was in poor condition. Taxa richness and PET scores were particularly low during 2018. The Box-Pyramid Creek system was experiencing a low flow and there was little instream habitat available for sampling. The bed of the creek was made up of a thick layer of silt.

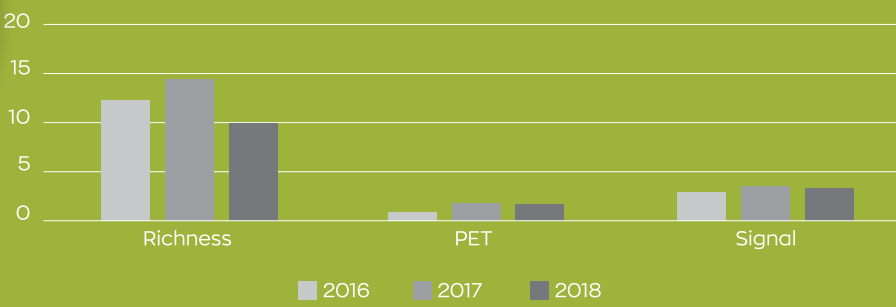
Gunbower Creek Waterbugs

Waterbug Taxa Richness	ALT EPT	Signal Score
10	1.5	3.2

Gunbower Creek was in poor ecological condition in 2018. As with Box-Pyramid Creek, there was a decline in ecological condition since 2016; the reason for the decline is unclear. Although Gunbower Creek saw a decrease in taxa richness since 2017, the PET index and ALT signal scores remained stable. Water quality data is unavailable.
