NORTH CENTRAL WATERWATCH

Moolort Landcare Group, Waterwatch Report.

Deep Creek, Mullins Bridge

Prepared by Kate Lottkowitz, North Central Waterwatch Co-ordinator January 1998.

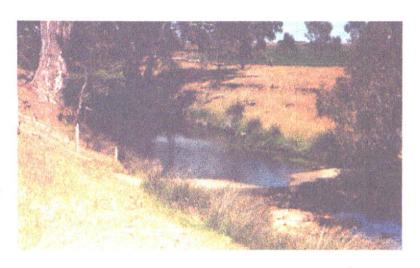
Joyces Creek

medium sized stream rising south Blampeid and meeting the Loddon River at Cairn Curran Reservoir. The monitoring site about seven kilometres south of Cairn Curran Reservoir unrestricted grazing land.

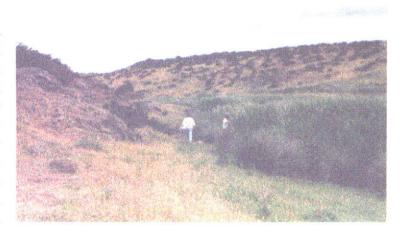
Middle Creek is a small to medium sized stream in a broad valley flowing through farmland. The monitoring is within a few kilometres of junction with Joyces Creek and it then flows Cairn into

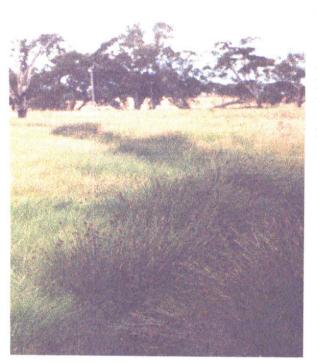
Boundary Gully is a narrow, minor tributary of the Loddon that drains local farmland and flows into the Loddon just downstream of Rumbolds Bridge. It has high salinity levels and in periods of high flow would contribute significant salt loads to the Loddon.

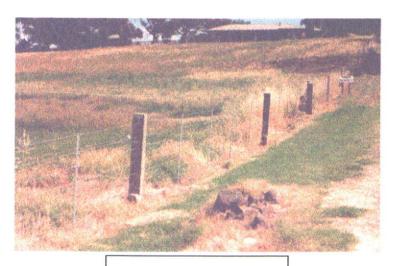
Fold down fencing at Dixons'

- Rabbit Eradication and fencing out riparian strips.
- Rehabilitation of streamsides, (see Riparian Management booklets, attached)

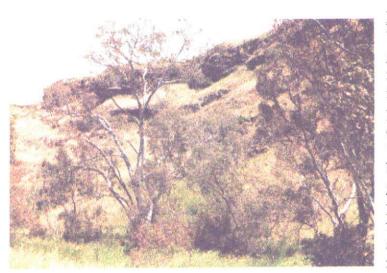
Fred's Ford on the Tullaroop Creek was given 'fair' habitat overall. The rating instream cover, riffles, pools and bends and erosion were all rated as 'good' whereas the verge being mainly pasture grasses dominated phalaris was 'poor' and the bank was only 'fair' in spite of it having a wide range of canopy age

including recruitment of native species. The middle storey that is often lacking at other sites included River bottlebrush and Wirilda. In-stream vegetation included elodea, water ribbons (*triglochin*) and phragmites. One side of the creek here is a gorge with boulders and grasses growing between.
