# North Central Waterwatch *Community Monitoring* Water Quality Data Report 2010

### *Water Quality Data Report*

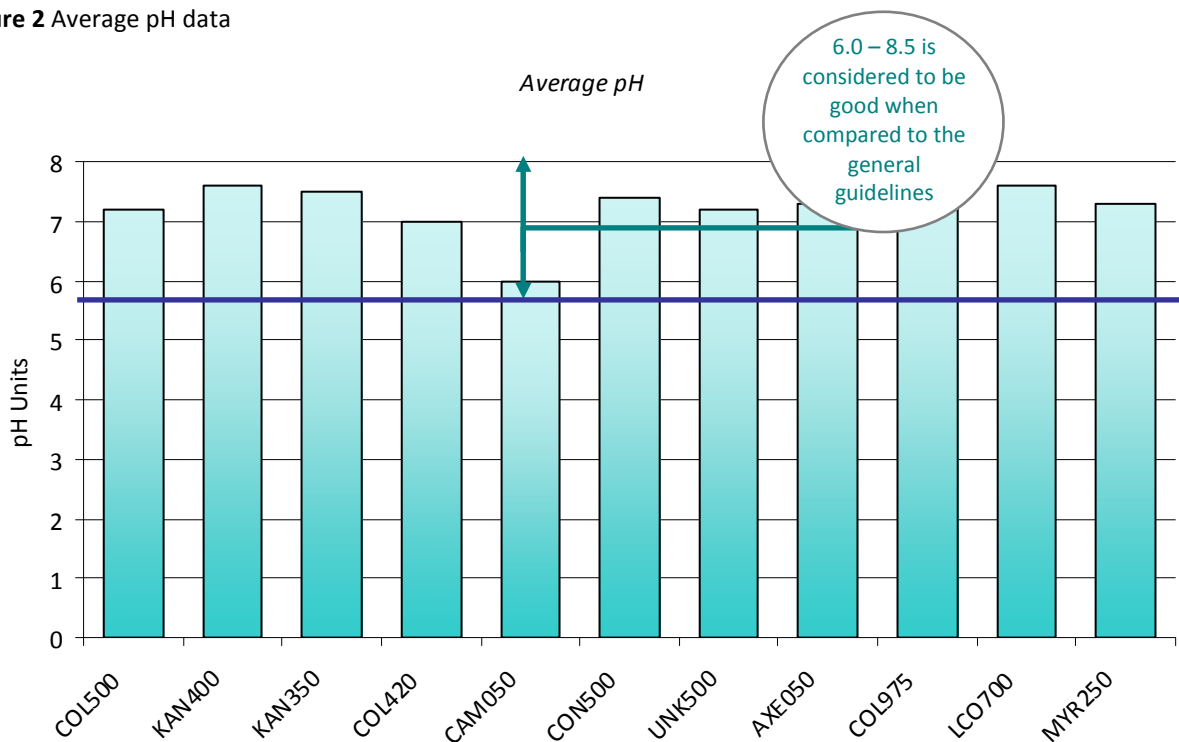
**Figure 2** Average pH data

Sites monitored for pH in the Upper Campaspe are considered good–excellent. However, monthly pH readings for LCO700 have peaked above the accepted range, and could be considered poor–degraded.

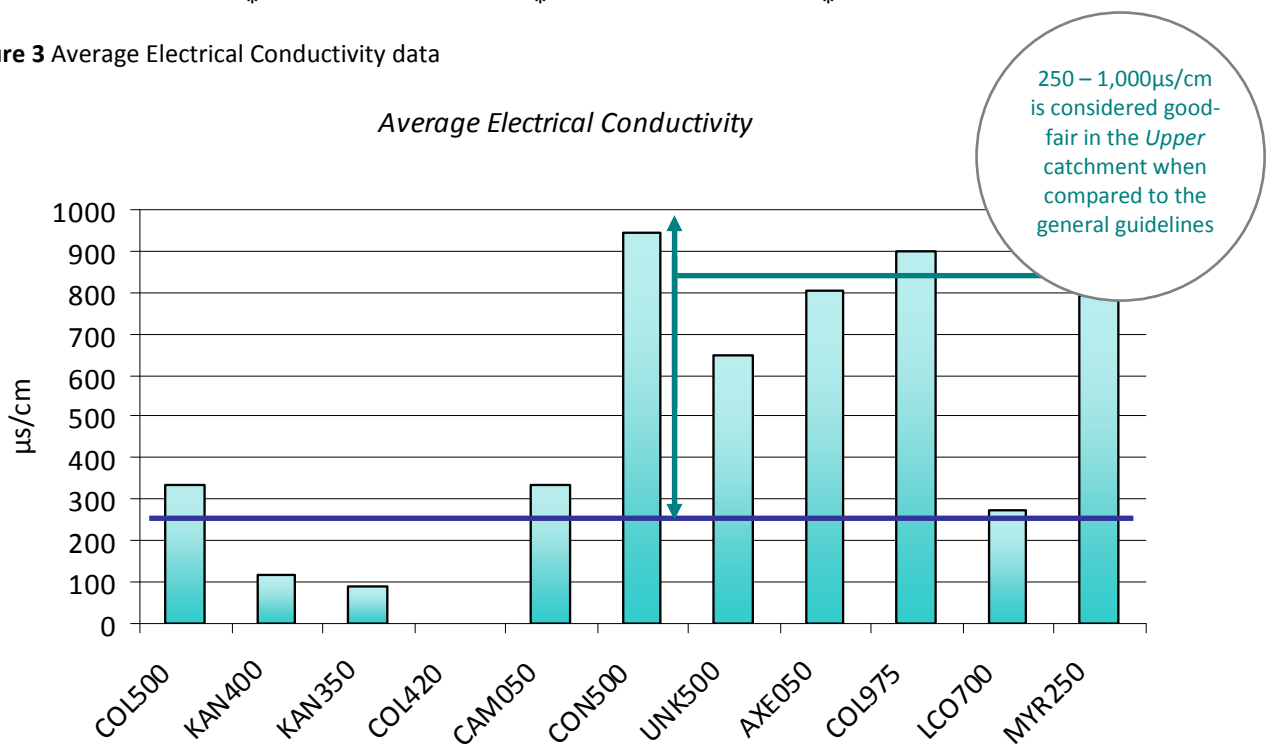
**Figure 3** Average Electrical Conductivity data

Sites monitored for electrical conductivity in the Upper Campaspe are good–fair. However, CON500 has variable salinity readings throughout the year; therefore, it could be considered as poor.

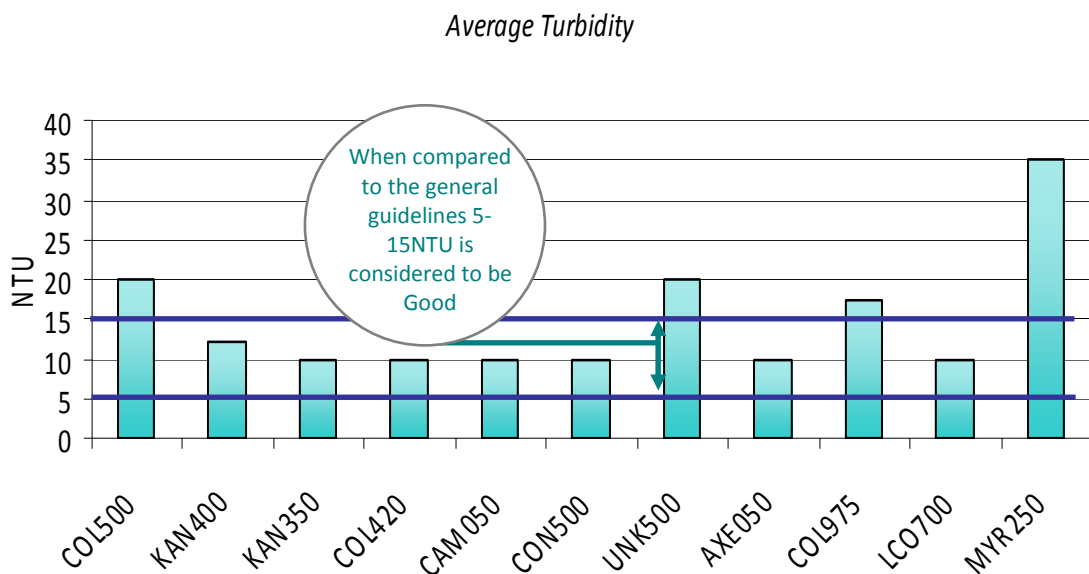
**Figure 4** Average Turbidity data

Sites monitored for turbidity in the Upper Campaspe are generally good. MYR250 has an average of 35 NTU and this could be considered as poor; however, the site’s long term pattern ranges between 10 and 50NTU indicating a range of good–poor.

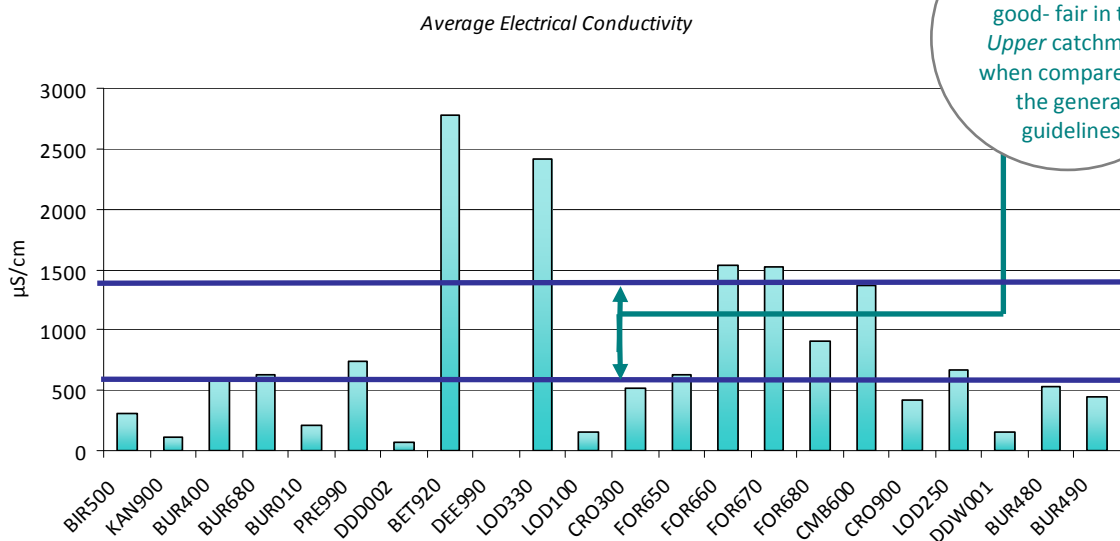
Figure 12 Average Electrical Conductivity

Electrical conductivity in the Upper Loddon is generally good. However, some sites such as BET920 and LOD330 range within poor–degraded.

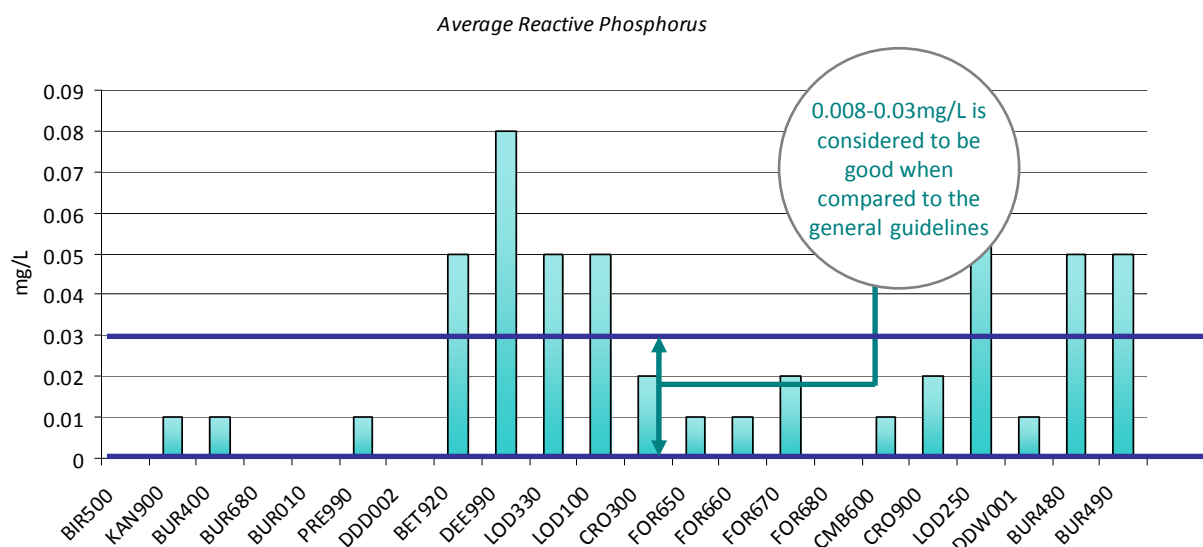
**Figure 14** Average Turbidity

Reactive phosphorus in the Upper Loddon is generally good–poor. However, average data shows that phosphorus is poor–degraded.

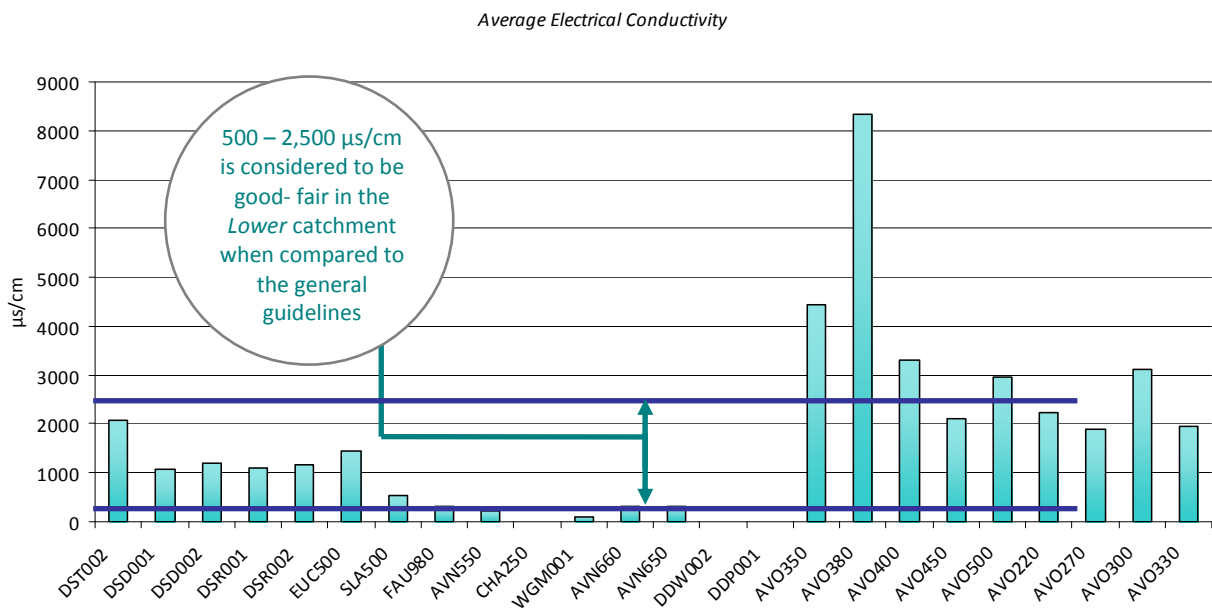
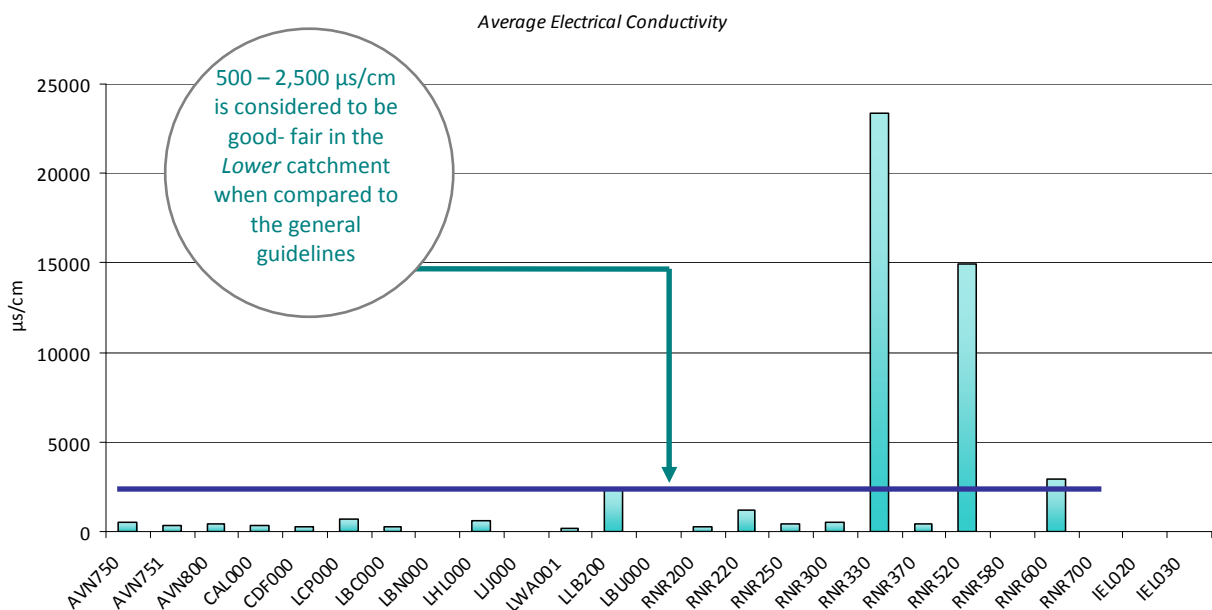
Figure 21 Average pH

Electrical conductivity in the Avoca and Avon-Richardson varies throughout the catchment, and is generally higher than recommended in the Guidelines.
