Improving Health of Avoca Reach 7

The health of deep pools in Avoca Reach 7 – Summary

PROJECT FACT SHEET

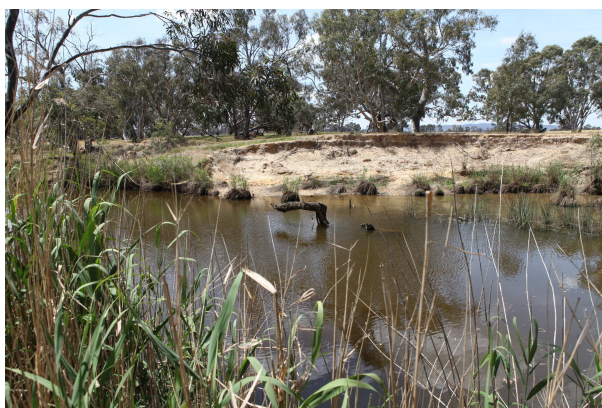
Figure 1: Vegetation contributes to bank stability as well as the formation and maintenance of deep pools through a scour process. River Red Gums at channel margins, and large woody debris, can play an important role in constricting flow as well as increasing scour to form or maintain pools within the river.

Pools form as a result of bed scour processes that occur during flow events. Scour processes are enhanced in areas where there is greater confinement of flow or increased channel curvature. Vegetation, in particular River Red Gums at channel margins and large woody debris, can play an important role in constricting flow and increasing scour to form or maintain pools within the river.
