Avon Plains Lakes Water Management Plan

REPORT

- Final
- 23 February 2006

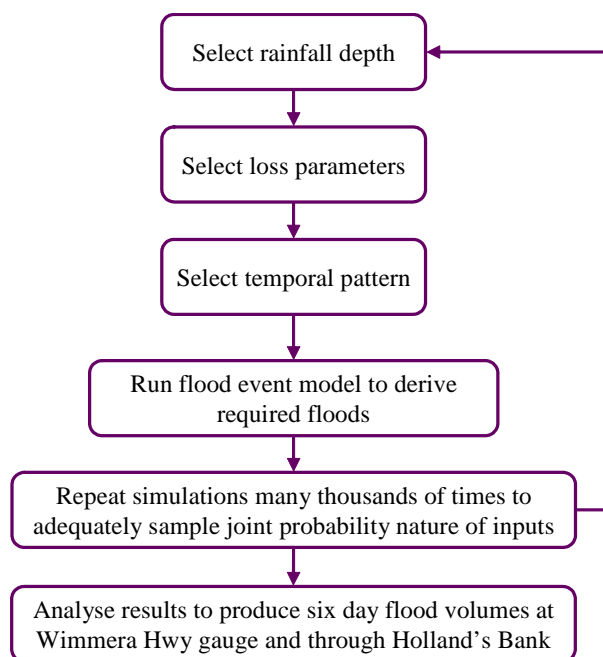
■ **Figure 2-4: Overview of adopted joint probability framework**

An overview of the joint probability framework adopted is illustrated in Figure 2-4. In essence the approach involves undertaking numerous model simulations where the model inputs are varied in accordance with that observed in nature. The inputs are sampled from non-parametric distributions that are either based on readily available design information or on the results of recent research.

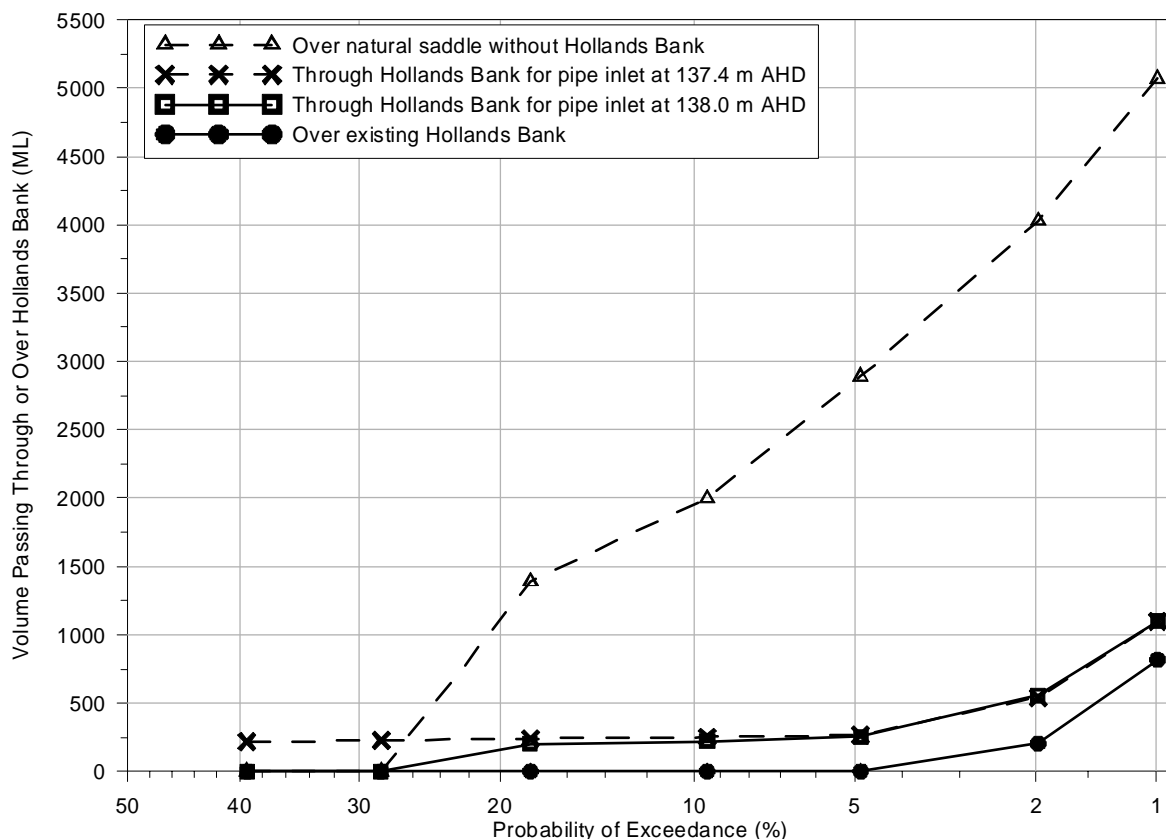
■ **Figure 2-9 Estimates of volumes through/over Holland’s Bank estimated from RORB model for each of the four scenarios**

Figure 2-9 shows the flood volumes passing through or over Hollands Bank in each of the four options considered. Under existing conditions, it would take a flood with an AEP of between 1 in 20 and 1 in 50 for flow to commence over Holland's Bank.

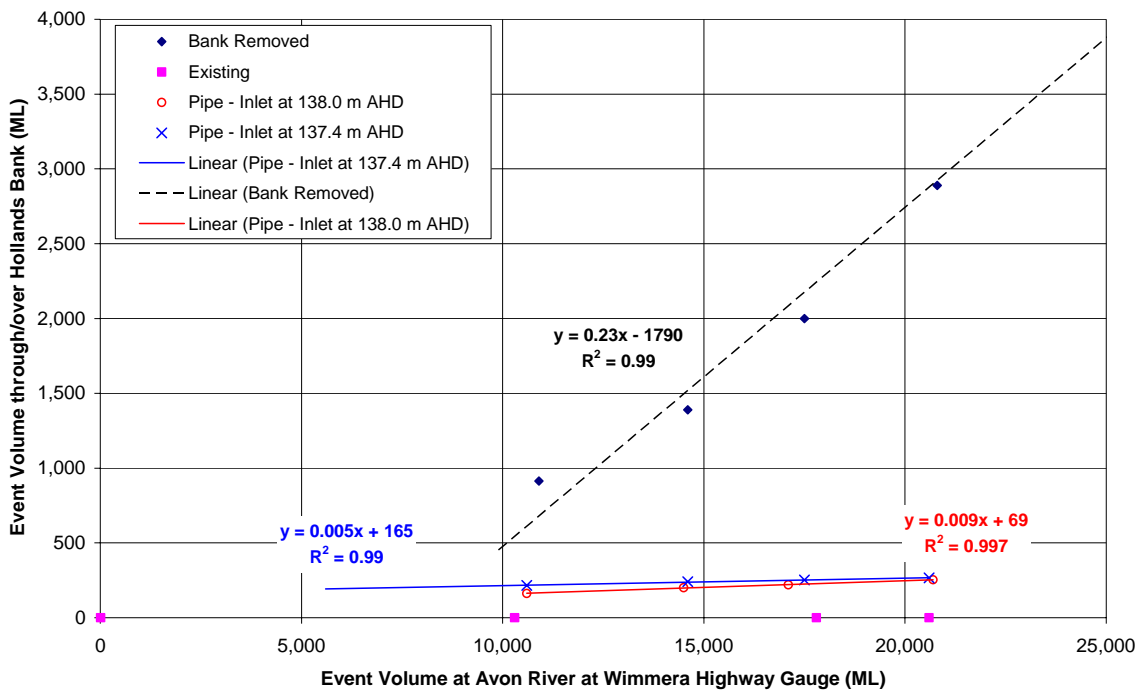
■ **Figure 2-10 Relationships between flood event volume for Avon River at Wimmera Highway Gauge and flood event volume through or over Hollands Bank for each of the scenarios modelled. The points show the estimated volumes from the RORB modelling, and linear relationships were fitted for the natural and each of the pipe cases.**

Figure 2-10 shows RORB model estimates of flood hydrograph volumes at the Avon River at Wimmera Highway gauge and flood volumes passing through or over Hollands Bank for each of the four options. Linear relationships were fitted to these RORB estimates for each of the four options considered. The relationships were used to estimate the volume of water passing into Souths Creek in each flood event, given the observed flows in the Avon River at the Wimmera Highway gauge. The time series of flood volumes that were derived in this manner were provided as additional flows into Souths Creek for the water balance modelling in Chapter 3 of this report.

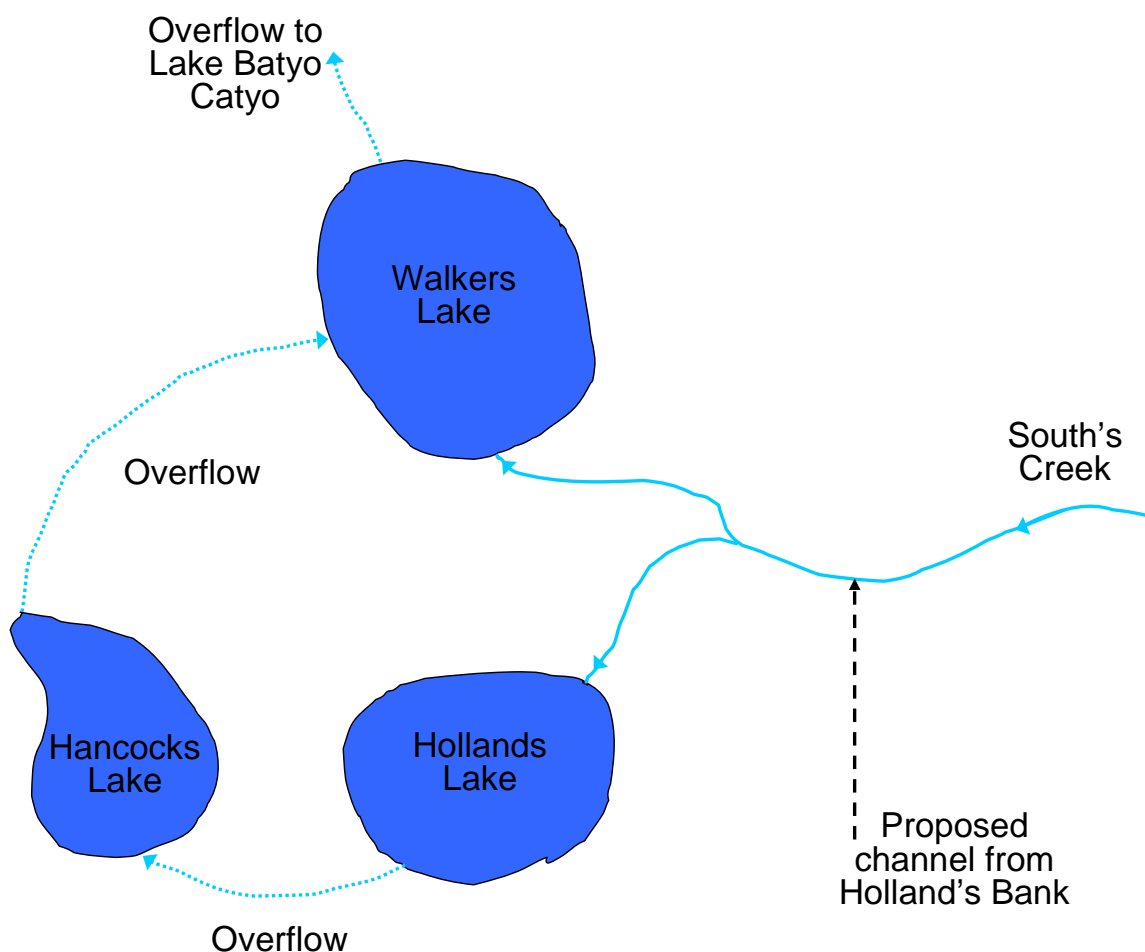
- **Figure 3-1 REALM water balance model schematic, showing the natural inflow from South's Creek, the proposed additional inflows from flow through Holland's Bank and the flow paths to and between the lakes.**

Figure 3-1 shows the schematic used to model the water balance of the Avon Plains Lakes in REALM. It can be seen that water from South's Creek can be directed each of the three lakes and that flow over or through Hollands Bank flows into South's Creek before it flows into the lakes. Both Hancocks and Hollands Lake the overflow to Walkers Lake and any overflow from Walkers Lake flows north towards Lake Batyo Catyo.

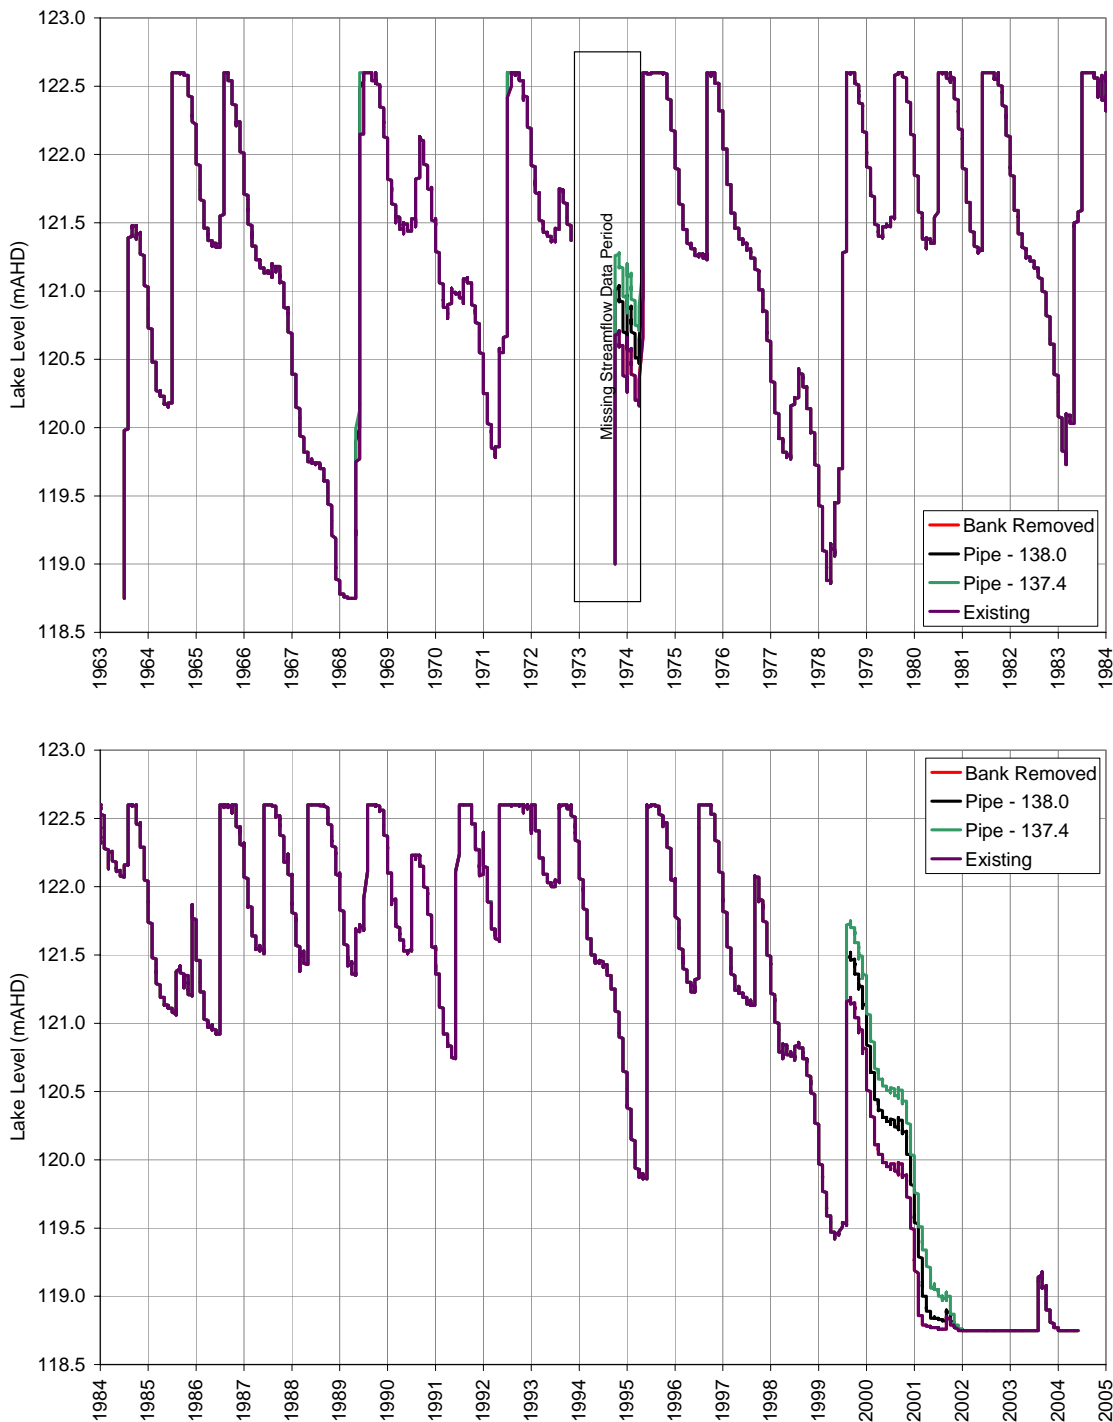
■ **Figure 3-4 Water Balance Model Results – Walkers Lake Levels for all scenarios**

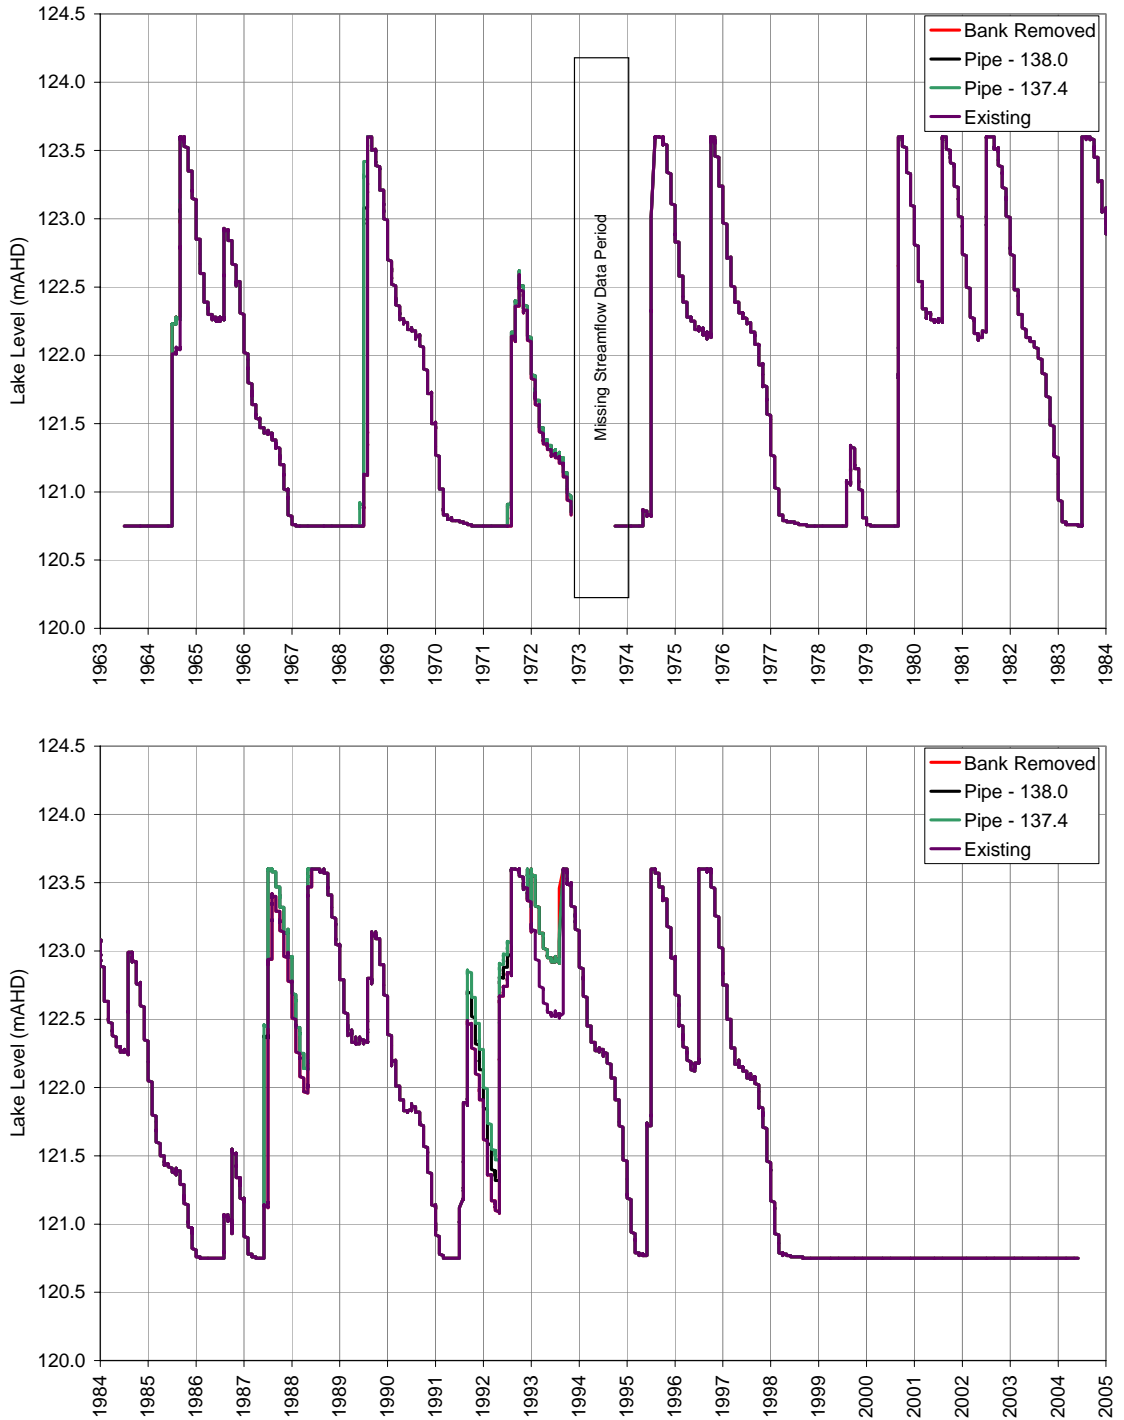
■ **Figure 3-5 Water Balance Model Results –Hollands Lake Levels for all scenarios**

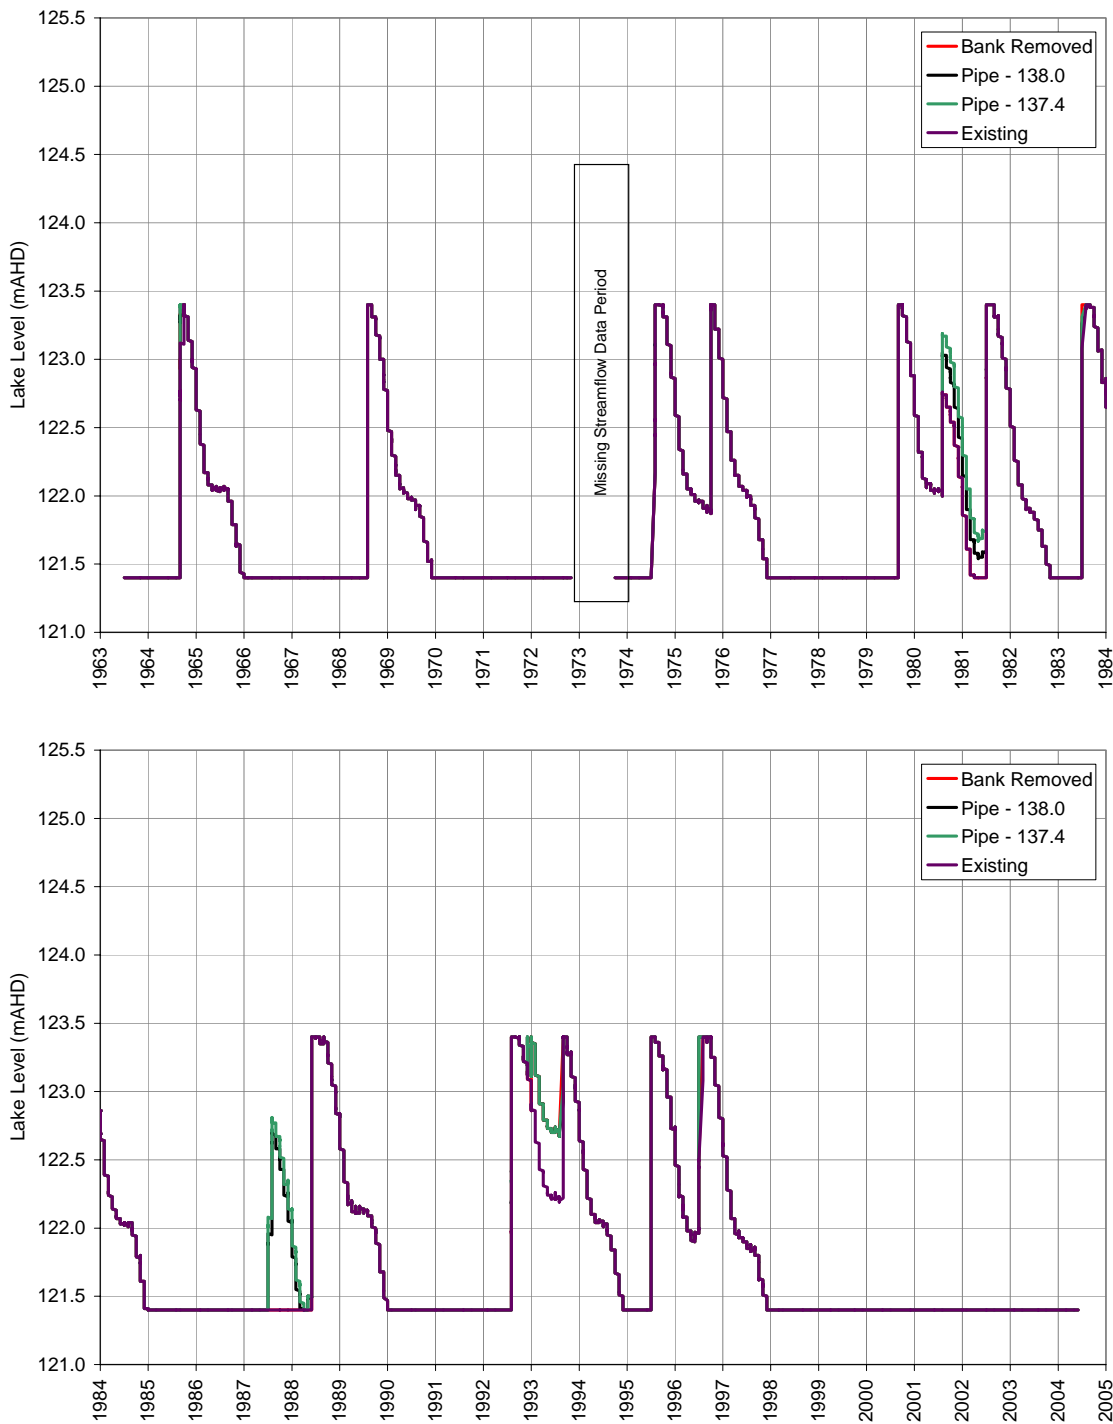
■ **Figure 3-6 Water Balance Model Results –Hancocks Lake Levels for all scenarios**

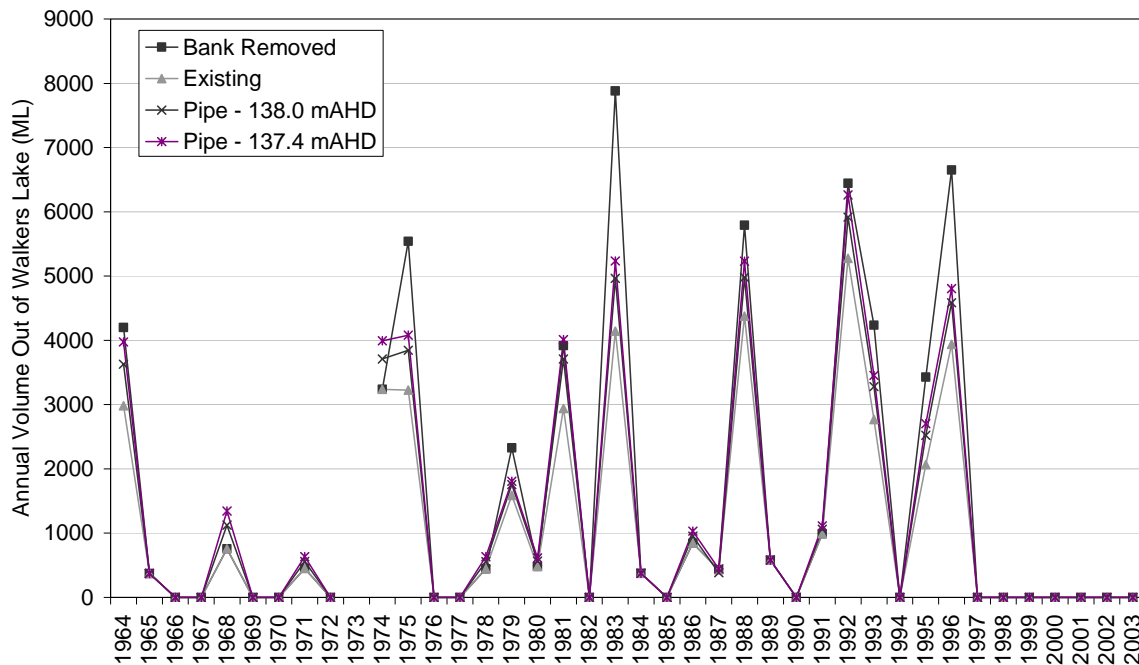
- **Figure 3-7 Annual series of outflow volume from Walkers Lake into Lake Batyo Catyo for each of the four options**
- **Table 3-2 Average annual outflow from Walkers Lake to Lake Batyo Catyo over modelling period (1963-2004)**

Figure 3-7 shows that either of the pipe options or removal of Hollands Bank would increase the total volume that would flow out of Walkers Lake and into Lake Batyo Catyo in those years when spills occur. Table 3-2 shows that the additional flows supplied during these wet years in either of the pipe options would increase the volume of water flushing through the Avon Plains Lakes system and into Lake Batyo Catyo. The option with the pipe through Hollands Bank with the inlet structure level at 137.4 m AHD, results in an average of an additional 267 ML/year of outflow from the lakes, which is 25% more than in the existing case. With the inlet to the pipe through Hollands Bank set at 138.0 m AHD there is 17% more water flushed through the lakes (183 ML/year on average). If Hollands Bank were removed, there would be an additional 439 ML/year (or 40%) flushed through the lakes than is the case under existing conditions.

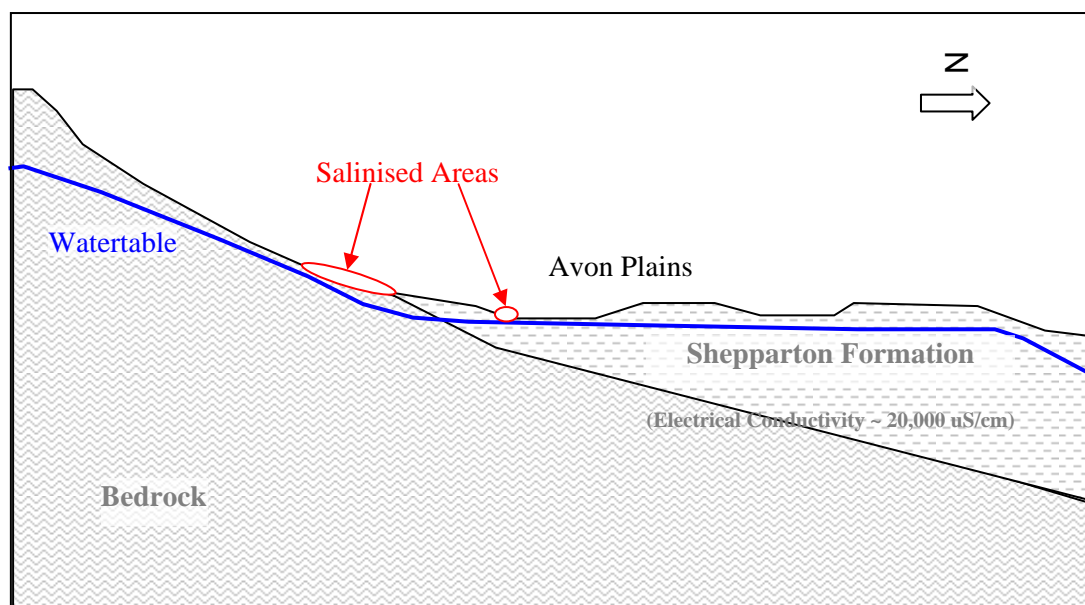
■ **Figure 4-1 Conceptual cross section of hydrogeology of Avon Plains Lakes area**

A conceptual hydrogeological model for the lakes is presented in Figure 4-1.

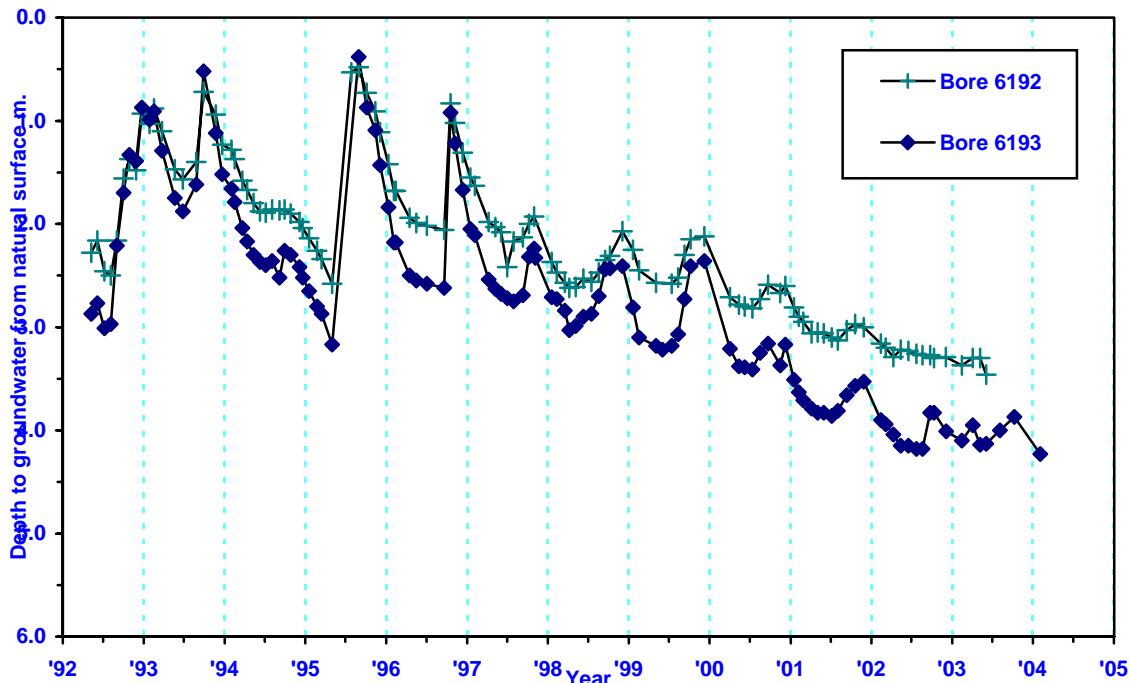
■ Figure A-1 Groundwater bore hydrographs for bores 6192 and 6193

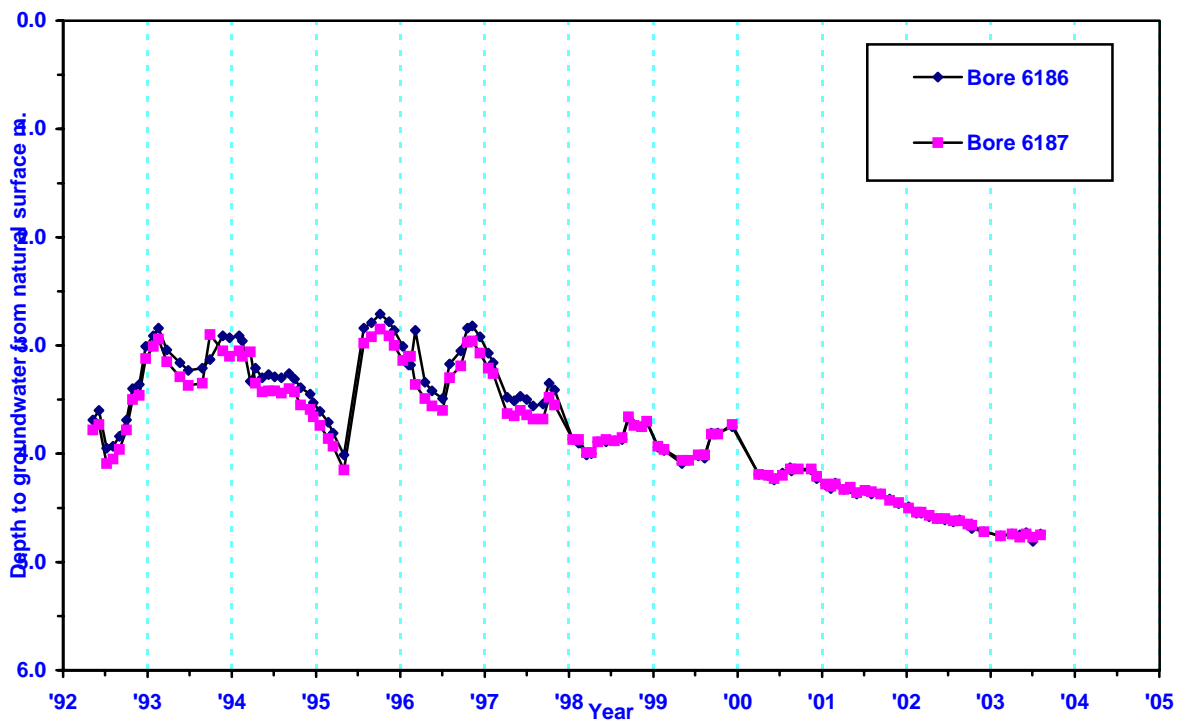
■ Figure A-4 Groundwater bore hydrographs for bores 6186 and 6187

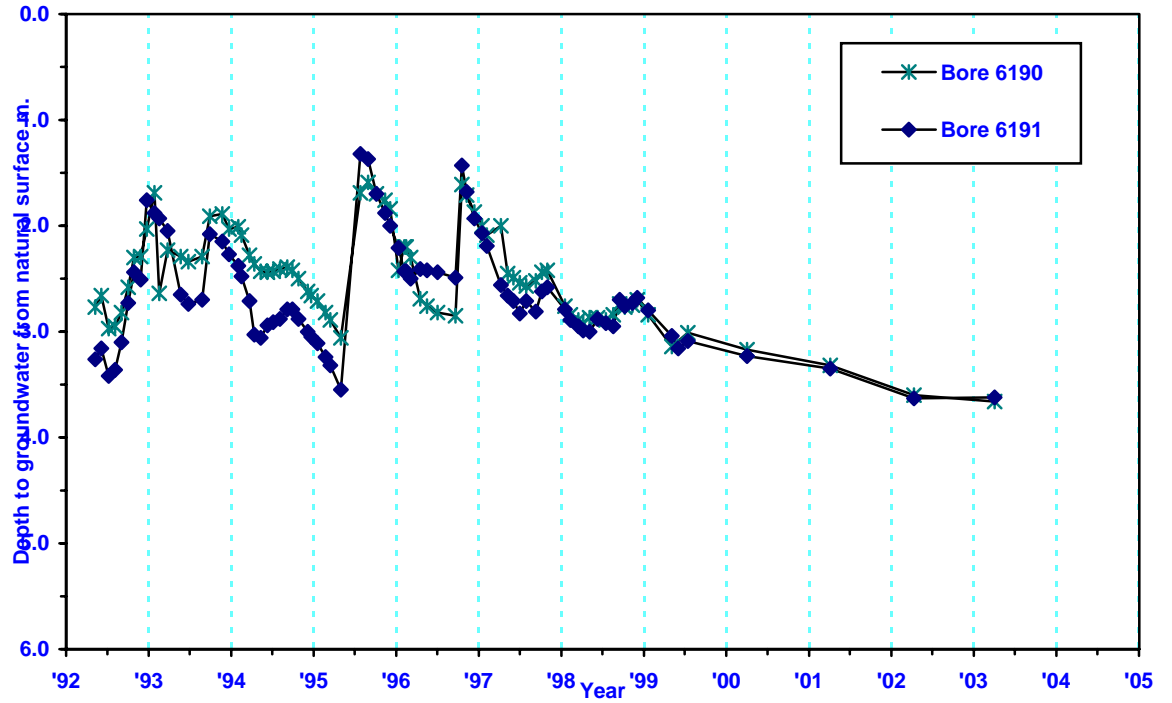
■ Figure A-5 Groundwater bore hydrographs for bores 6190 and 6191

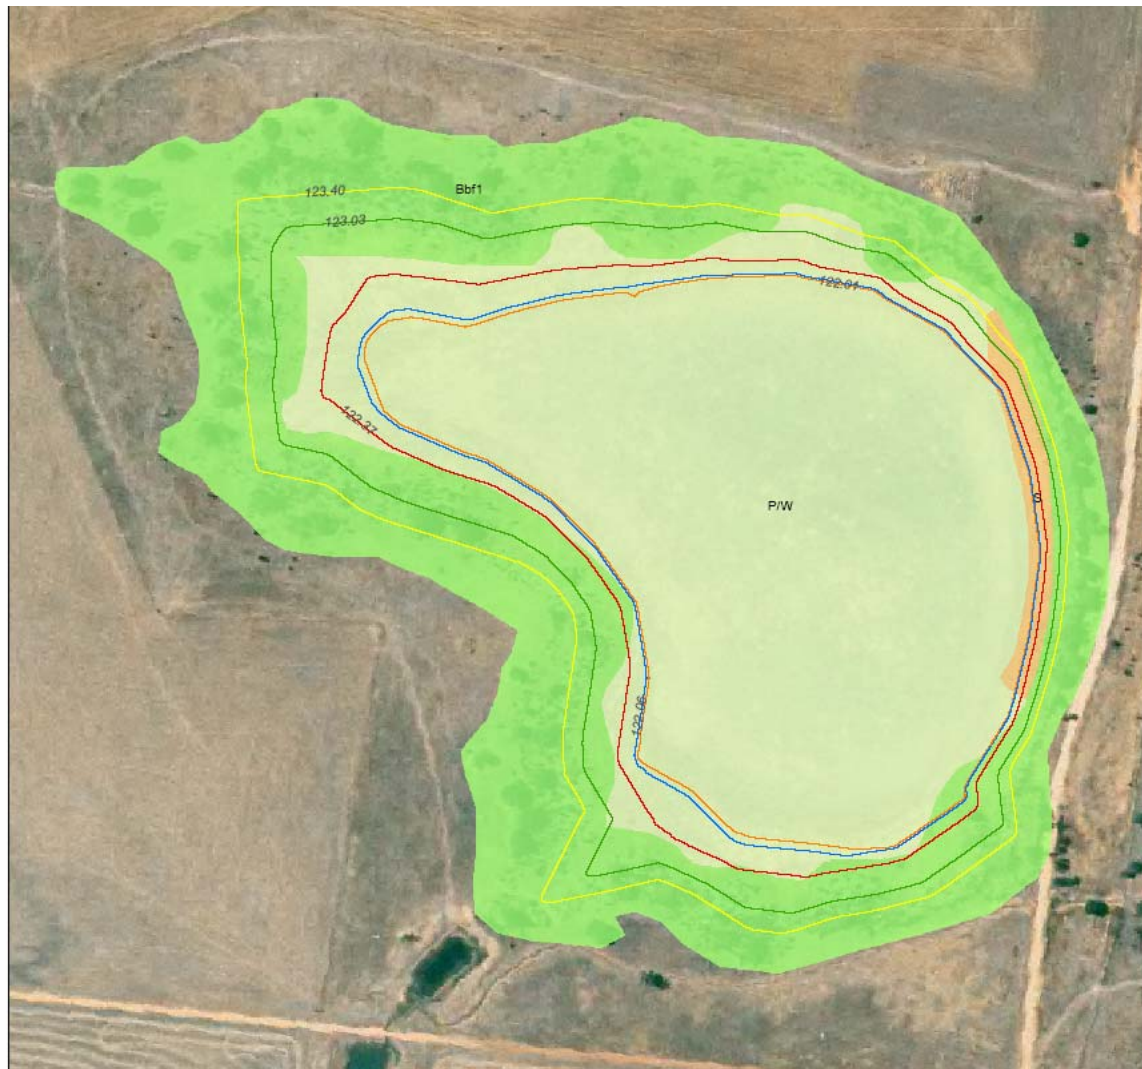
Hancocks Lake Vegetation Communities and Median Seasonal Lake Levels

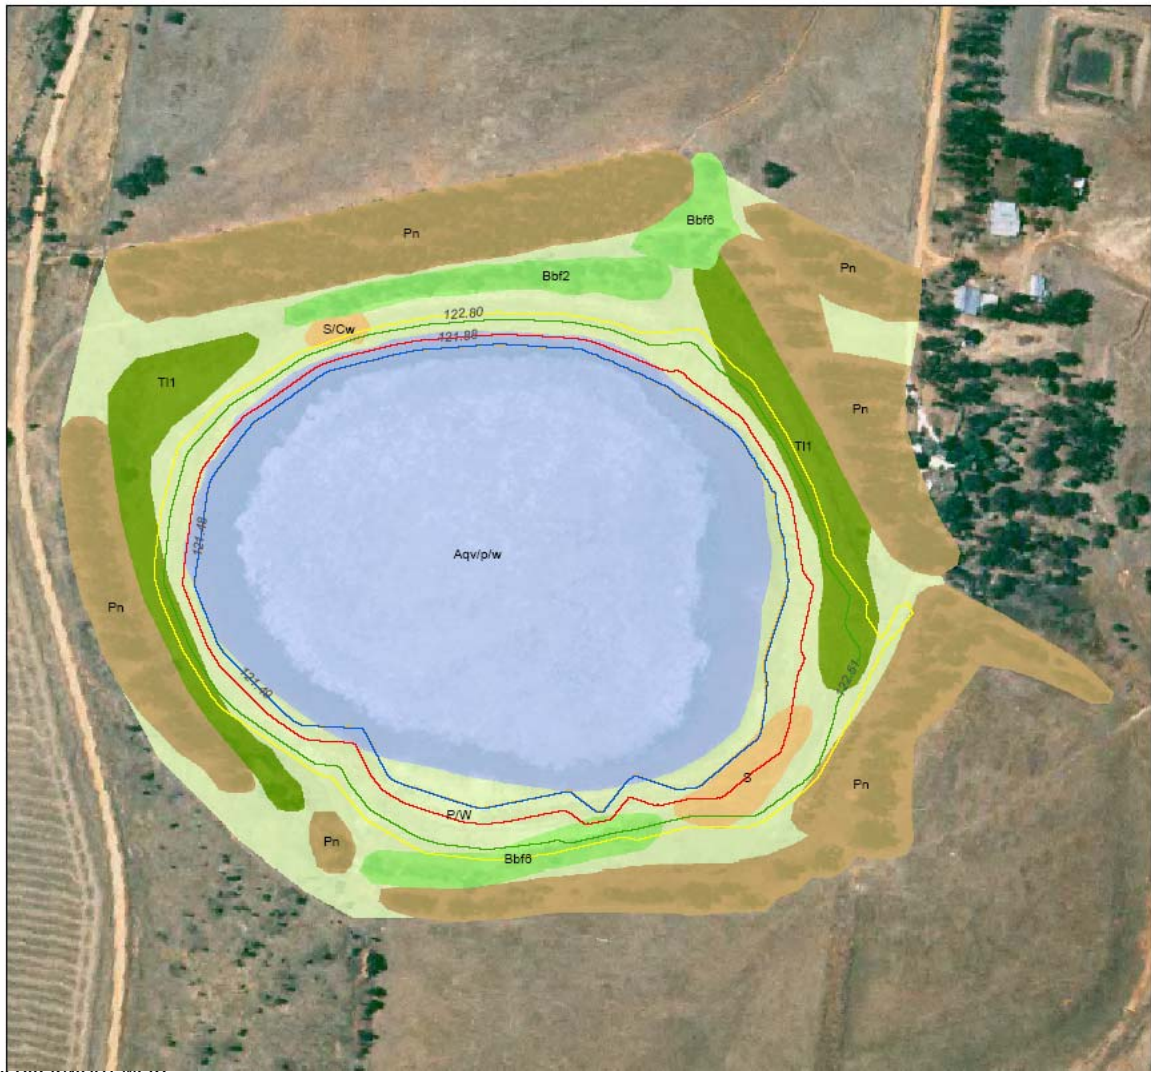
Hollands Lake Vegetation Communities and Median Seasonal Lake Levels
