Flood Recovery Works Update

North Central CMA Region

June 2013

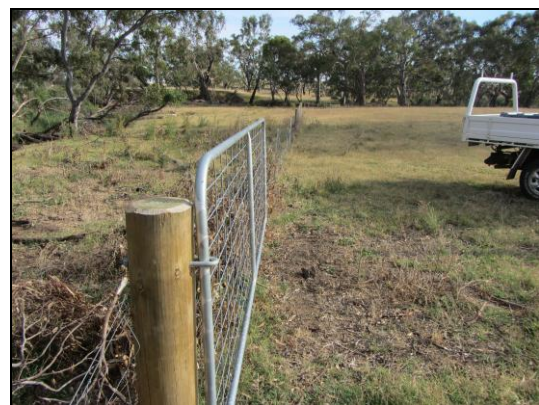
Figure 1: Repaired waterway protection fencing along Tullaroop Creek, Carisbrook.

- Over the past 18 months, the North Central CMA has worked with 166 landholders across the region to repair or replace previously funded, flood damaged fencing along waterways.
- \$1.6M of Natural Disaster Relief funding enabled 176km of fencing to be repaired and 89km to be completely replaced due to the damage caused by floodwater and associated debris.
- Reinstating stock-proof fencing along waterways will continue to protect the banks, riparian vegetation and water quality from the impacts of stock.

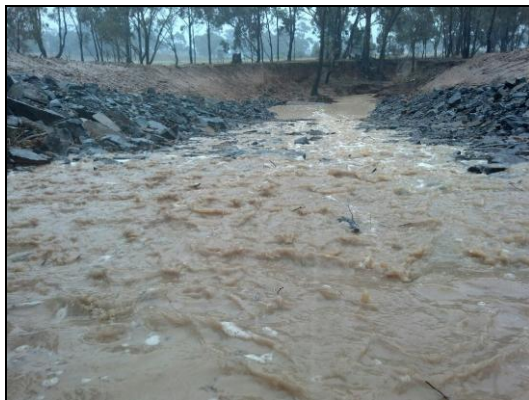
Figure 2: A repaired erosion control structure near Tarnagulla performing its role of reducing the in-stream gradient and preventing further streambed incision, June 2013.

- To date, over \$3M of Natural Disaster Relief funding has seen the completion of 116 repairs to previously installed erosion control structures on 59 properties.
- The remaining 25% of repairs will be completed in coming months pending suitable weather conditions.
- To see time-lapse footage of the replacement of a failed erosion control structure in the upper Avon-Richardson catchment go to <https://www.youtube.com/watch?v=WPRiAQUzMBI>

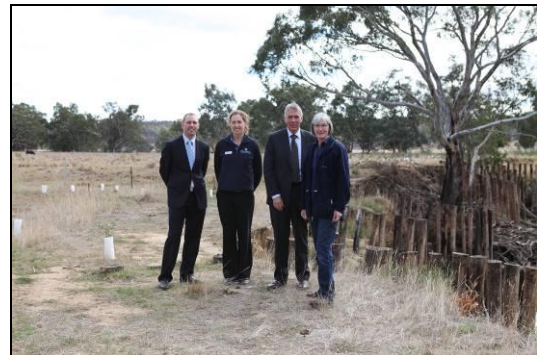
Figure 3: In April 2013 Victorian Minister for Water, Peter Walsh MP, visited a repaired pile field at Newstead with North Central CMA's Damian Wells (CEO), Christine Brooke (Deputy Board Chair) and Angela Gladman (Project Manager).

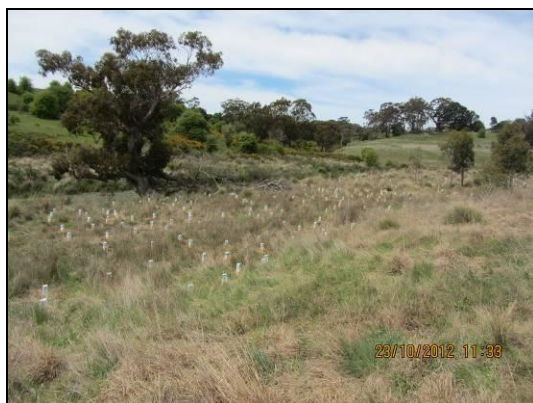
Figure 4: Replacement of flood damaged revegetation in October 2012 along the Campaspe River, Woodend.

- Replacement of approximately 200,000 seedlings was completed on 56 properties during spring 2012. These plants replaced previous North Central CMA plantings destroyed by floodwaters along waterways throughout the region.
- In spring 2013 the North Central CMA will coordinate the planting of an additional 80,000 plants around the repaired erosion control structures on 38 landholder properties.

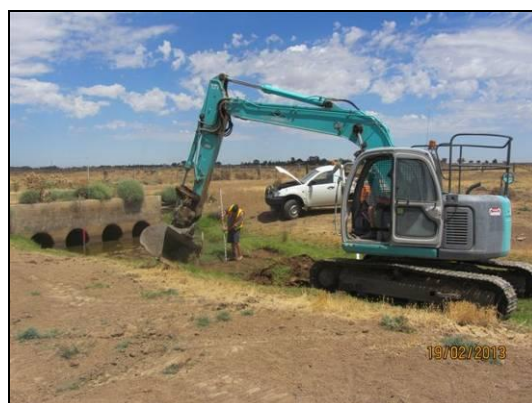
Figure 5: Desilting a section of Seven Months Creek near Pyramid Hill, February 2013.

- In February 2013 the North Central CMA began to remove silt and repair damaged culverts where required along 329 km of regional surface water drains damaged by flood across the seven waterways that make up the Bullock Creek Improvement Trust drainage system.

- Repair works involving 19 landholders have been completed along Seven Months Creek and the Western Depression Drain, with some minor delays due to wet conditions. Works will continue systematically across sections of Bullock, Welshes, Calivil, Nine Mile and Pennyroyal creeks over coming months.

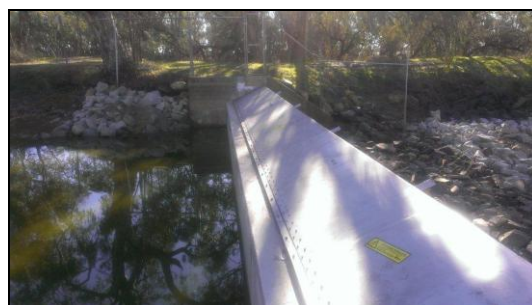
Figure 6: Concrete reinforcement of the Quambatook Weir commenced in May with the gate fitted in June 2013 (Photo: Gannawarra Shire Council)

- Natural Disaster Relief funding was secured to replace the flood damaged Quambatook Weir on the Avoca River.
- The North Central CMA contracted Gannawarra Shire Council to build a replacement structure by 31 August 2013 at which time ownership of the asset will transfer to the Council.
- The repairs, which commenced in late May 2013, will see an operable structure rebuilt at the same full supply level as the flood damaged weir.

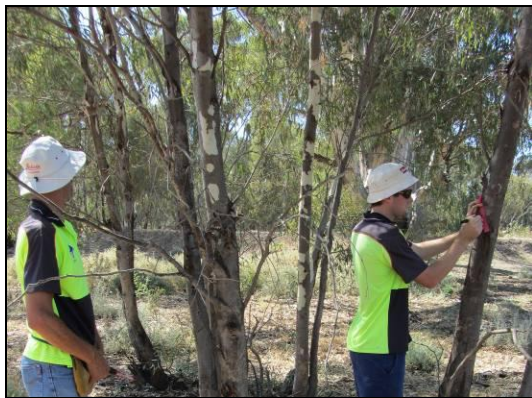
Figure 7: Surveyors marking trees within the construction zone along the Pental Island levee realignment, February 2013.

- A 3.3 km section of the Pental Island levee (a North Central CMA asset) will be realigned with the Natural Disaster Relief funding.
- The aim of the project is to:
 - realign the levee to a standard and location consistent with the existing Pental Island levee system
 - maintain the protection of all life and property on Pental Island as far as possible from flooding
 - minimise harm to sites of cultural heritage significance
 - minimise the environmental impact of works.
- To date, a feature survey and a flora, fauna and net gain assessment, finalisation of the alignment and an arborist assessment on impacted trees have been completed. Discussions are currently underway with the Department of Environment and Primary Industries (DEPI) regarding the native vegetation offsets required.
- Pending approvals, construction is planned for summer 2013-14.

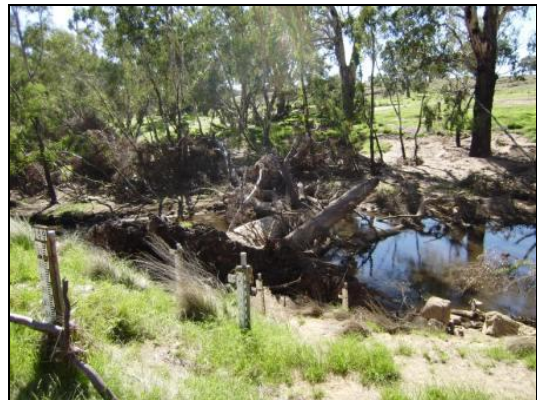
Figure 8: Flood debris removed at a Campaspe River stream gauge, Eppalock (Photo: Thiess Services)

- Repairs to 13 water quality stream gauges along key waterways were completed with \$93,000 of Natural Disaster Relief funding over the past two years.

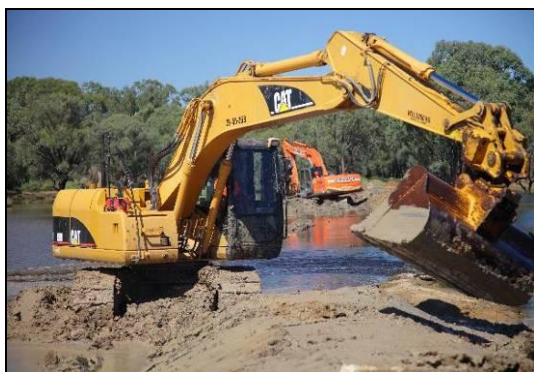
Figure 9: An emergency levee repair, January 2011

- As a result of the 2010-11 floods in Victoria, a number of levees in north central Victoria were breached or otherwise damaged. A number of these levees, which are located both on Crown and privately-owned land, are of unknown origin and ownership; however they contribute to the protection of public assets.
- On behalf of the Victorian Government the North Central CMA undertook 202 emergency and strategic levee repairs on the Loddon floodplain over a two-year period since the January 2011 flood event at a cost of \$1.05M.
- Each levee repair was inspected by engineering consultants and a brief report provided on the integrity of the repair works.

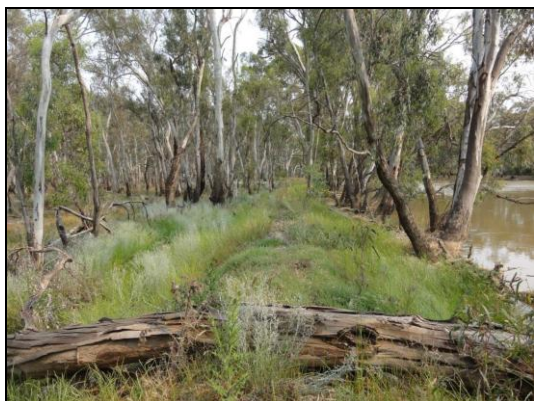
Figure 10: A section of the Murray Murrabit levee surveyed in November 2012 (Photo: Water Technology)

- A Victorian Government funded project to survey and assess the condition of over 250 km of strategic levees along the Murray and Loddon rivers from Echuca to Tyntynder was completed in May 2013.
- The project involved detailed field surveys (July-December 2012) to plot long- and cross-sections of levees, capture geo-referenced photos and identify points of weakness and height.

- Twenty-six kilometres of levee (10%) was found to have a crest height below the standard level of protection (100 year ARI).
- Points of weakness (discrete locations along a levee that do not offer the same level of protection) were also identified, e.g. infrastructure such as tracks and pipes traversing the levee; or biological impacts such as saplings, rabbit burrows and wear by cattle or horses.

- Of the more than 7,000 points of weakness identified, 257 sites and approximately 1.5 km of linear features were ranked as extreme or high risk.
- An indicative capital cost of \$11M has been calculated for the identified works addressing the priority points of weakness and sections of levees below the standard level of protection. An annual maintenance allowance of \$180,000 is estimated.
