Tullaroop Catchment

Citizen Science Project

River Health Snapshot Report 2022

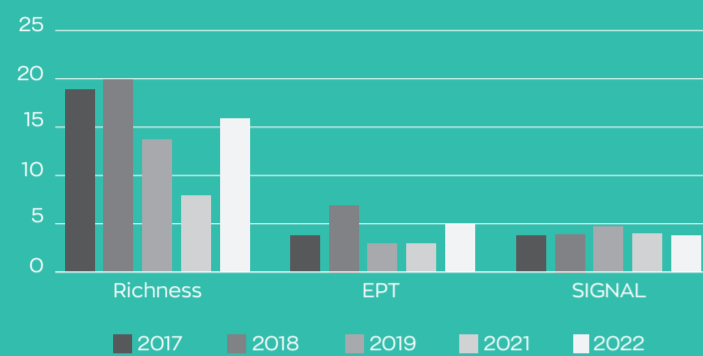
Daylesford Clunes Road waterbug time series

Near the confluence of Birch's Creek with Tullaroop Creek and surrounded by agricultural land, there have been several on-ground works nearby including fencing, weed control, and revegetation. All waterbug indicators have remained steady in the moderate range in recent years, and, as revegetation continues to establish, the increase in instream and flanking vegetation is expected to result in increased diversity in macroinvertebrate species in future years.

Waterbug Indicators		
Richness	EPT	Signal
16	5	3.8

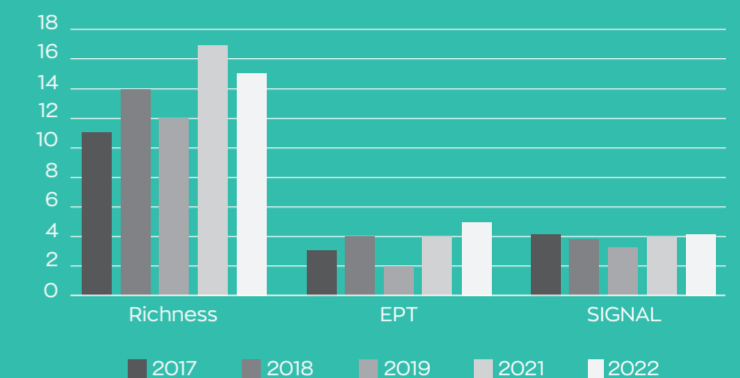
Andersons Mill waterbug time series

Near the township of Smeaton, the land use surrounding this area is primarily agricultural. Although waterbug species richness does not quite meet ALT objectives, EPT is close, and the SIGNAL score successfully meets that of a healthy ecosystem. EPT results have increased annually since 2019 and correlates with willow removal in 2018-19 and subsequent revegetation.

Waterbug Indicators		
Richness	EPT	Signal
15	5	4.2
