Tullaroop Catchment

Citizen Science Project

River Health Snapshot Report 2021

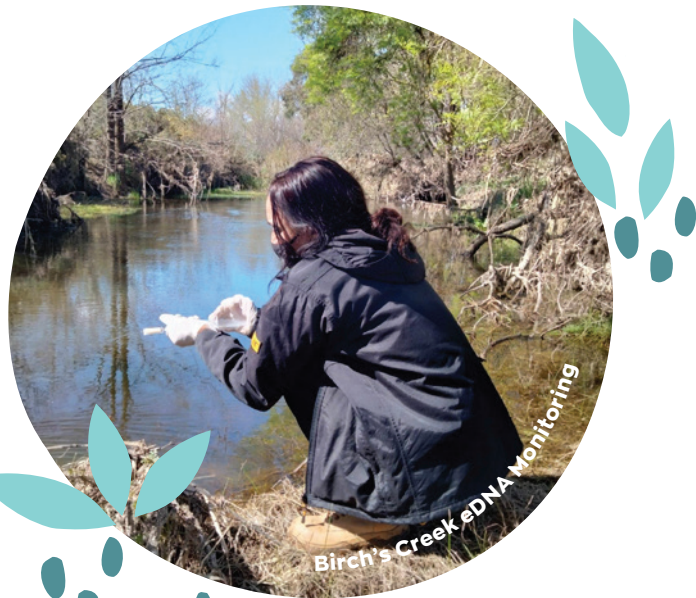
eDNA Results

Results show an increase of both platypus and river blackfish from 2015 to 2021. Platypuses were detected at 92 per cent of sites in 2021 compared with 69 per cent in 2015. River blackfish were detected at 56 per cent of sites, compared with 42 per cent in 2015.

Their range has increased too; in 2015, neither platypus or river blackfish were detected in Creswick or Tullaroop creeks (only in Birch's Creek), however they were detected in all three creeks in the 2021 surveys.

On-ground works completed under the Tullaroop Catchment Restoration Project have improved the quality of habitat throughout Birch's and Tullaroop creeks, and it is possible these works have led to an increase in the occurrence of platypus and river blackfish in the catchment.

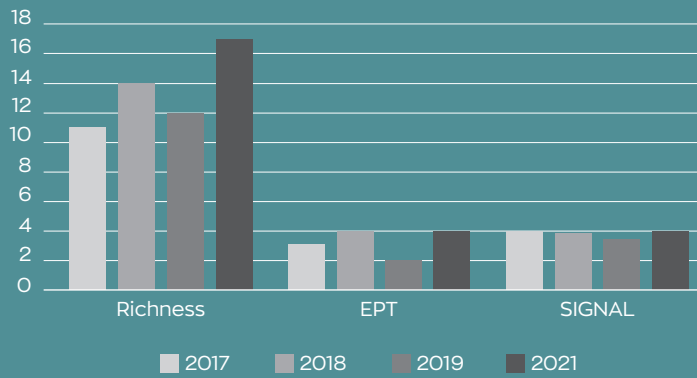
Andersons Mill waterbug time series

The site is directly west of the township of Smeaton, surrounded by agricultural land. Willows at the site were removed between the 2018 and 2019 waterbug sampling events, likely contributing to the sharp decline in the macroinvertebrate scores over this time.

In 2021 we begin to see a gradual improve in overall results. The removal of willows has provided the opportunity to revegetate with native plants, which will stabilise banks and create habitat. In future years we anticipate a return to at least the 2017 results as native vegetation continues to establish.

eDNA from both platypus and river blackfish were positively detected at this location in 2021.

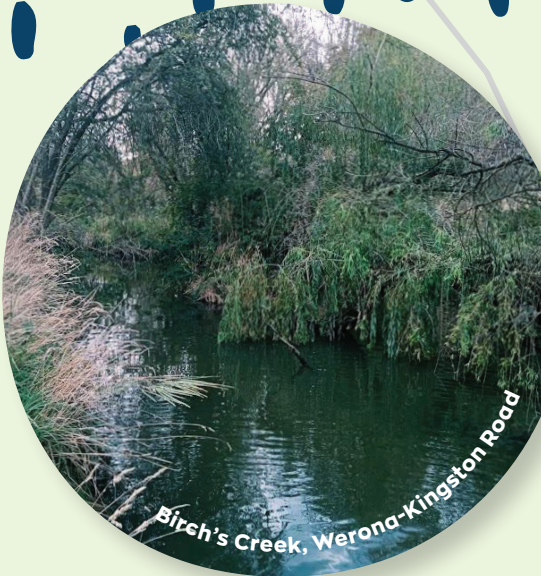
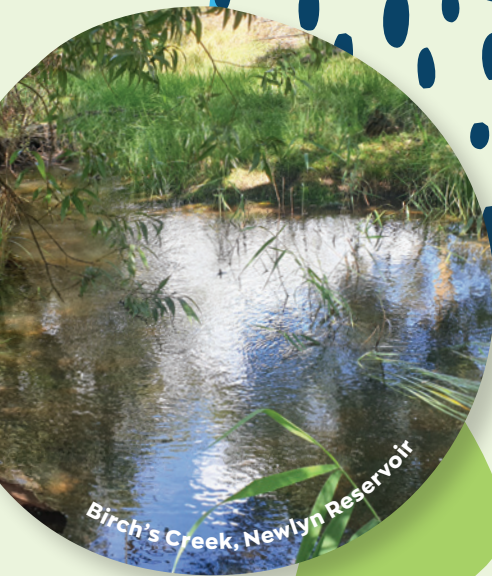
The results in this report are based on the analysis of macroinvertebrate monitoring data collected in spring 2017, 2018, 2019 and 2021. The report provides a baseline assessment of the current condition of Birch's Creek using citizen science data.
