Bendigo Creek

Citizen Science Project

River Health Snapshot Report 2021

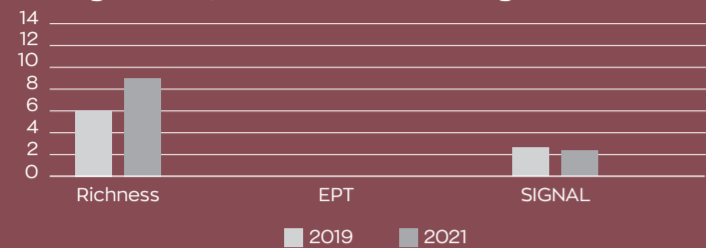
Bendigo Creek, Scott Street waterbug time series

COVID-19 restrictions during the reporting period led to insufficient water quality monitoring data being collected. Waterbug monitoring was undertaken with scores being very poor, likely due to lack of shade and variety of habitats at the site. Being downstream of the CBD, it can be assumed that the site may have recorded poor results for water quality indicators also. There was a slight increase in waterbug richness compared to 2019 results, however, a score of 9 is still well below 21 which is the expected score for a site of good ecological condition.

Richness	EPT	Signal
9	0	2.6

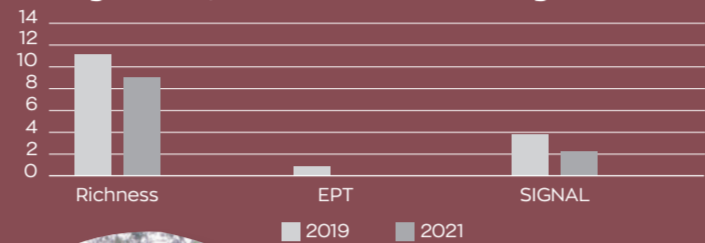
Bendigo Creek, Millwood Road waterbug time series

Water quality results in 2021 are much the same as 2019. As the creek exits the town center there is a gradual improvement in water quality. Aquatic plants and reed beds found through Epsom and Huntly help to filter nutrients and contaminants and no doubt contribute to the improved water quality at this site.

Phosphorous levels and electrical conductivity results have improved from poor to moderate since 2019. Turbidity has also improved due to suspended solids (sediments) being filtered out by the continuing instream vegetation.

Even though water quality scores for this site are good, the waterbug richness and EPT scores remain poor. The SIGNAL score, indicating the presence of more sensitive bugs at the site, has fallen since the 2019 survey.

pH	EC	Phos	Turbidity
7.7	823	0.05	15

Richness	EPT	Signal
9	1	2.3
