RiverScan **Annual River Health Snapshot Report 2017**

North Central Waterwatch and the Native Fish Recovery Plan have again teamed up in 2017 to work with RiverScan volunteers to monitor waterway health and to support the recovery of native fish populations in north central Victoria.

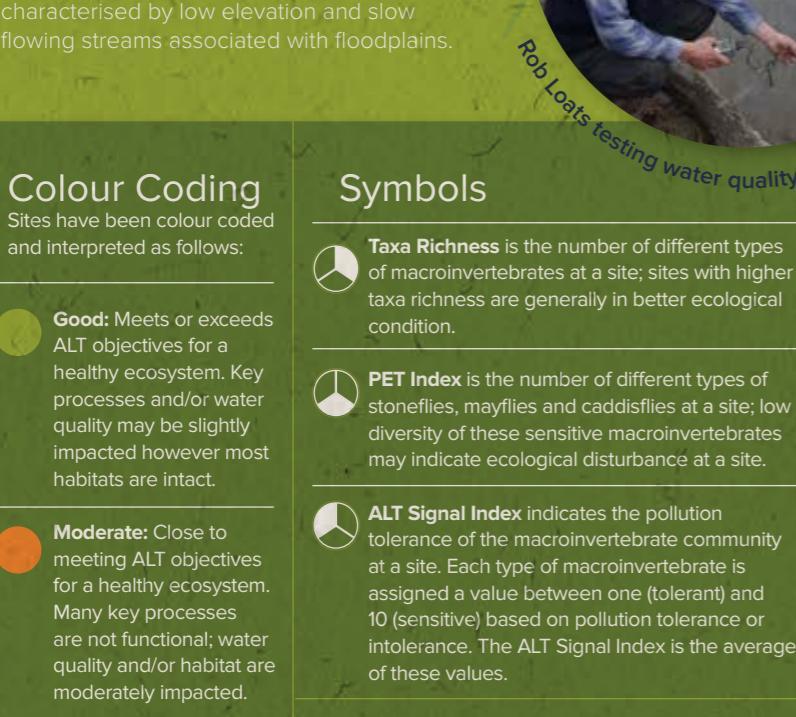
Poor: Does not meet

ALT objectives for a

key processes are not

ALT objectives, meets the following targets

TAXA richness PET index ALT signal

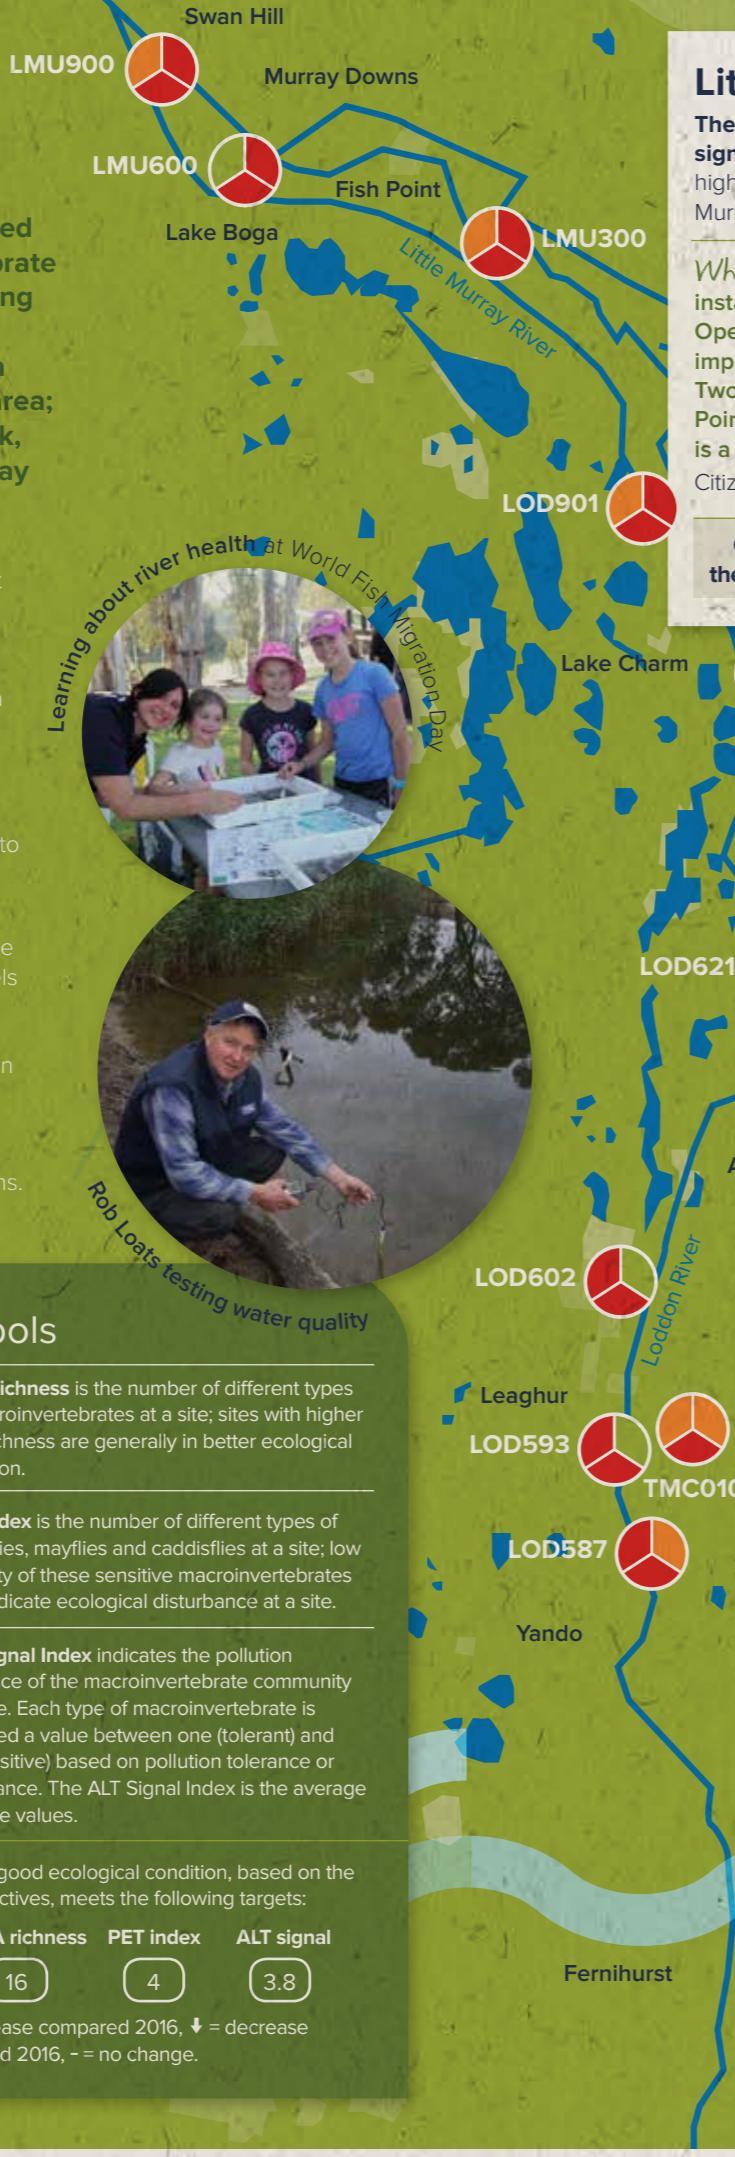
↑ = increase compared 2016, ↓ = decrease compared 2016, - = no change

The Little Murray River is generally in moderate to poor ecological condition. While signal scores meet the objectives, taxa richness and PET are poor. This may be a result of highly altered flow regimes and degraded aquatic habitat. Overall, the ecological health of Little Murray River has not significantly changed since 2016.
