North Central Waterwatch & Native Fish **Recovery Plan Annual River Health Snapshot** Report 2016

The results in this report are based on the Lake Boga analysis of macroinvertebrate monitoring data collected in spring 2016. The report provides an assessment of the current condition of four main waterways in the program area; Loddon River, Box-Pyramid Creek, Gunbower Creek and Little Murray River.

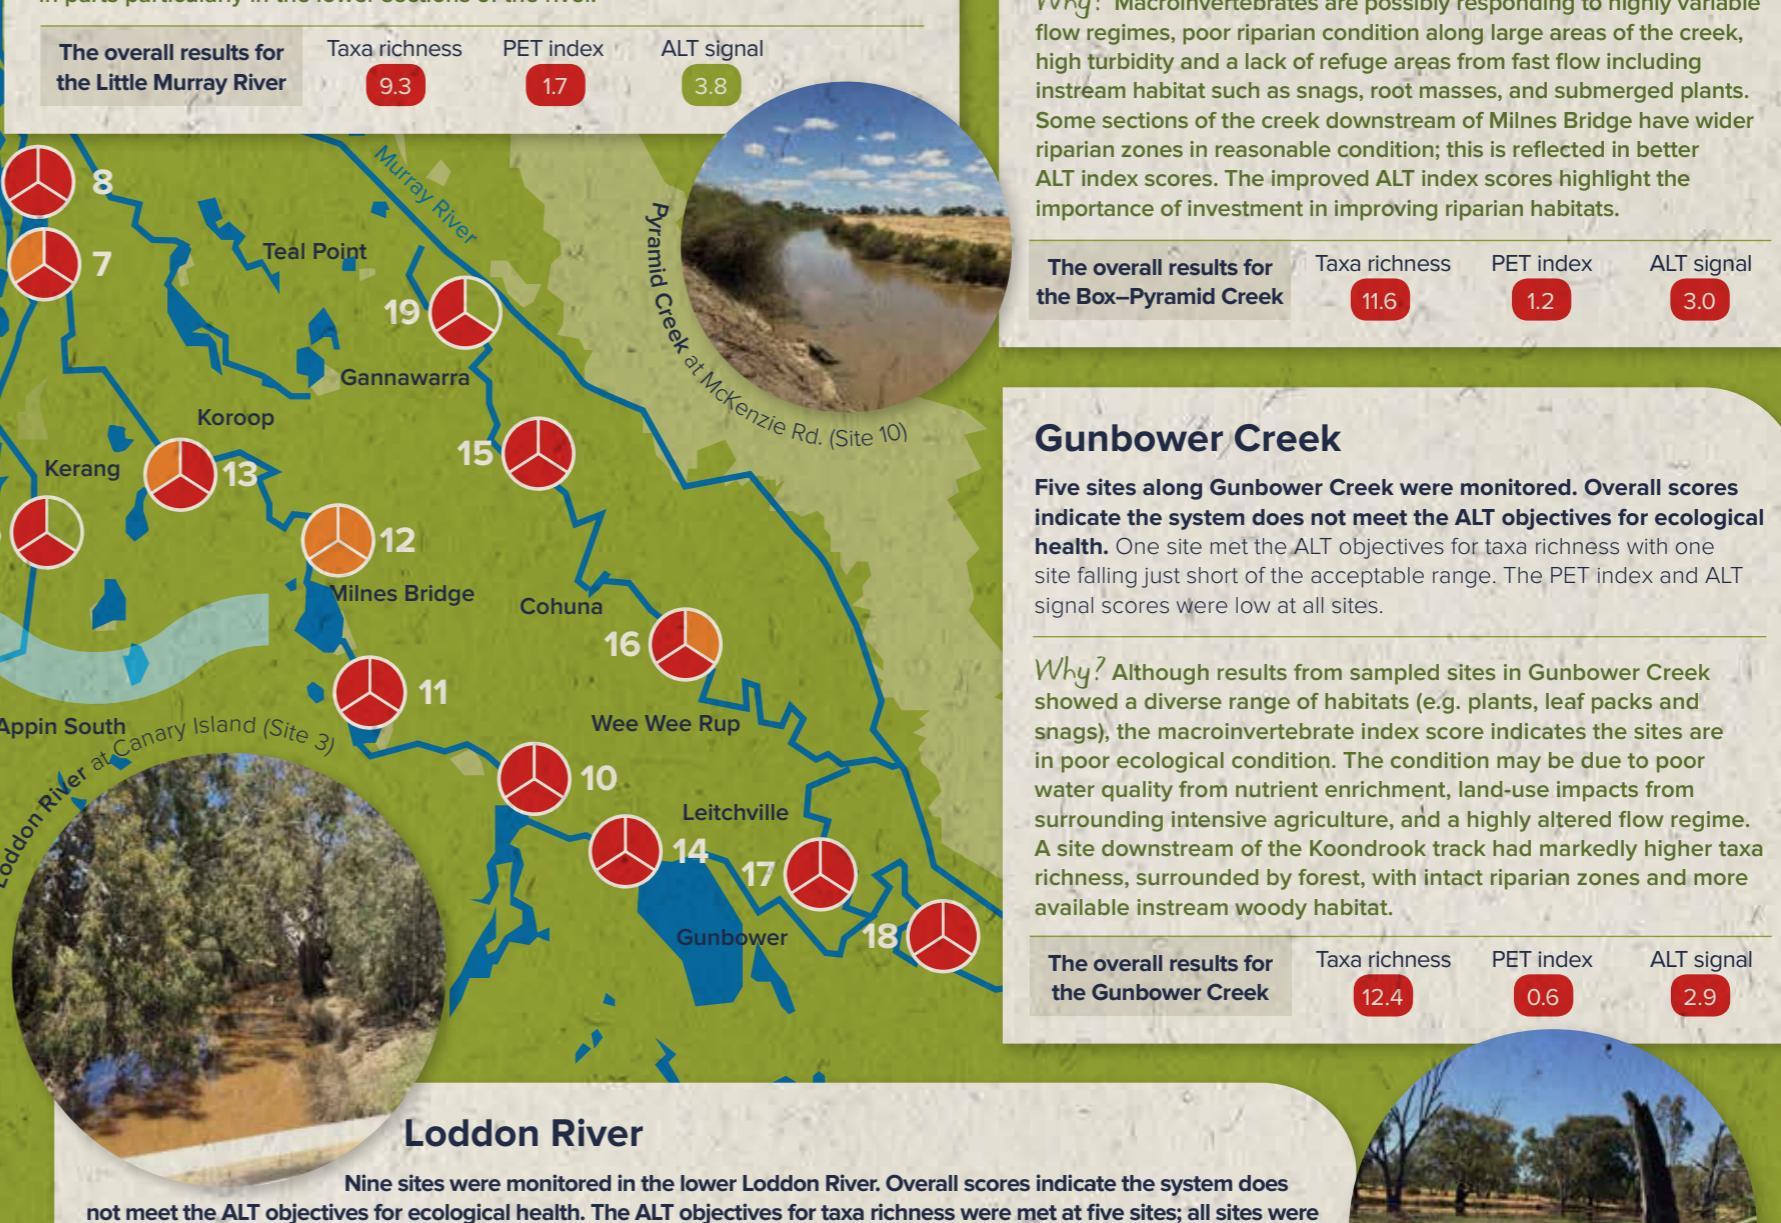
upstream of the Kerang Weir. The ALT objectives for taxa richness were met at five sites, all sites upstream of the Kerang Weir. The remaining four sites had very low taxa richness scores and therefore did not meet the ALT objectives. The PET index score was very low at all but one site. The ALT signal score was poor at five sites, while four sites were close to meeting objectives.

Why? Macroinvertebrate communities in the lower Loddon River have likely been affected by a highly altered flow regime, decreased over-bank flooding, poor water quality (such as high turbidity and low dissolved oxygen levels), degraded habitat from infilling of pools with sediment, and poor riparian condition through past clearing and stock access. While instream woody habitat densities upstream of Kerang Weir are near natural levels, there are areas downstream of the weir that have been channelized and de-snagged in the past. Where riparian improvements have been delivered in the Loddon system, the water quality and macroinvertebrates may take time to recover to a good condition.
