North Central Waterwatch & Native Fish Recovery Plan Annual River Health Snapshot Report 2016

Understanding and reporting on the condition of our waterways is important for guiding waterway management decisions and demonstrating management outcomes.

The results in this report are based on the analysis of macroinvertebrate monitoring data collected in spring 2016. The report provides an assessment of the current condition of four main waterways in the program area; Loddon River, Box-Pyramid Creek, Gunbower Creek and Little Murray River.

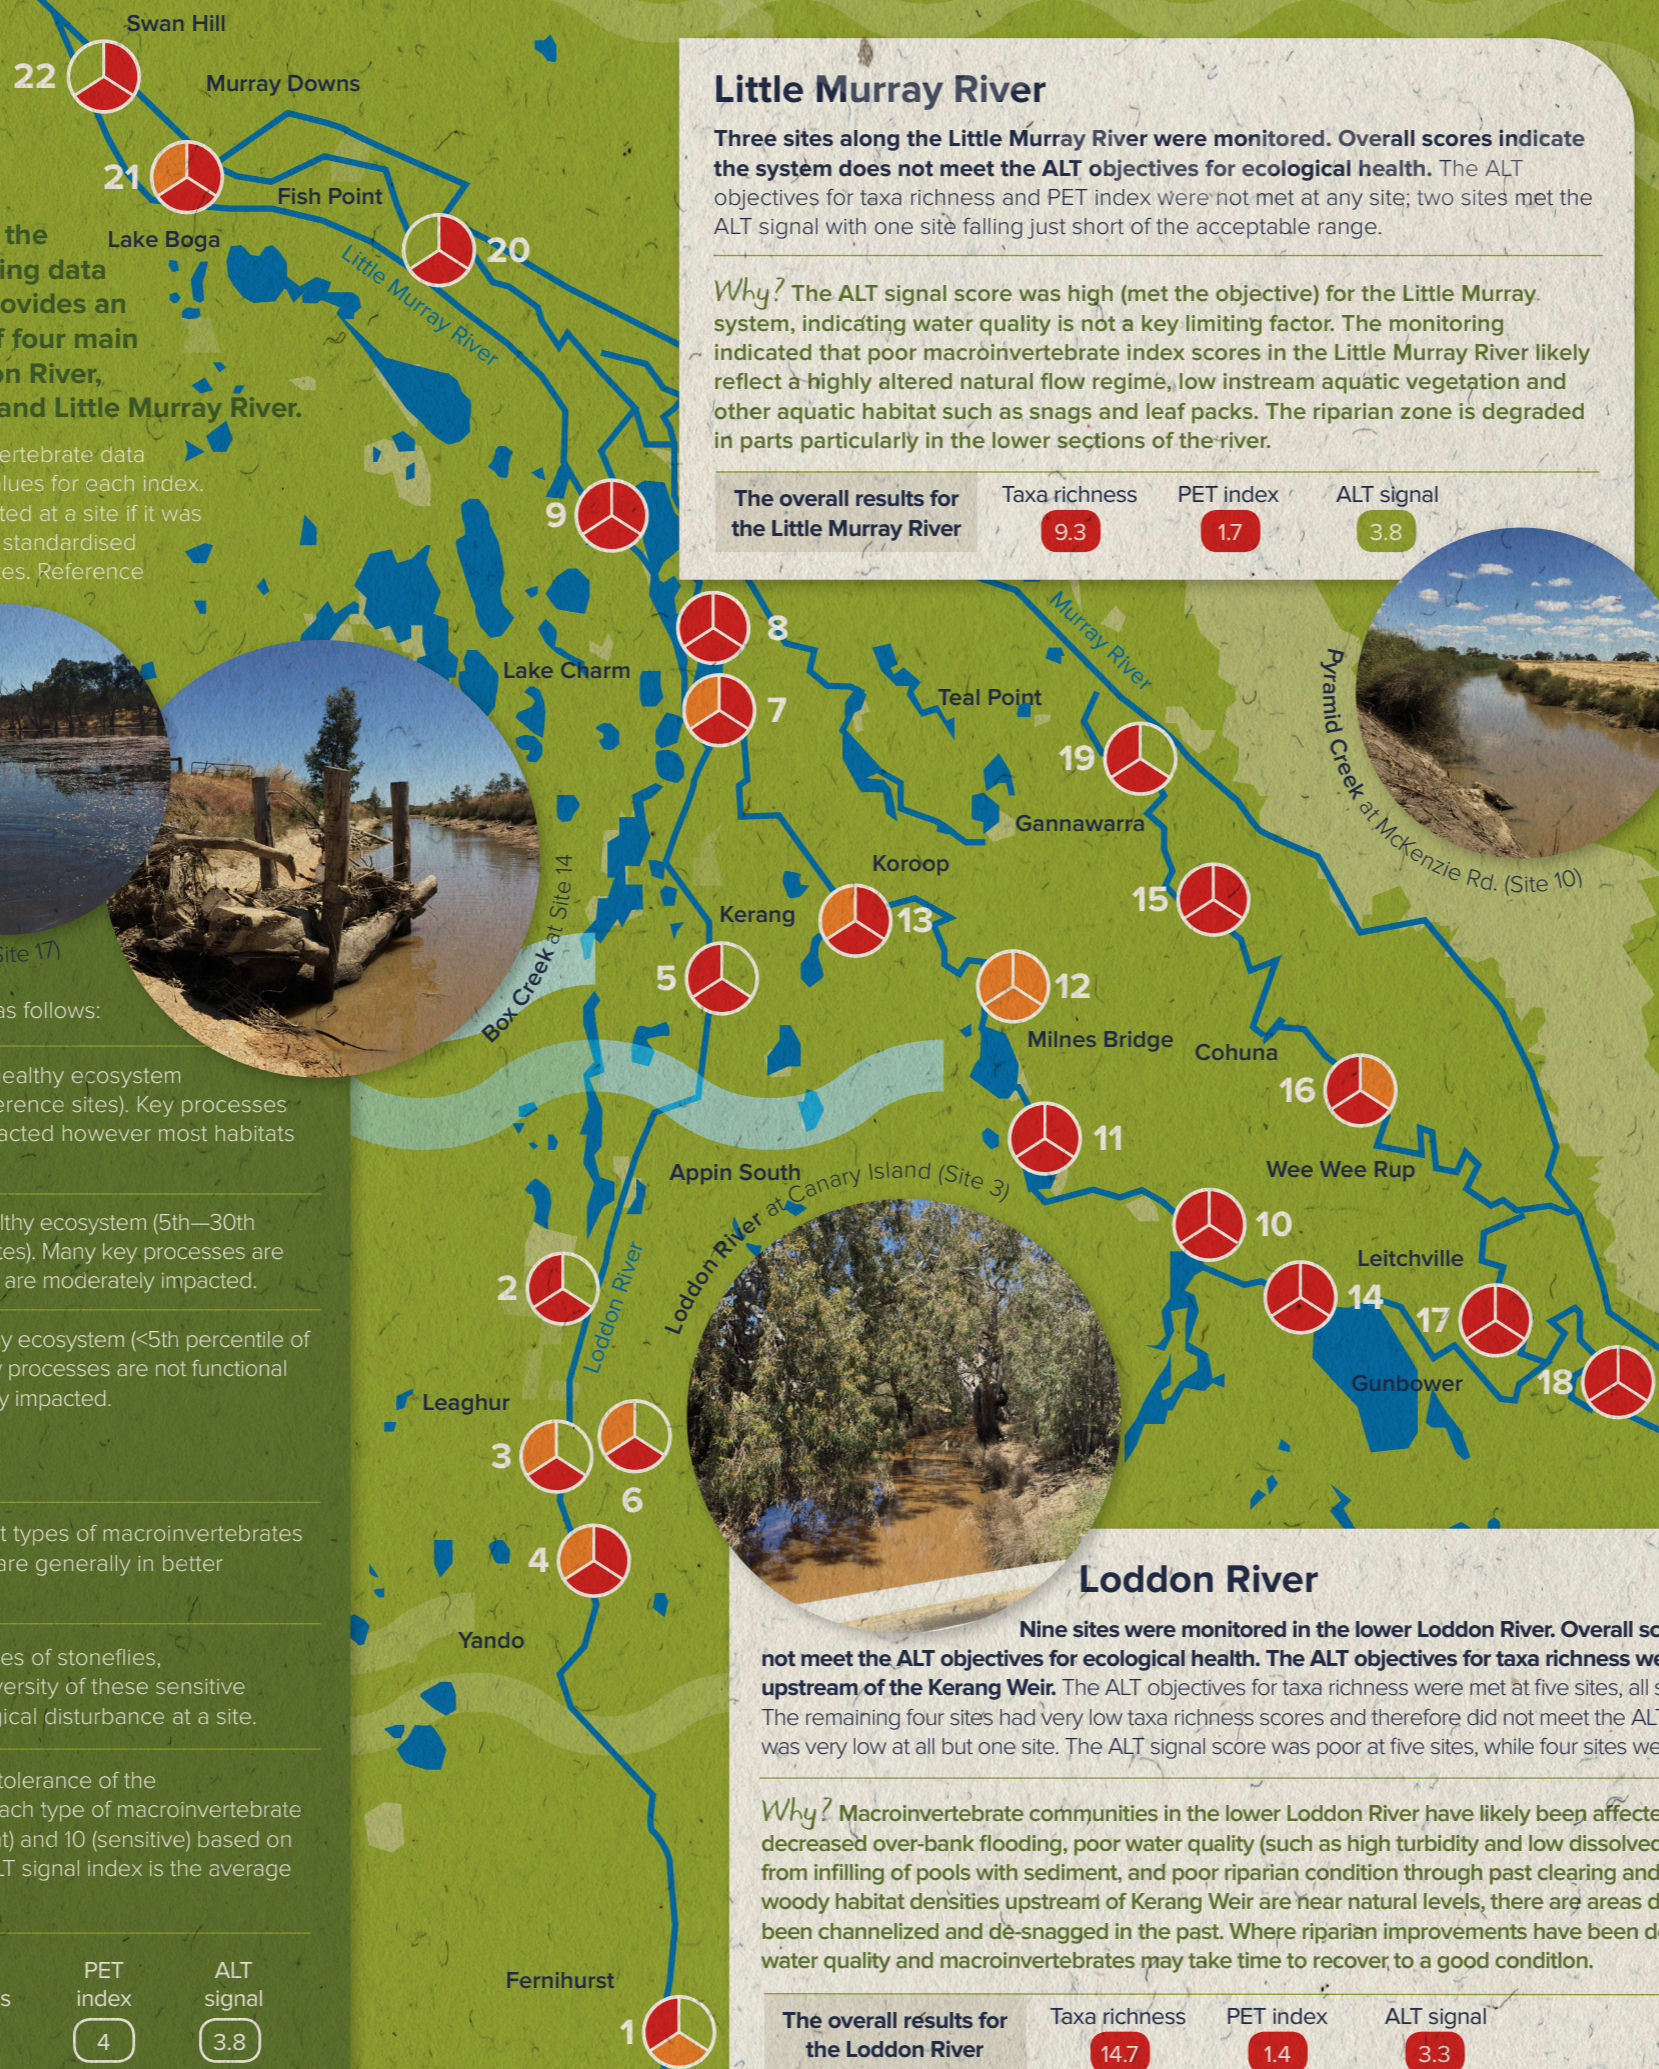
Colour Coding

Sites have been colour coded and interpreted as follows:

- Meets or exceeds ALT objectives for a healthy ecosystem (>30th percentile of index values for reference sites). Key processes and/or water quality may be slightly impacted however most habitats are intact.
- Close to meeting ALT objectives for a healthy ecosystem (5th–30th percentile of index values for reference sites). Many key processes are not functional; water quality and/or habitat are moderately impacted.
- Does not meet ALT objectives for a healthy ecosystem (<5th percentile of index values for reference sites). Most key processes are not functional and water quality and/or habitat is severely impacted.
